*California Department of Transportation  
Division of Maintenance*

*Structure Maintenance and Investigations*

CONDITION TEXT

To ease identification structure was renamed from MOUNT VERNON AVE OH to MOUNT VERNON AVE OH - 1934 to include year built to differentiate from the other structure with the same name built in 1958.

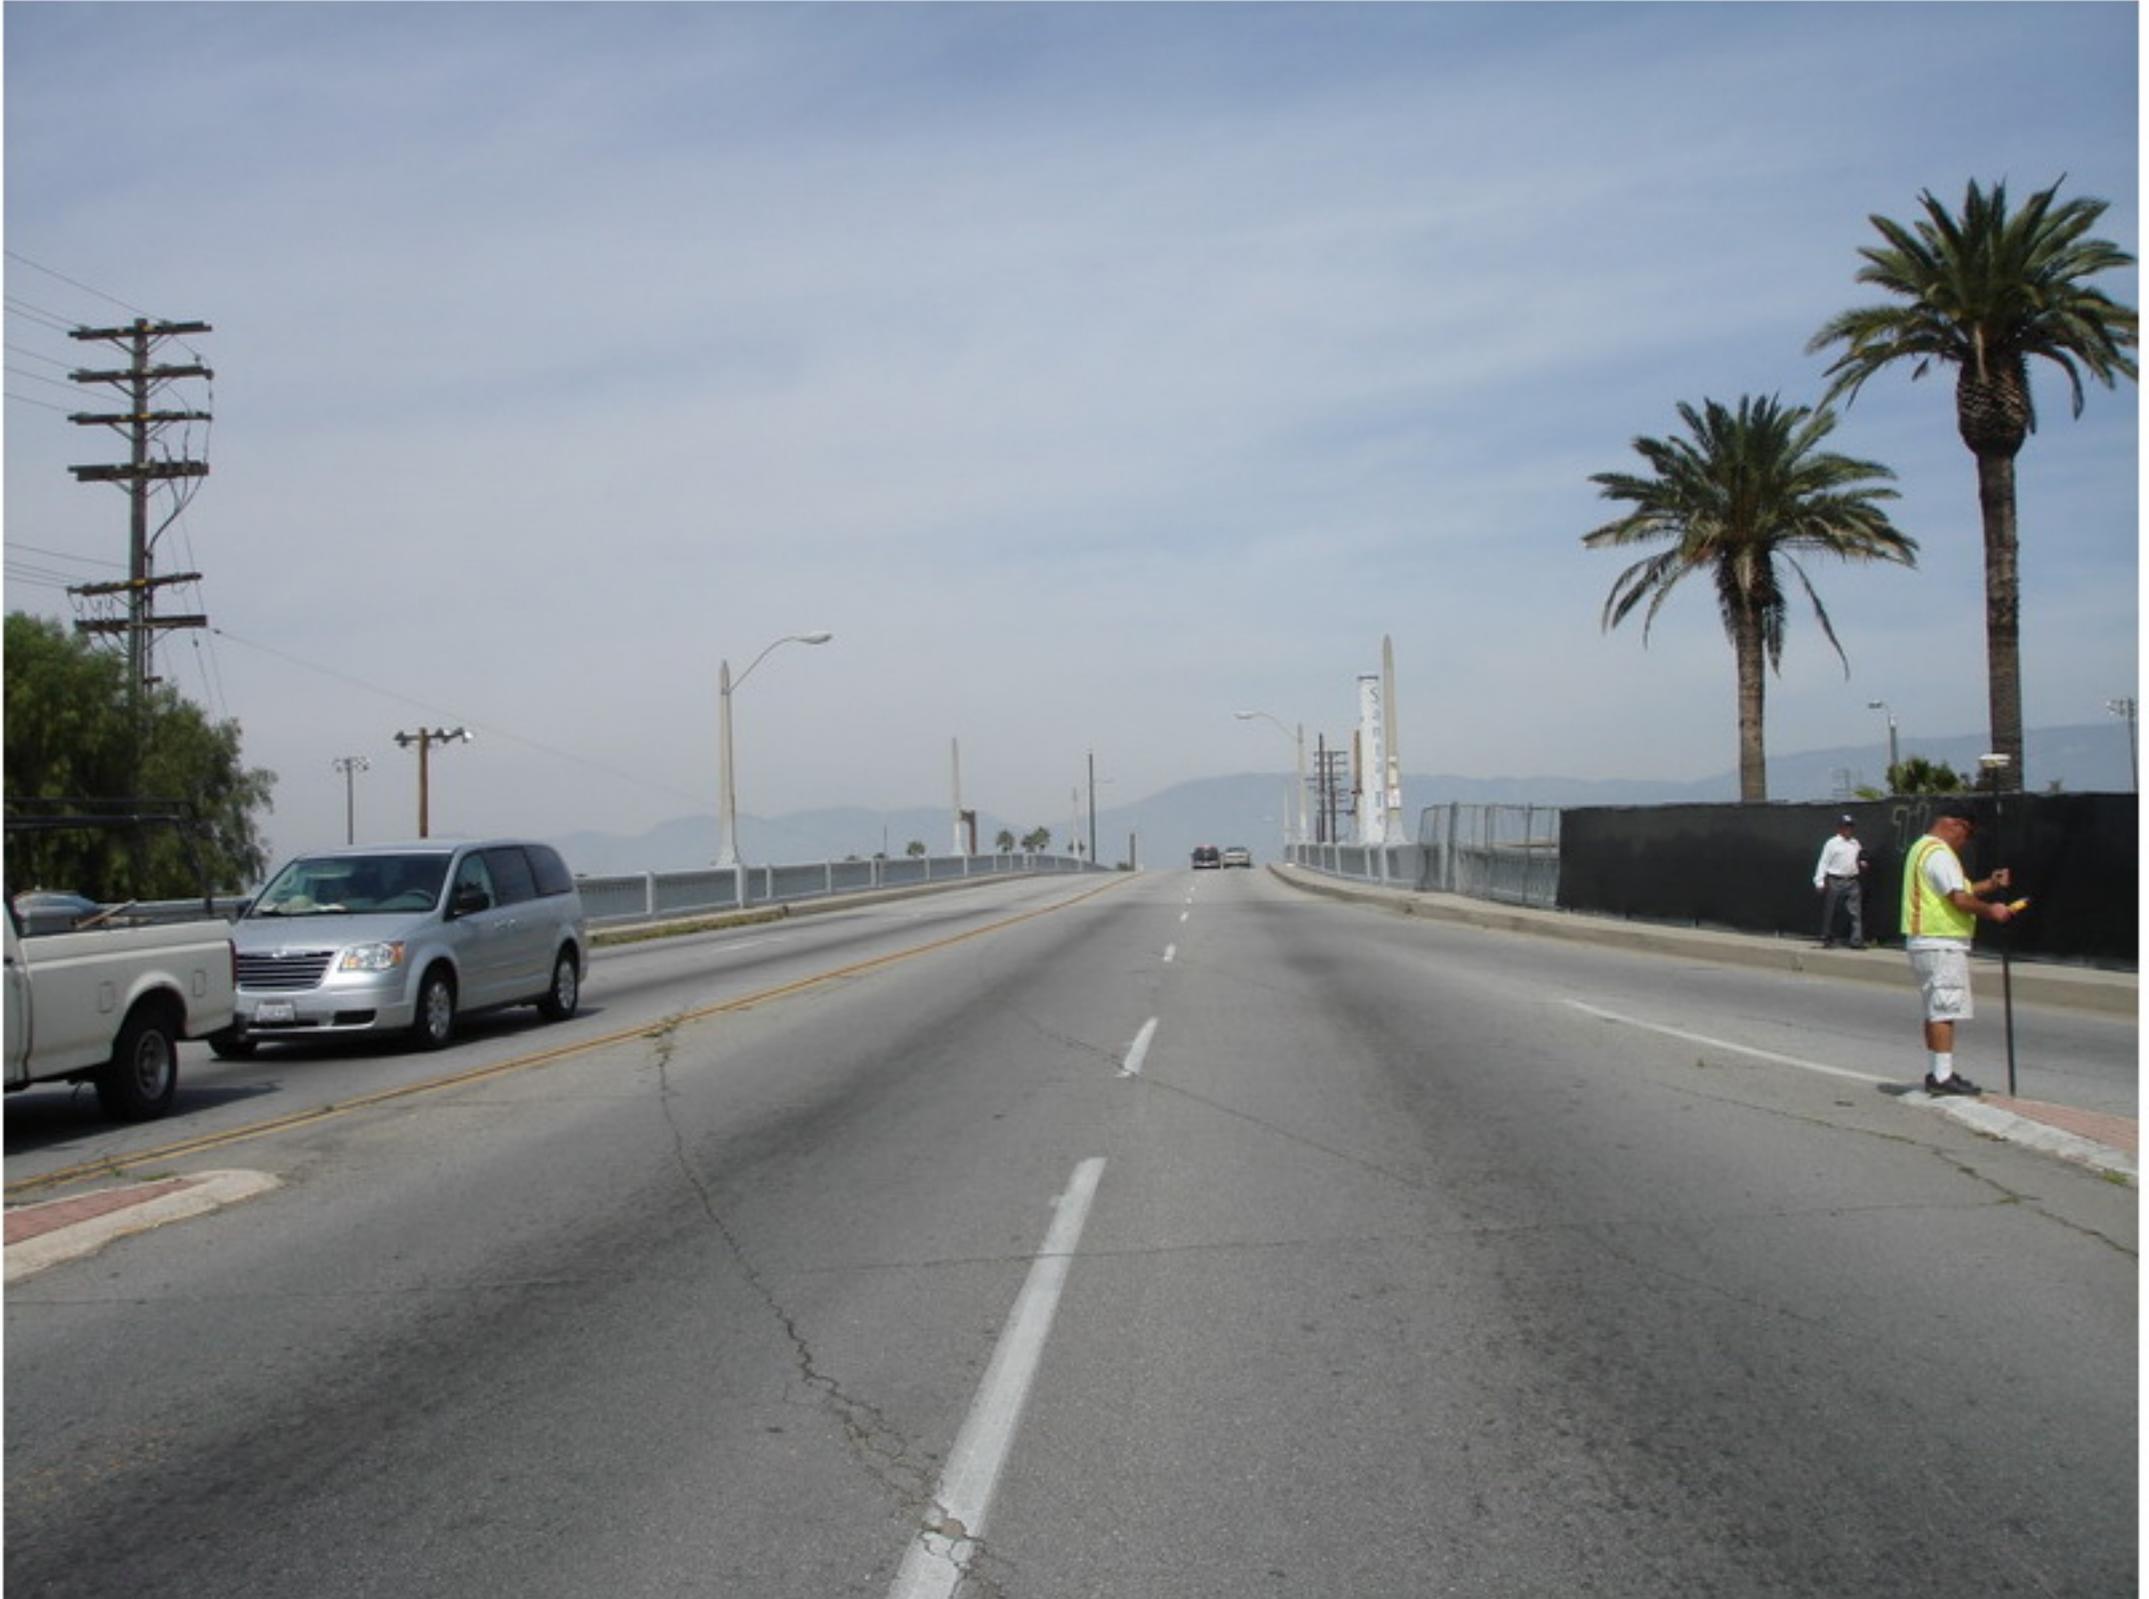
Photo No. 1  
Routine deck view looking north on Mt Vernon

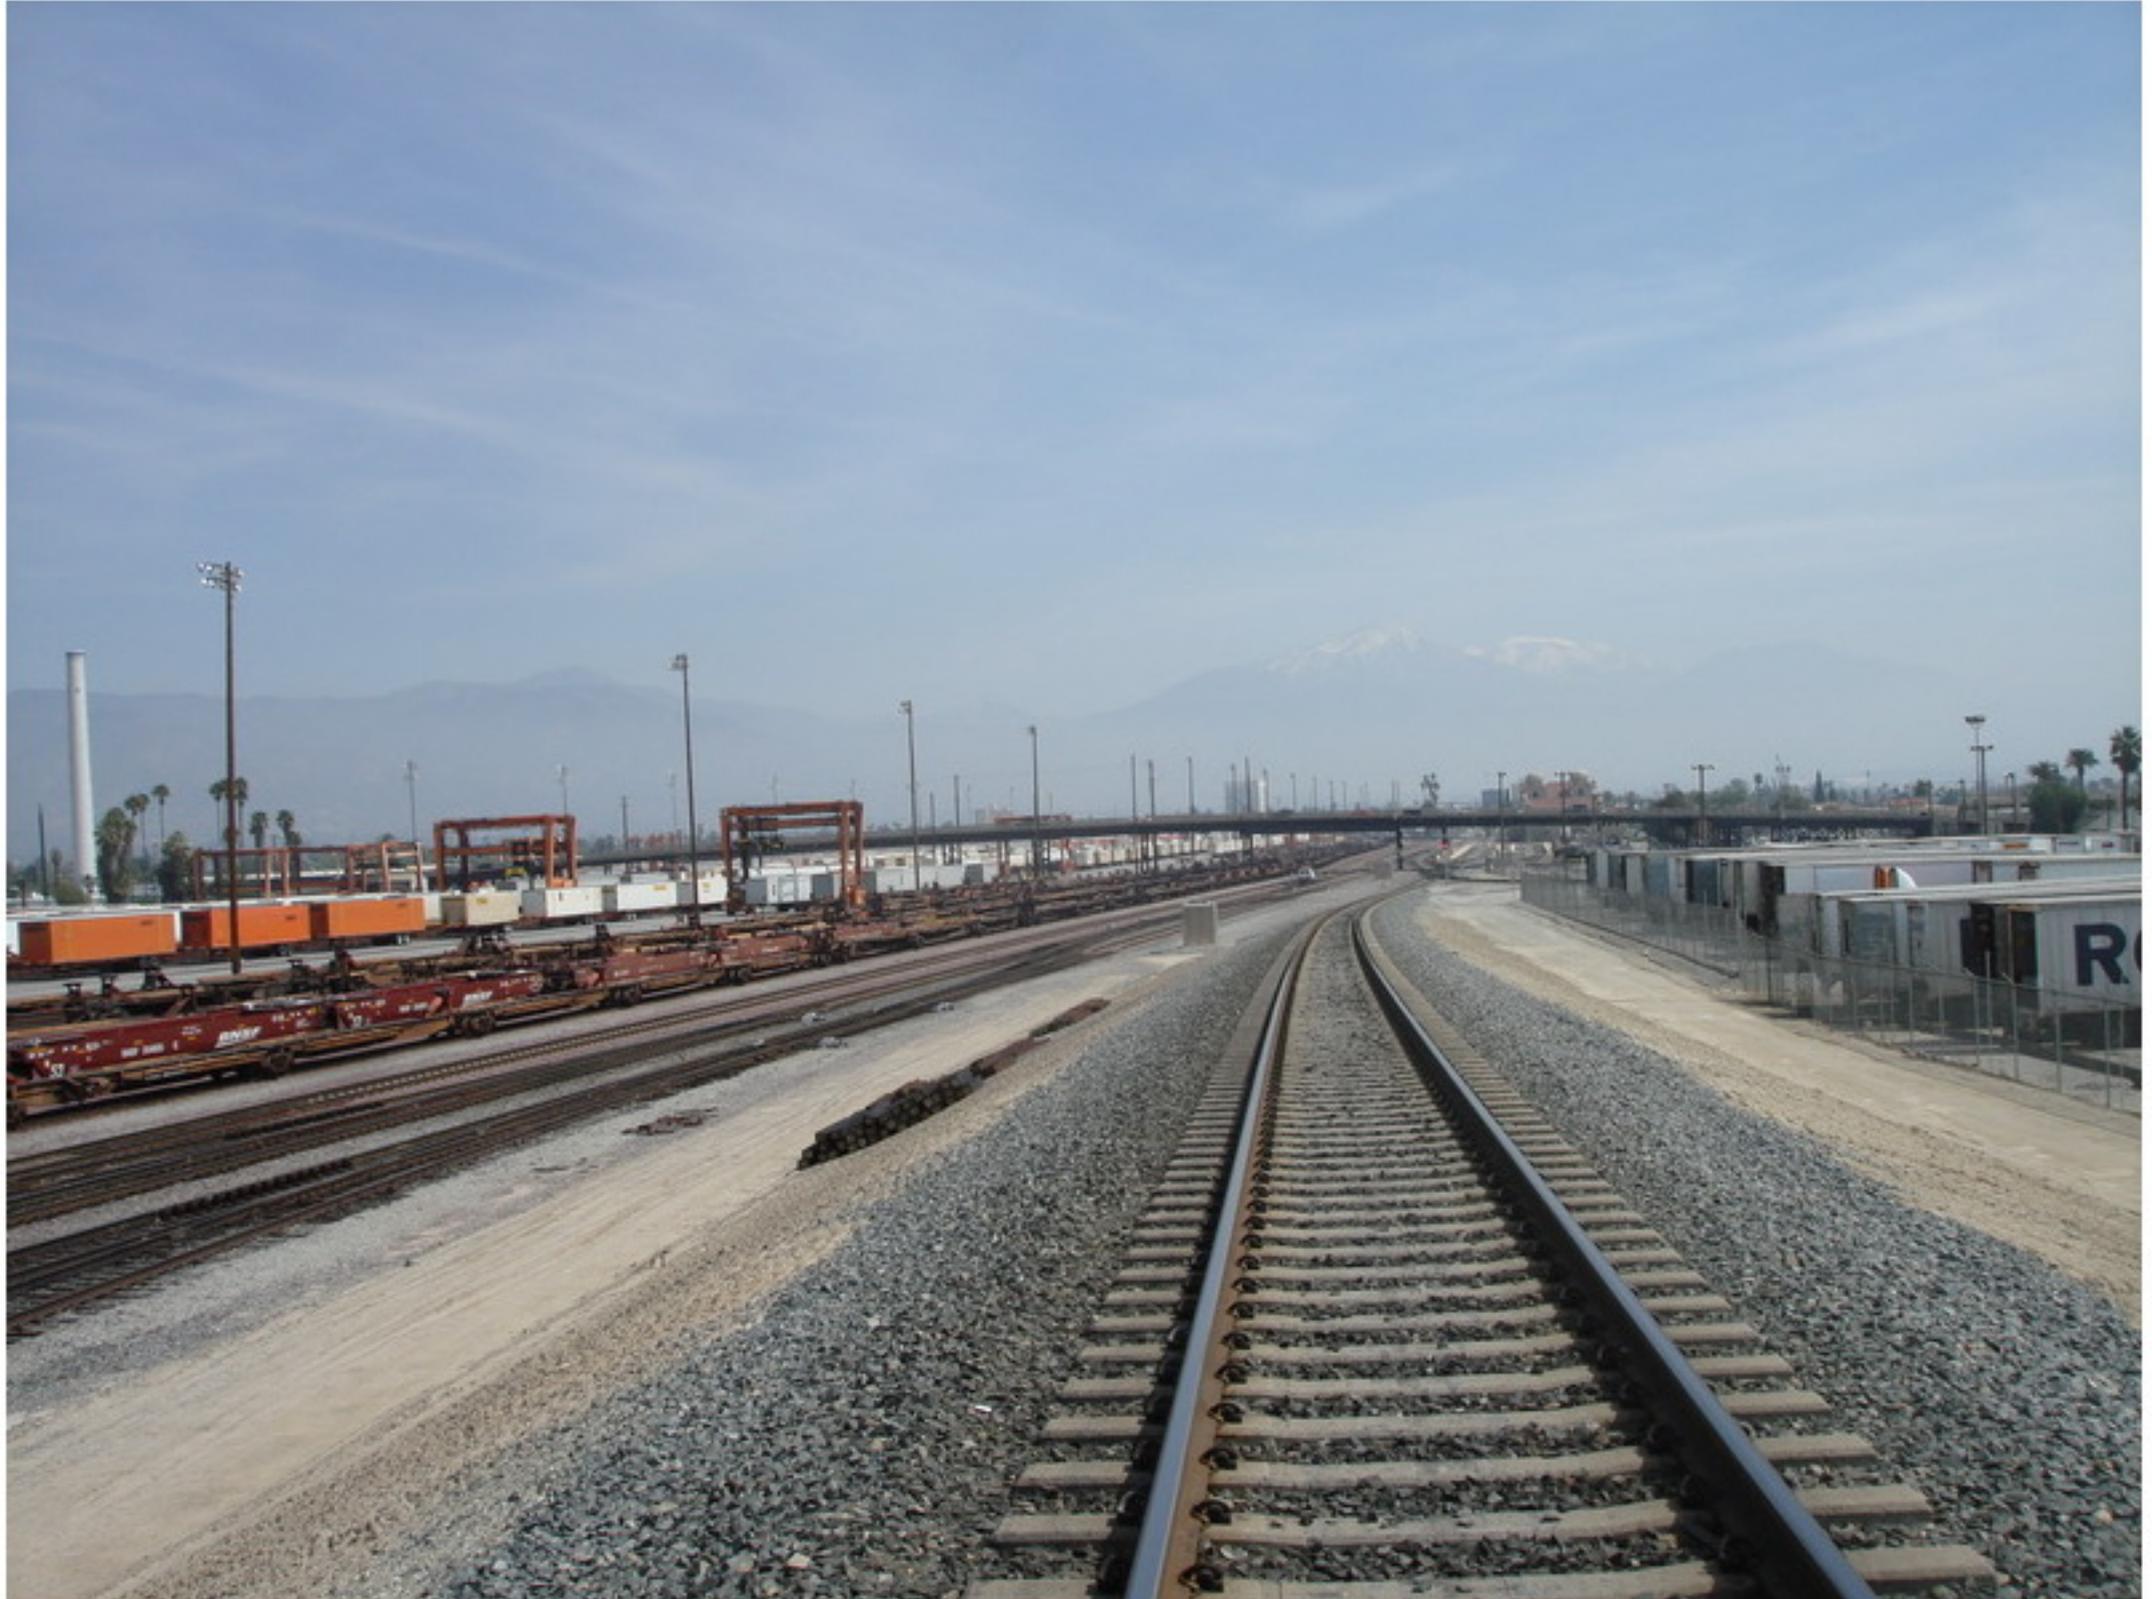
Photo No. 1  
Routine elevation from distance capture both ends of bridge

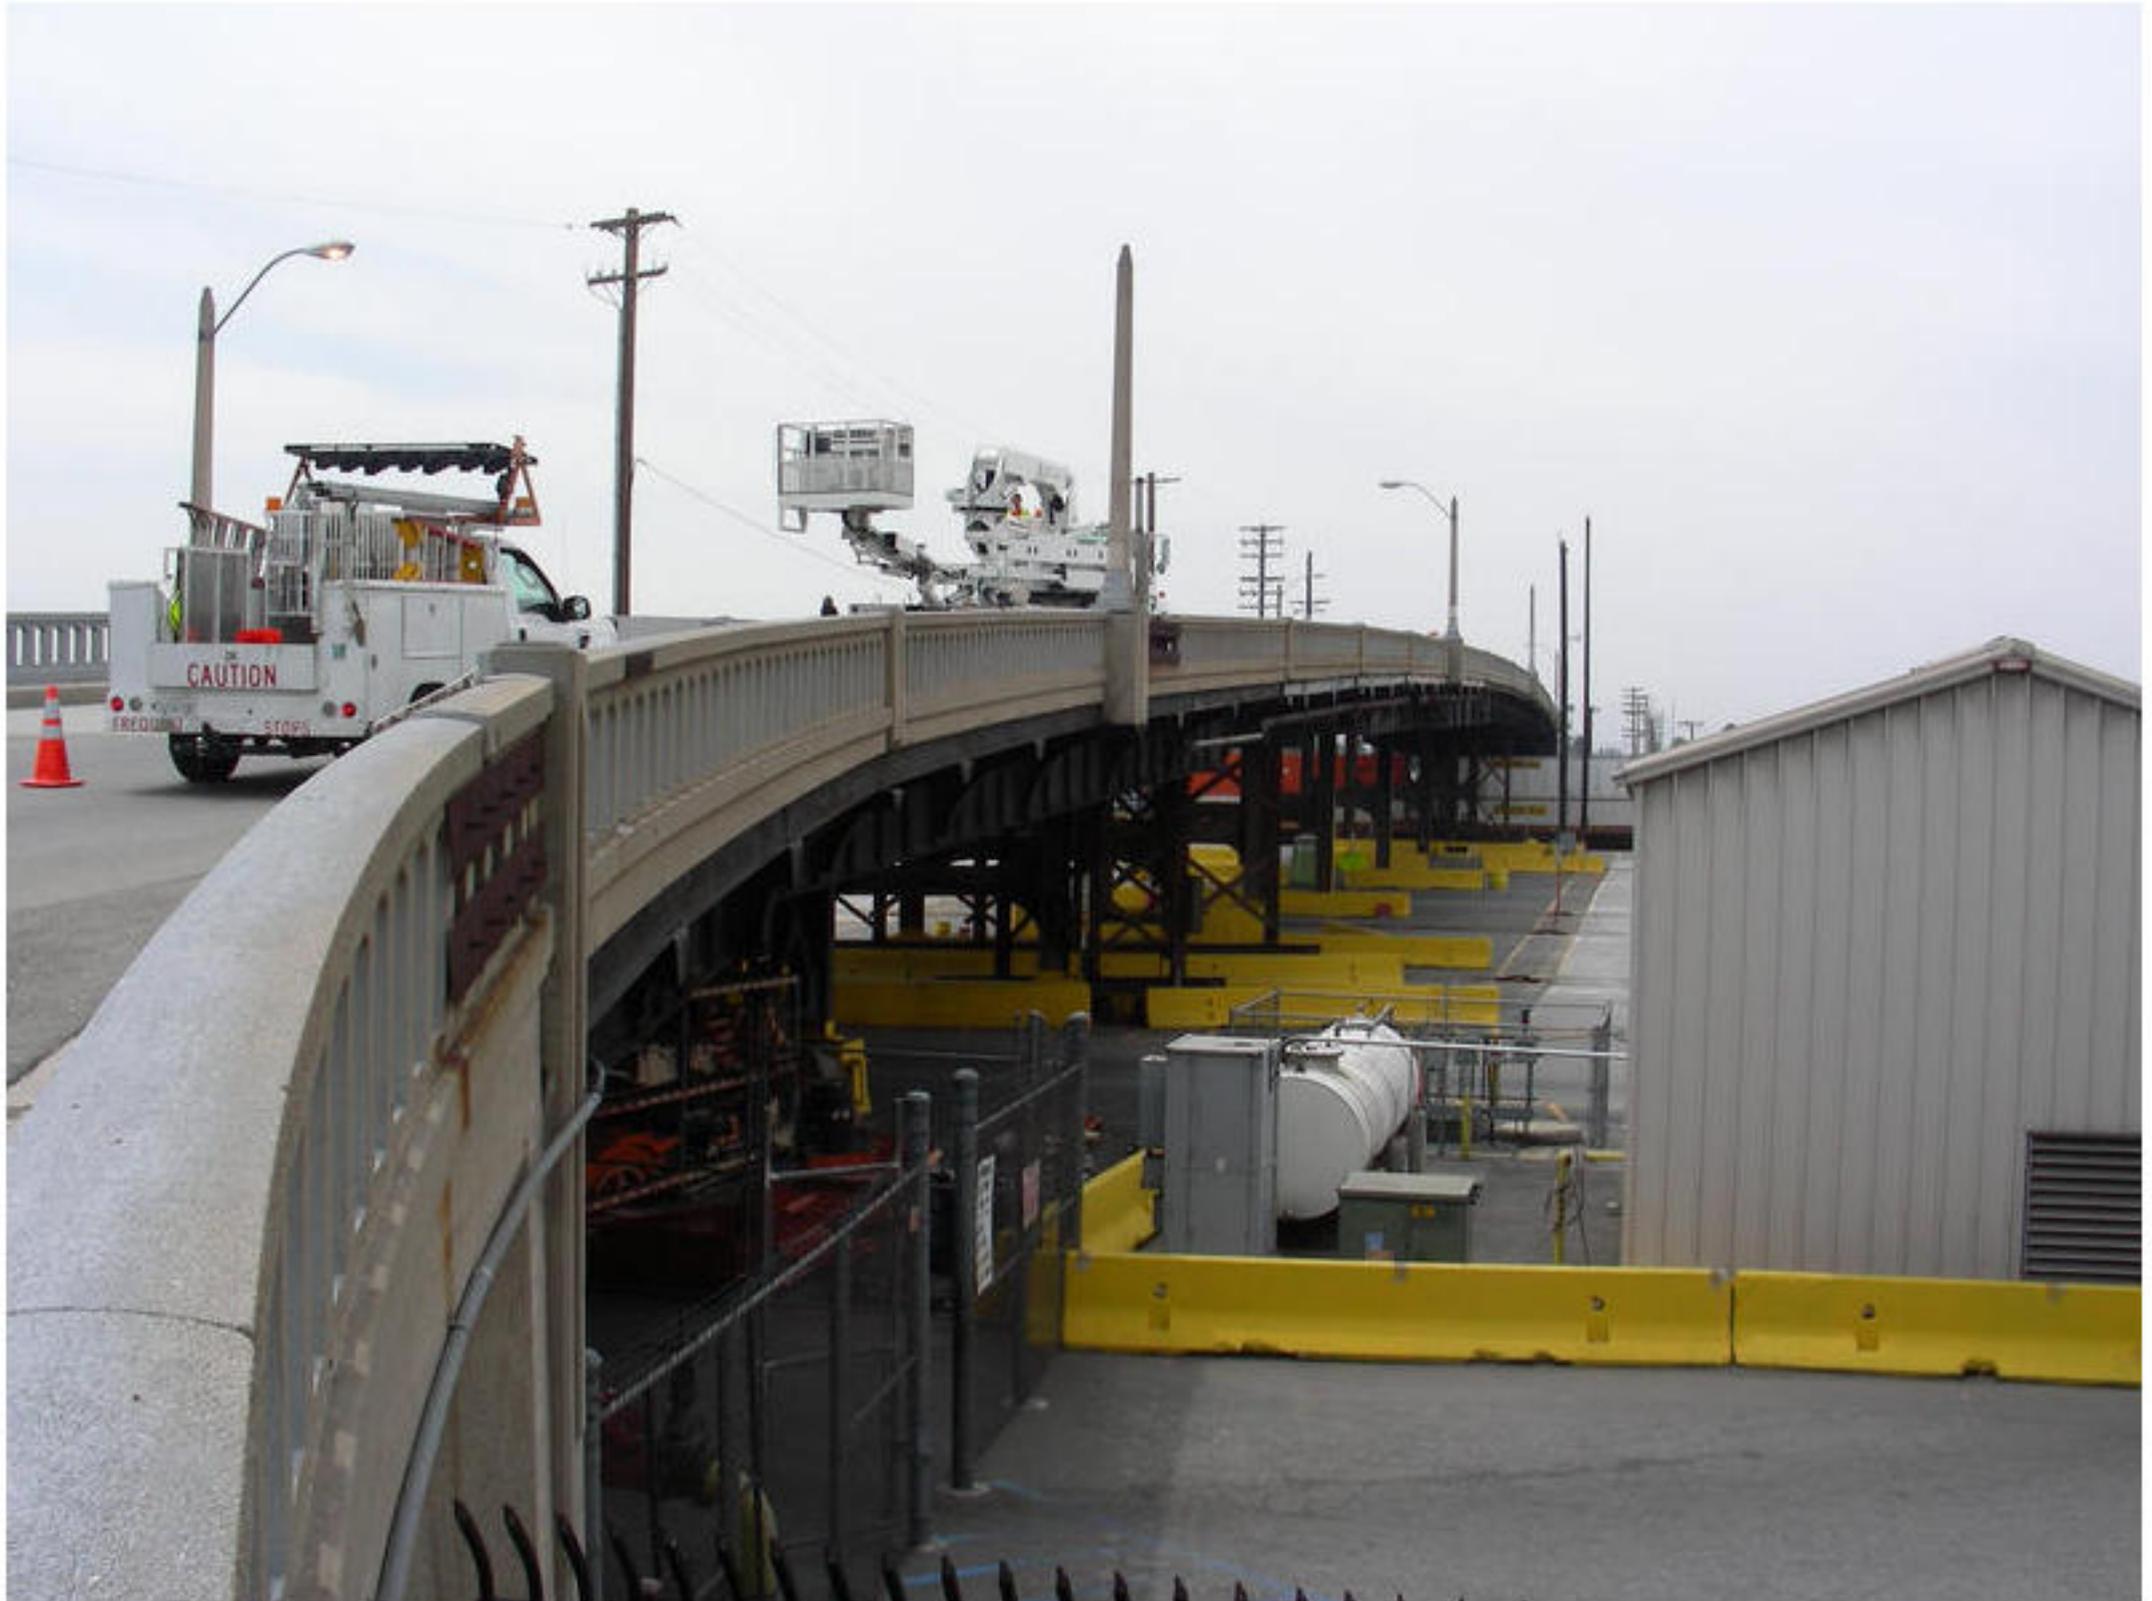
Photo No. 1  
Partial Elevation Showing Structure Over the BNSF Yard

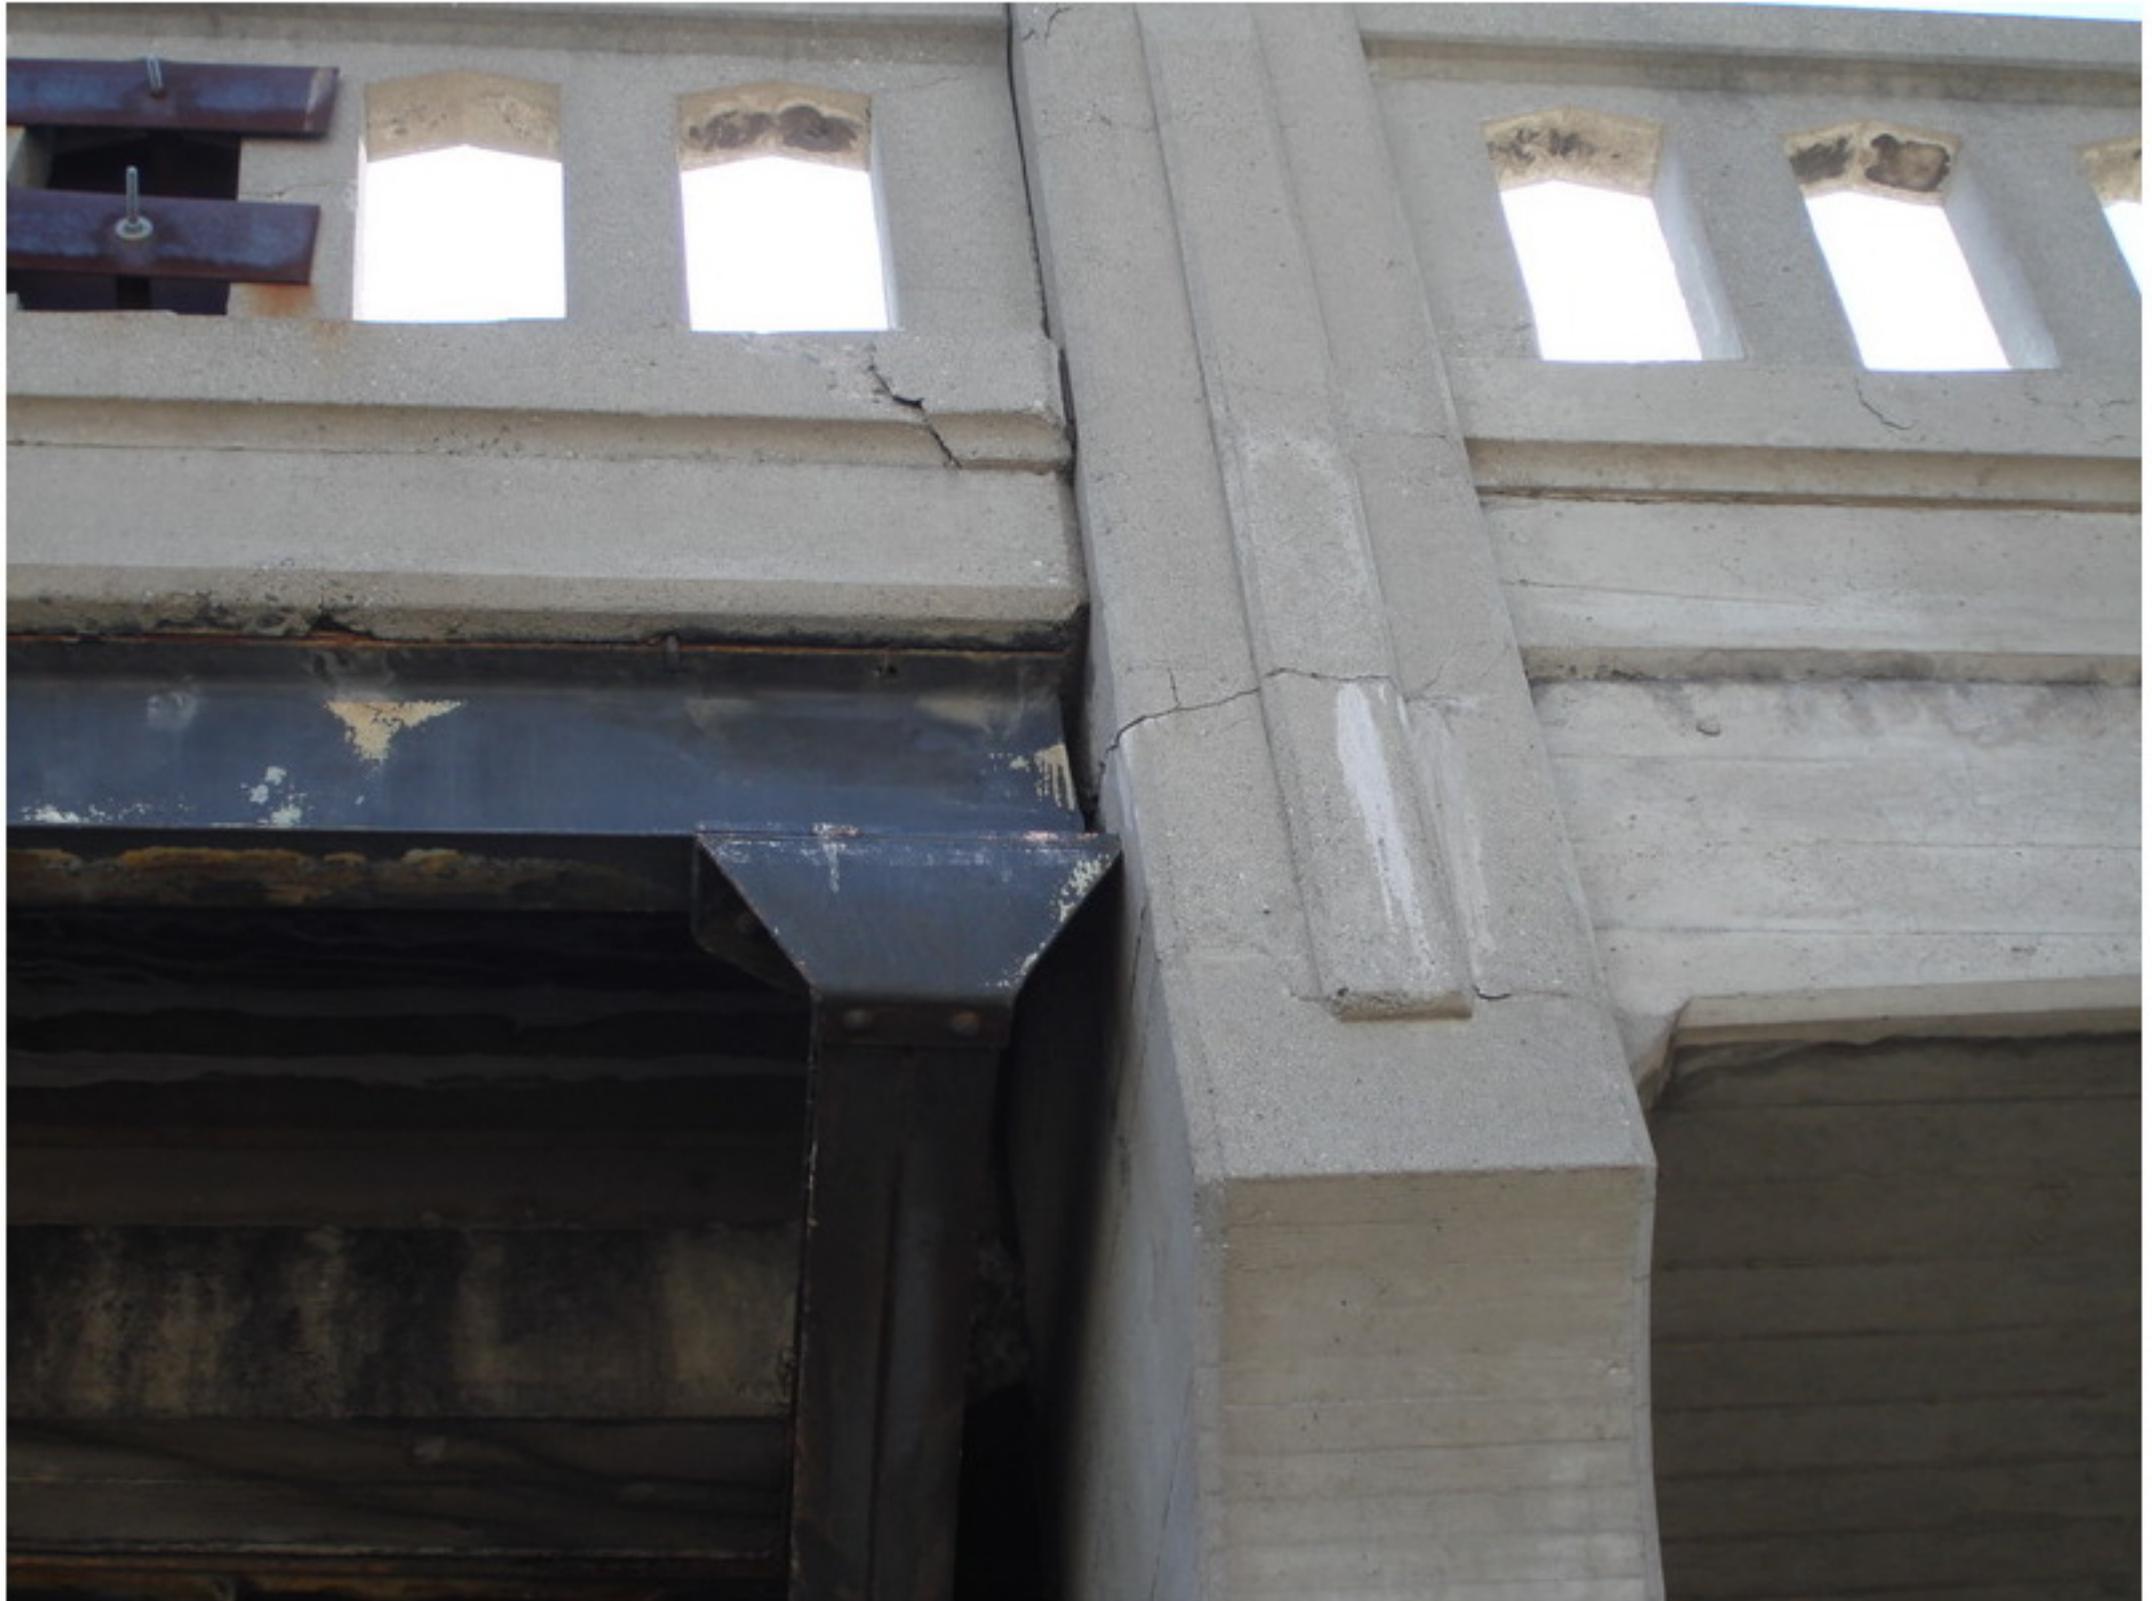
Photo No. 1  
Spalls developing along the old decoarative barrier

Maintain temporary shoring in satisfactory condition until replacement of structure ASAP  
Remove concrete spalls that are loose at B3 on the westerly side of the bridge.

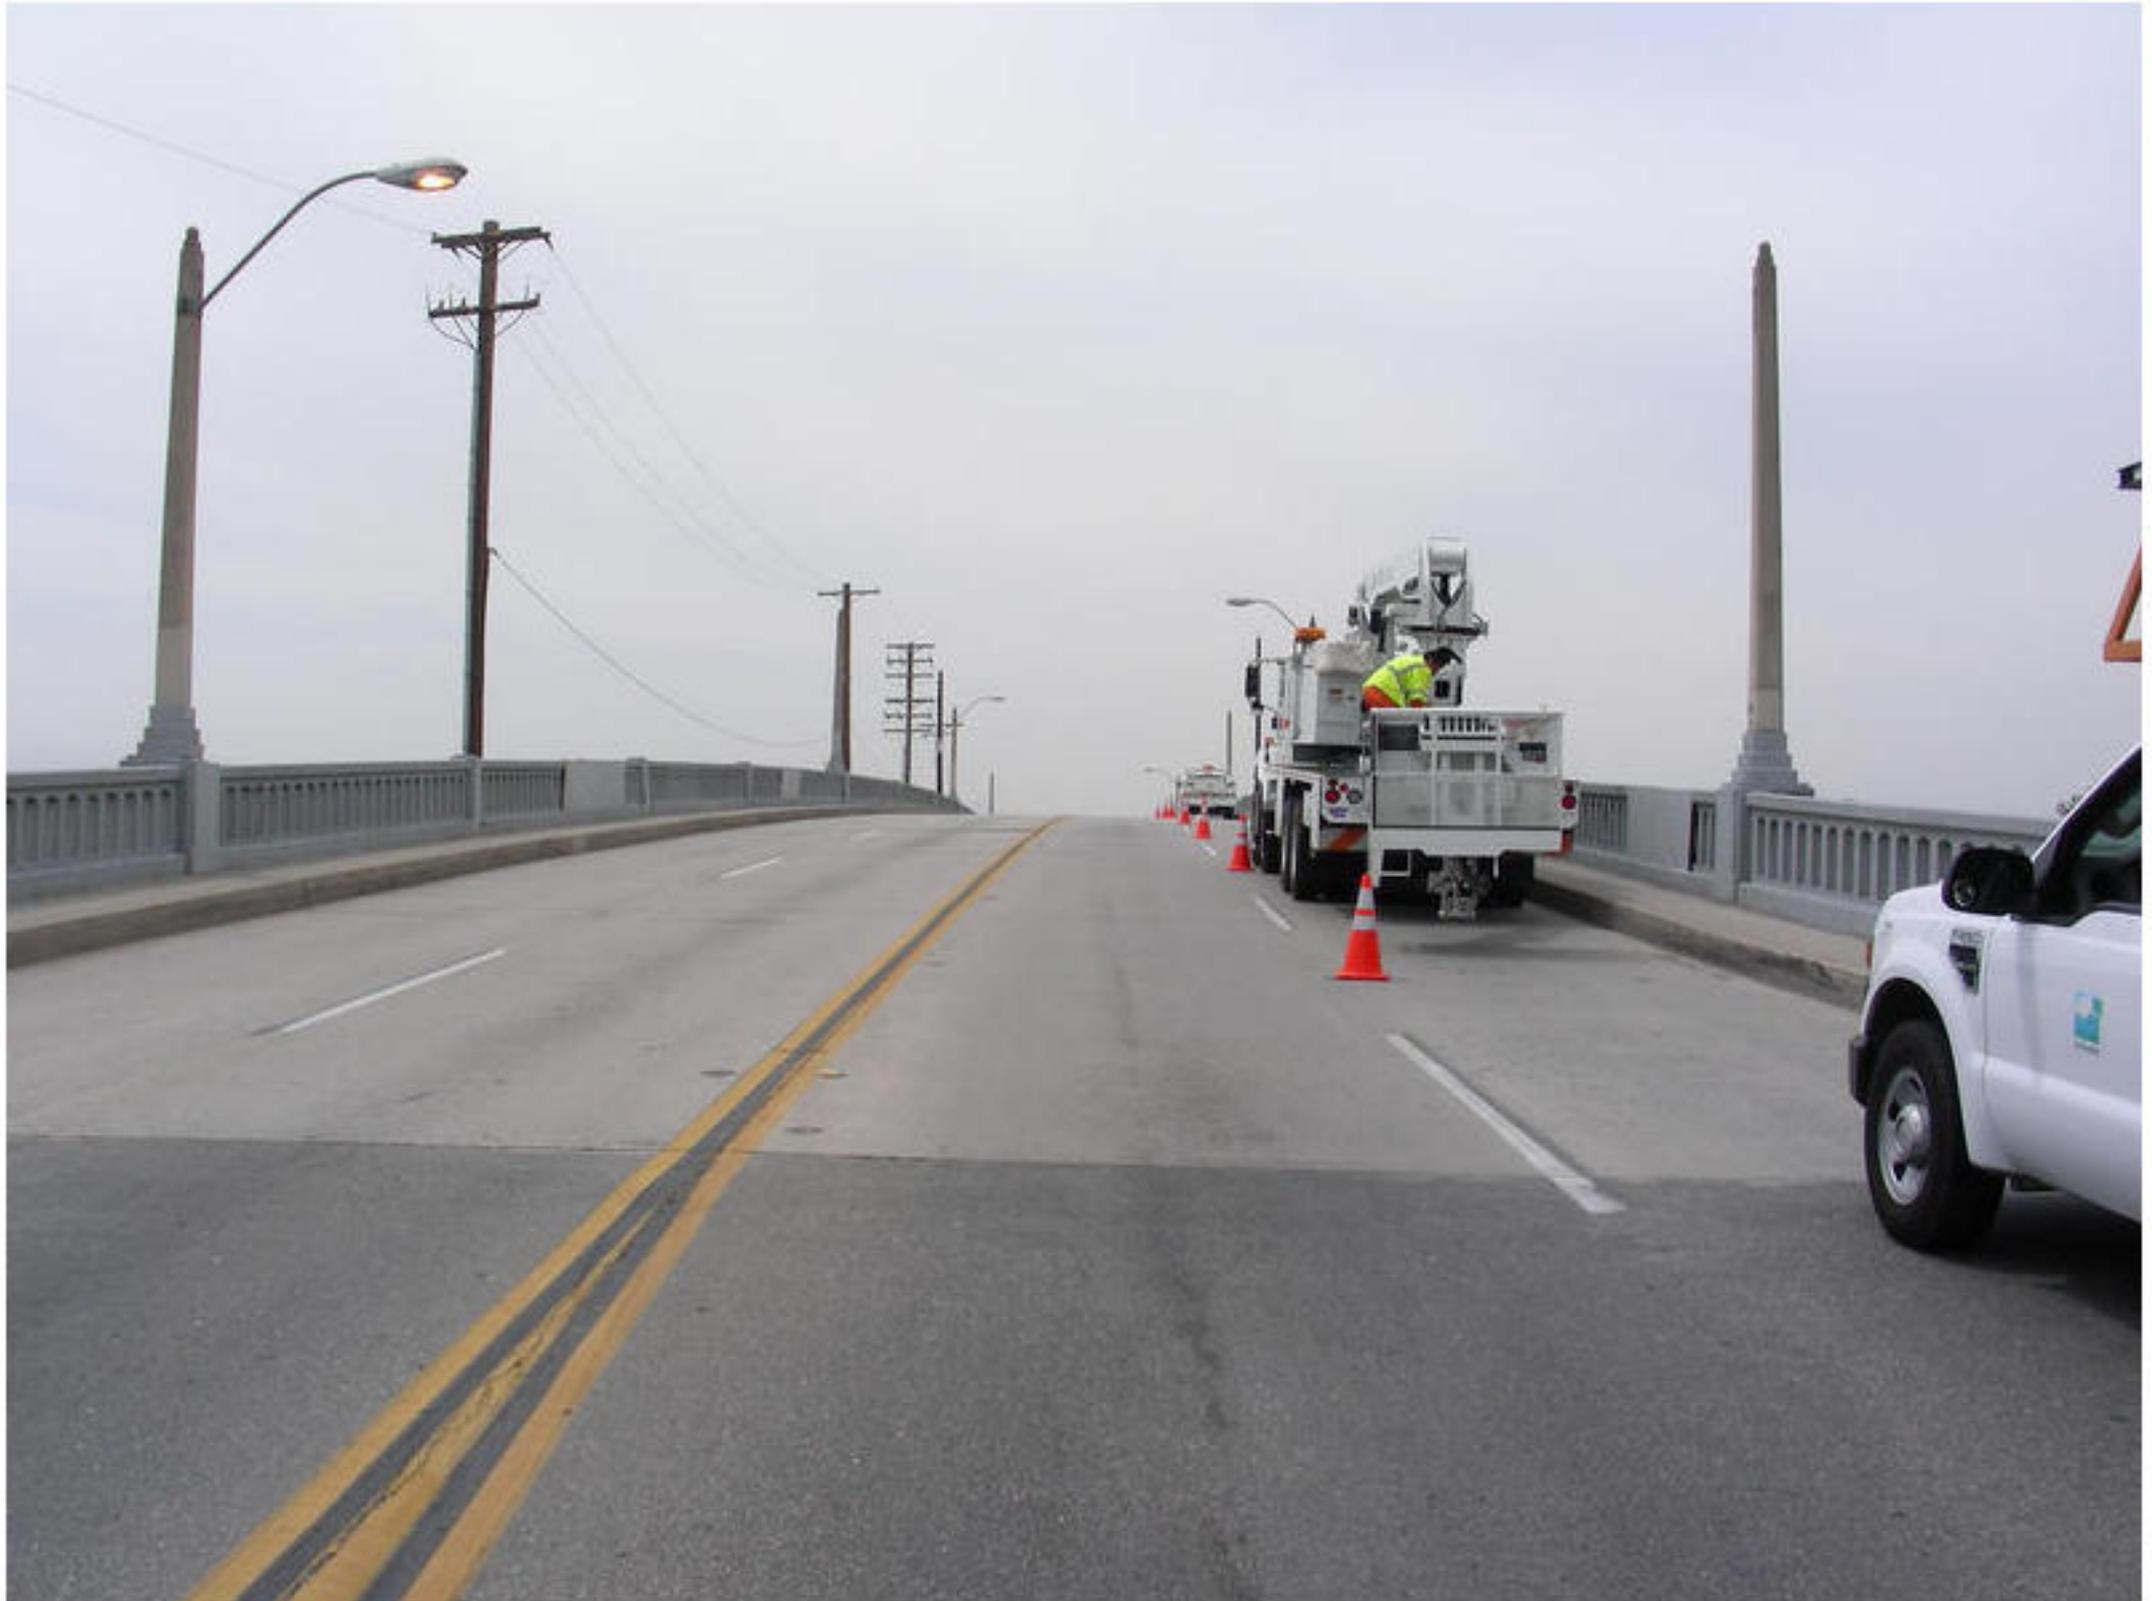
Photo No. 2  
Roadway View of Southbound Lane Closure on Mount Vernon Avenue

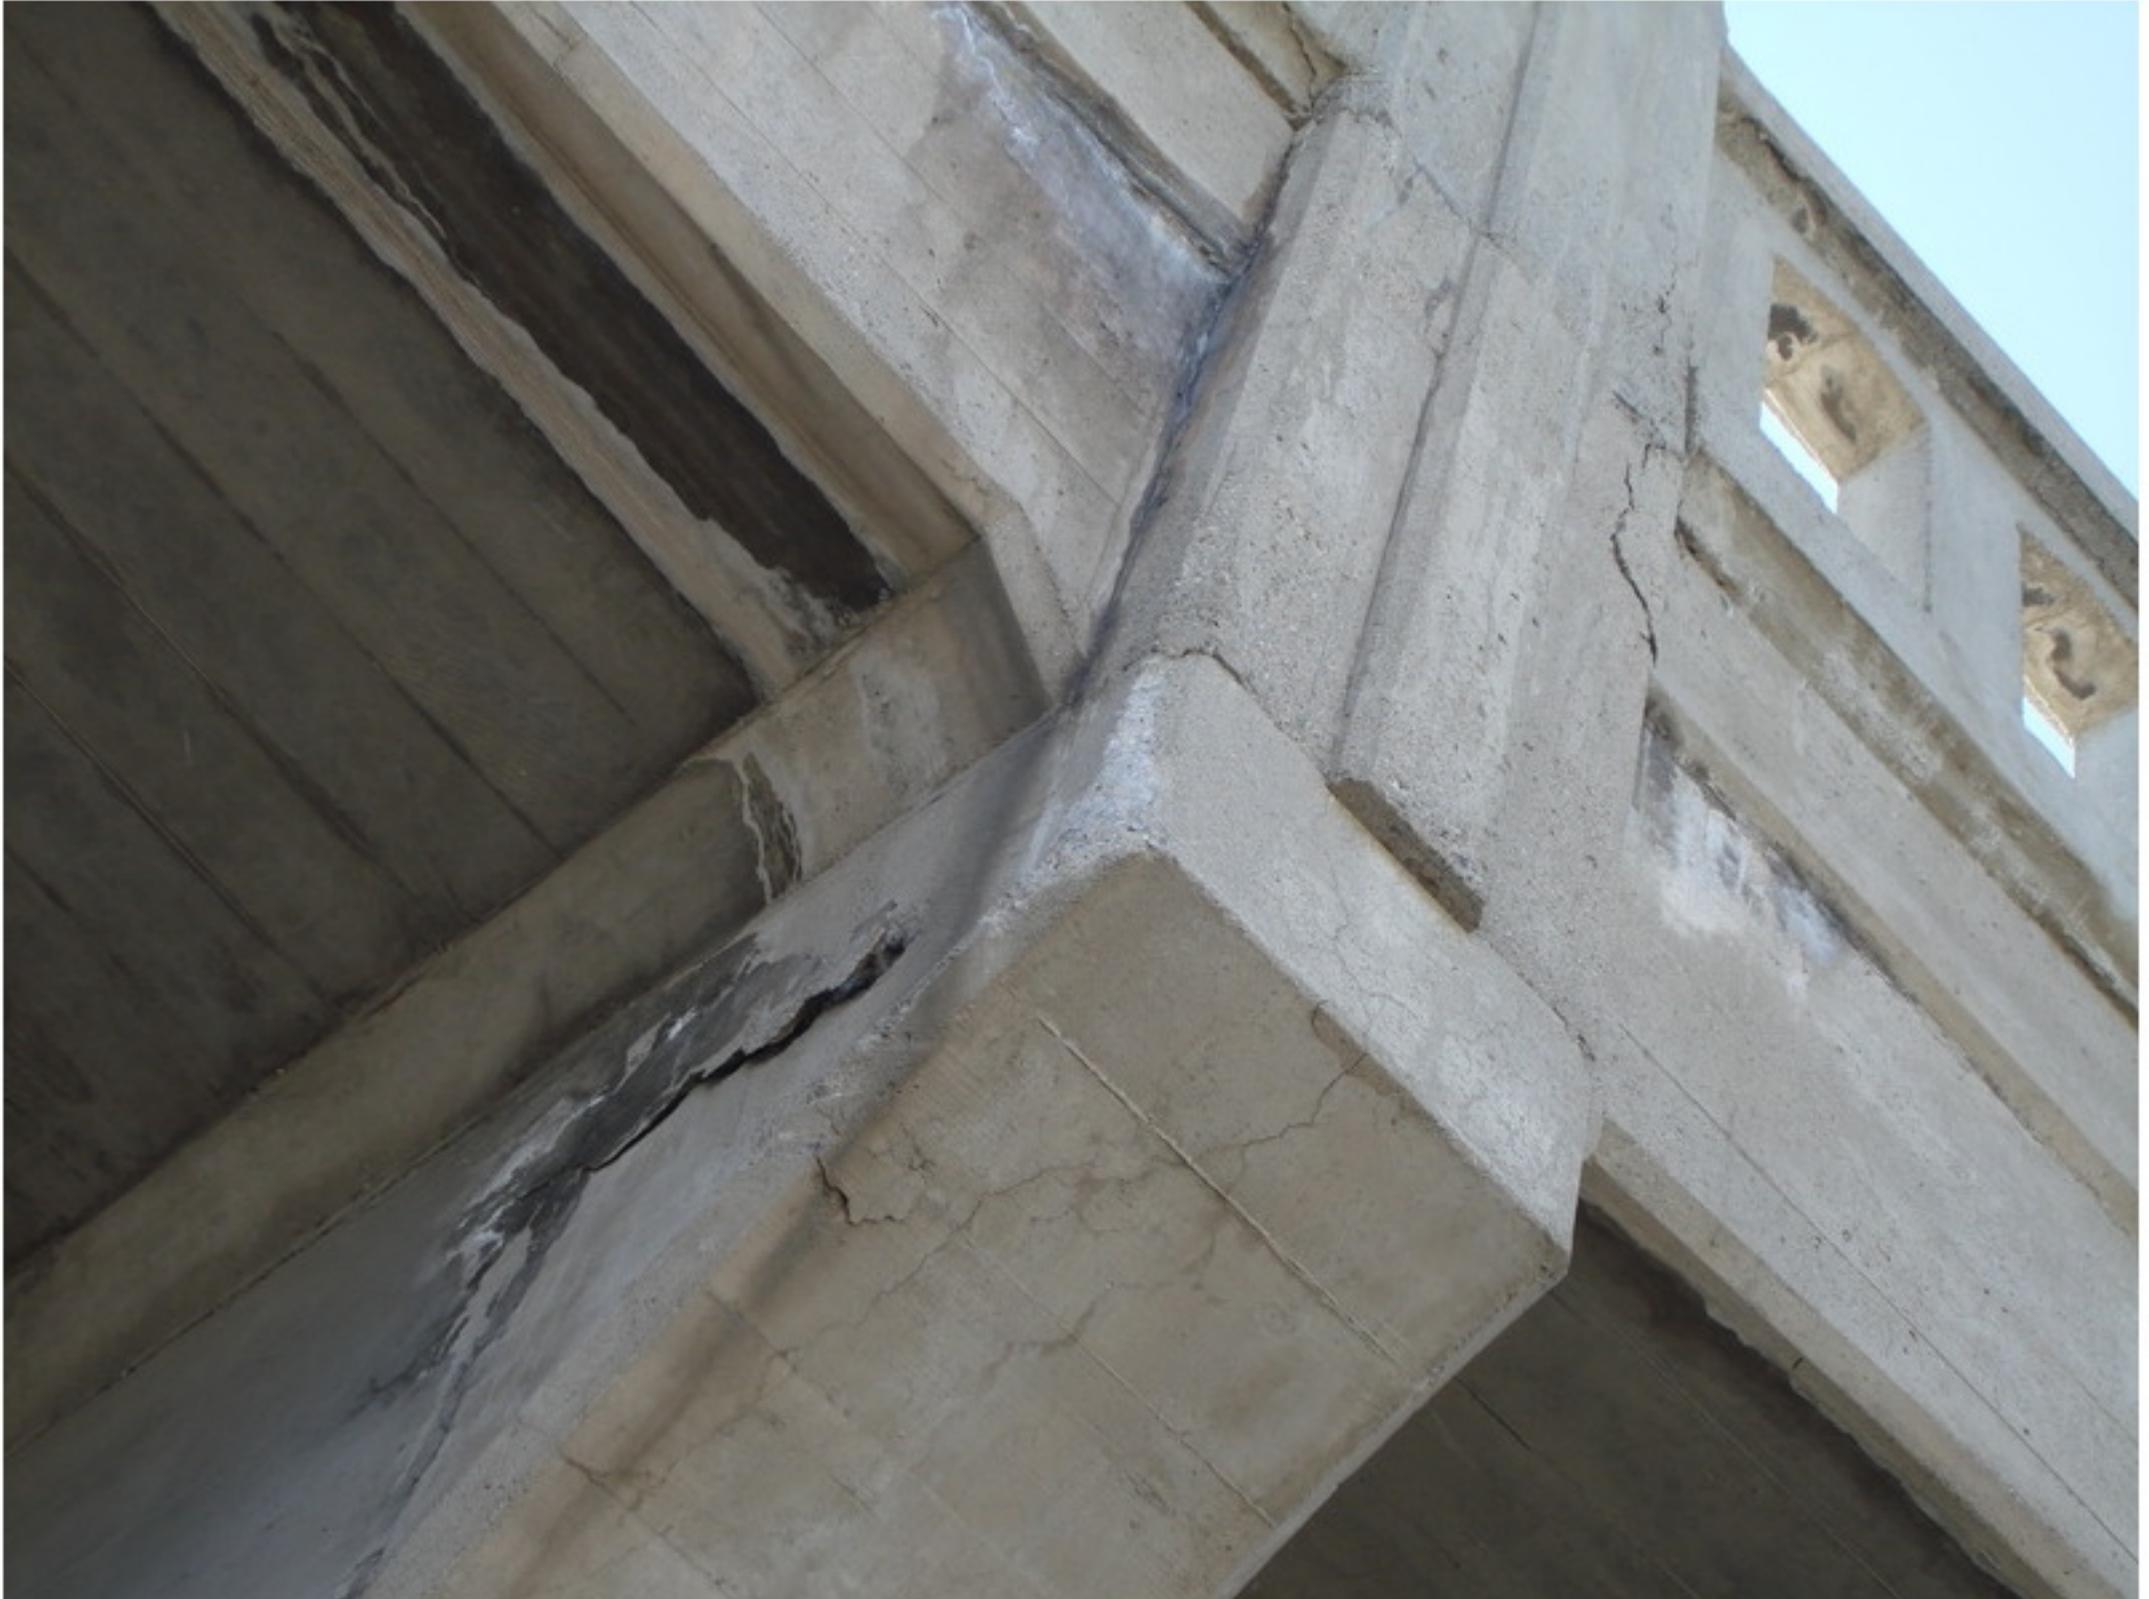
Photo No. 2  
Bent cap with a plate spall developing at a corroding rebar
