*California Department of Transportation  
Division of Maintenance*

*Structure Maintenance and Investigations*

CONDITION TEXT

To ease identification structure was renamed from MOUNT VERNON AVE OH to MOUNT VERNON AVE OH - 1934 to include year built to differentiate from the other structure with the same name built in 1958.

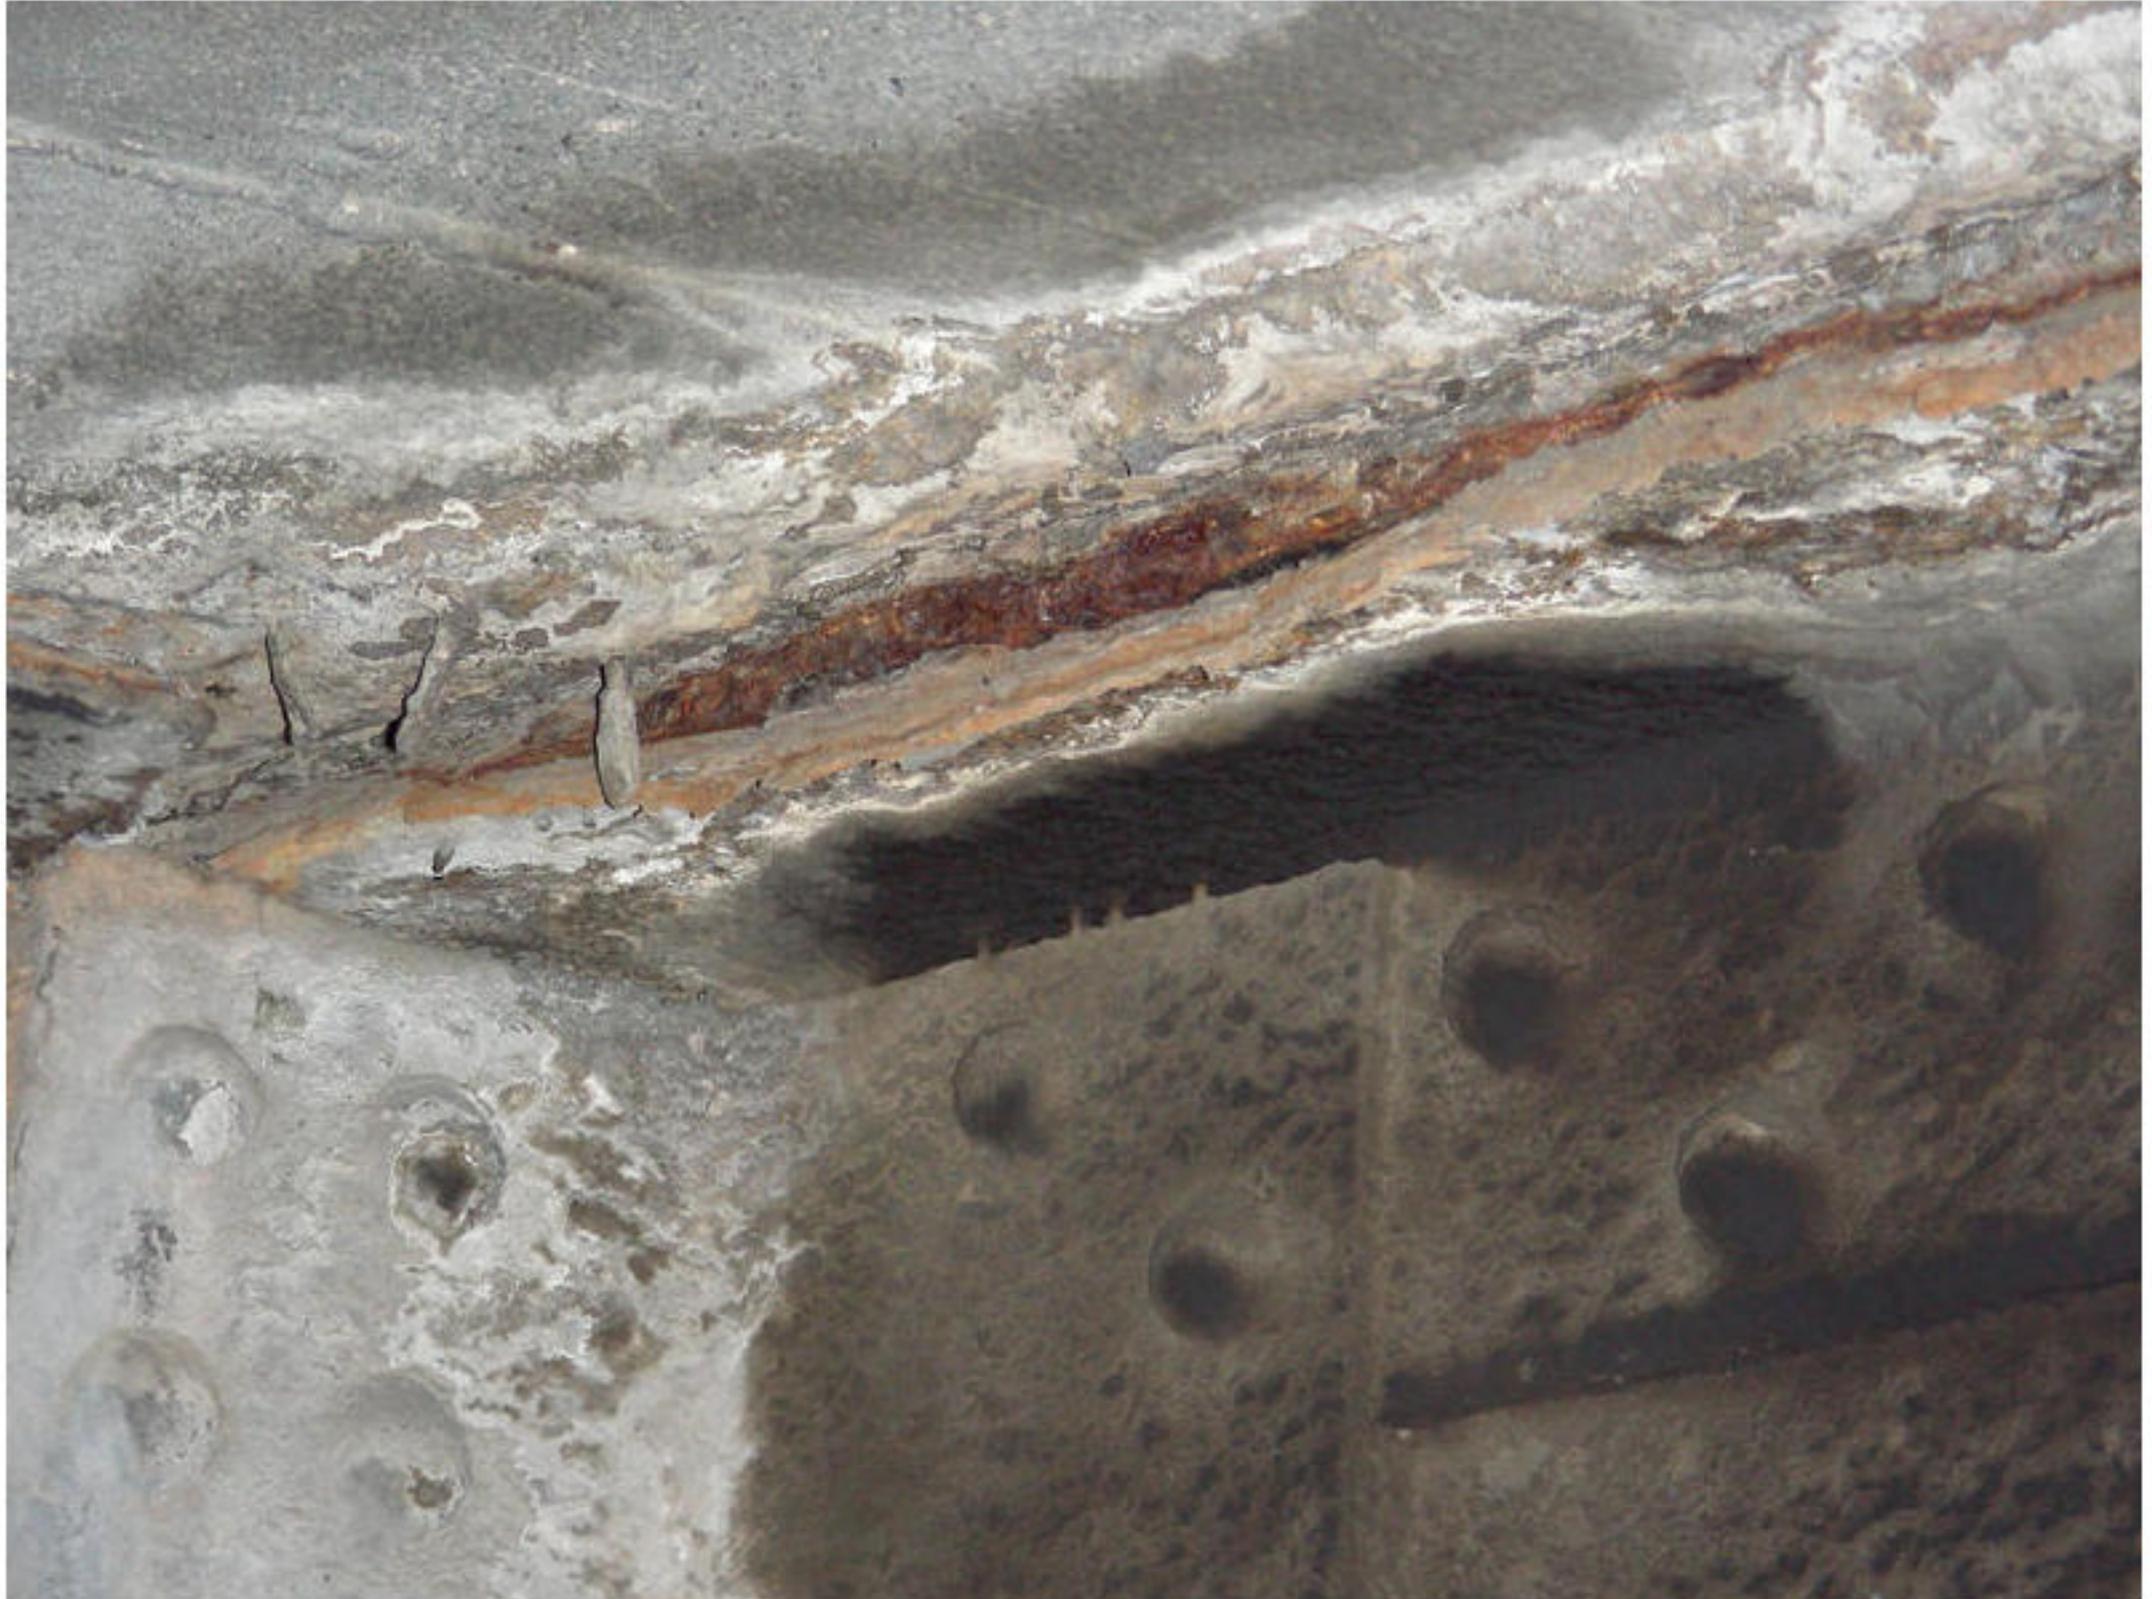
Photo No. 3  
Typical View Pack Rust Corrosion Between the Bent Cap Top Flange and the RC Deck

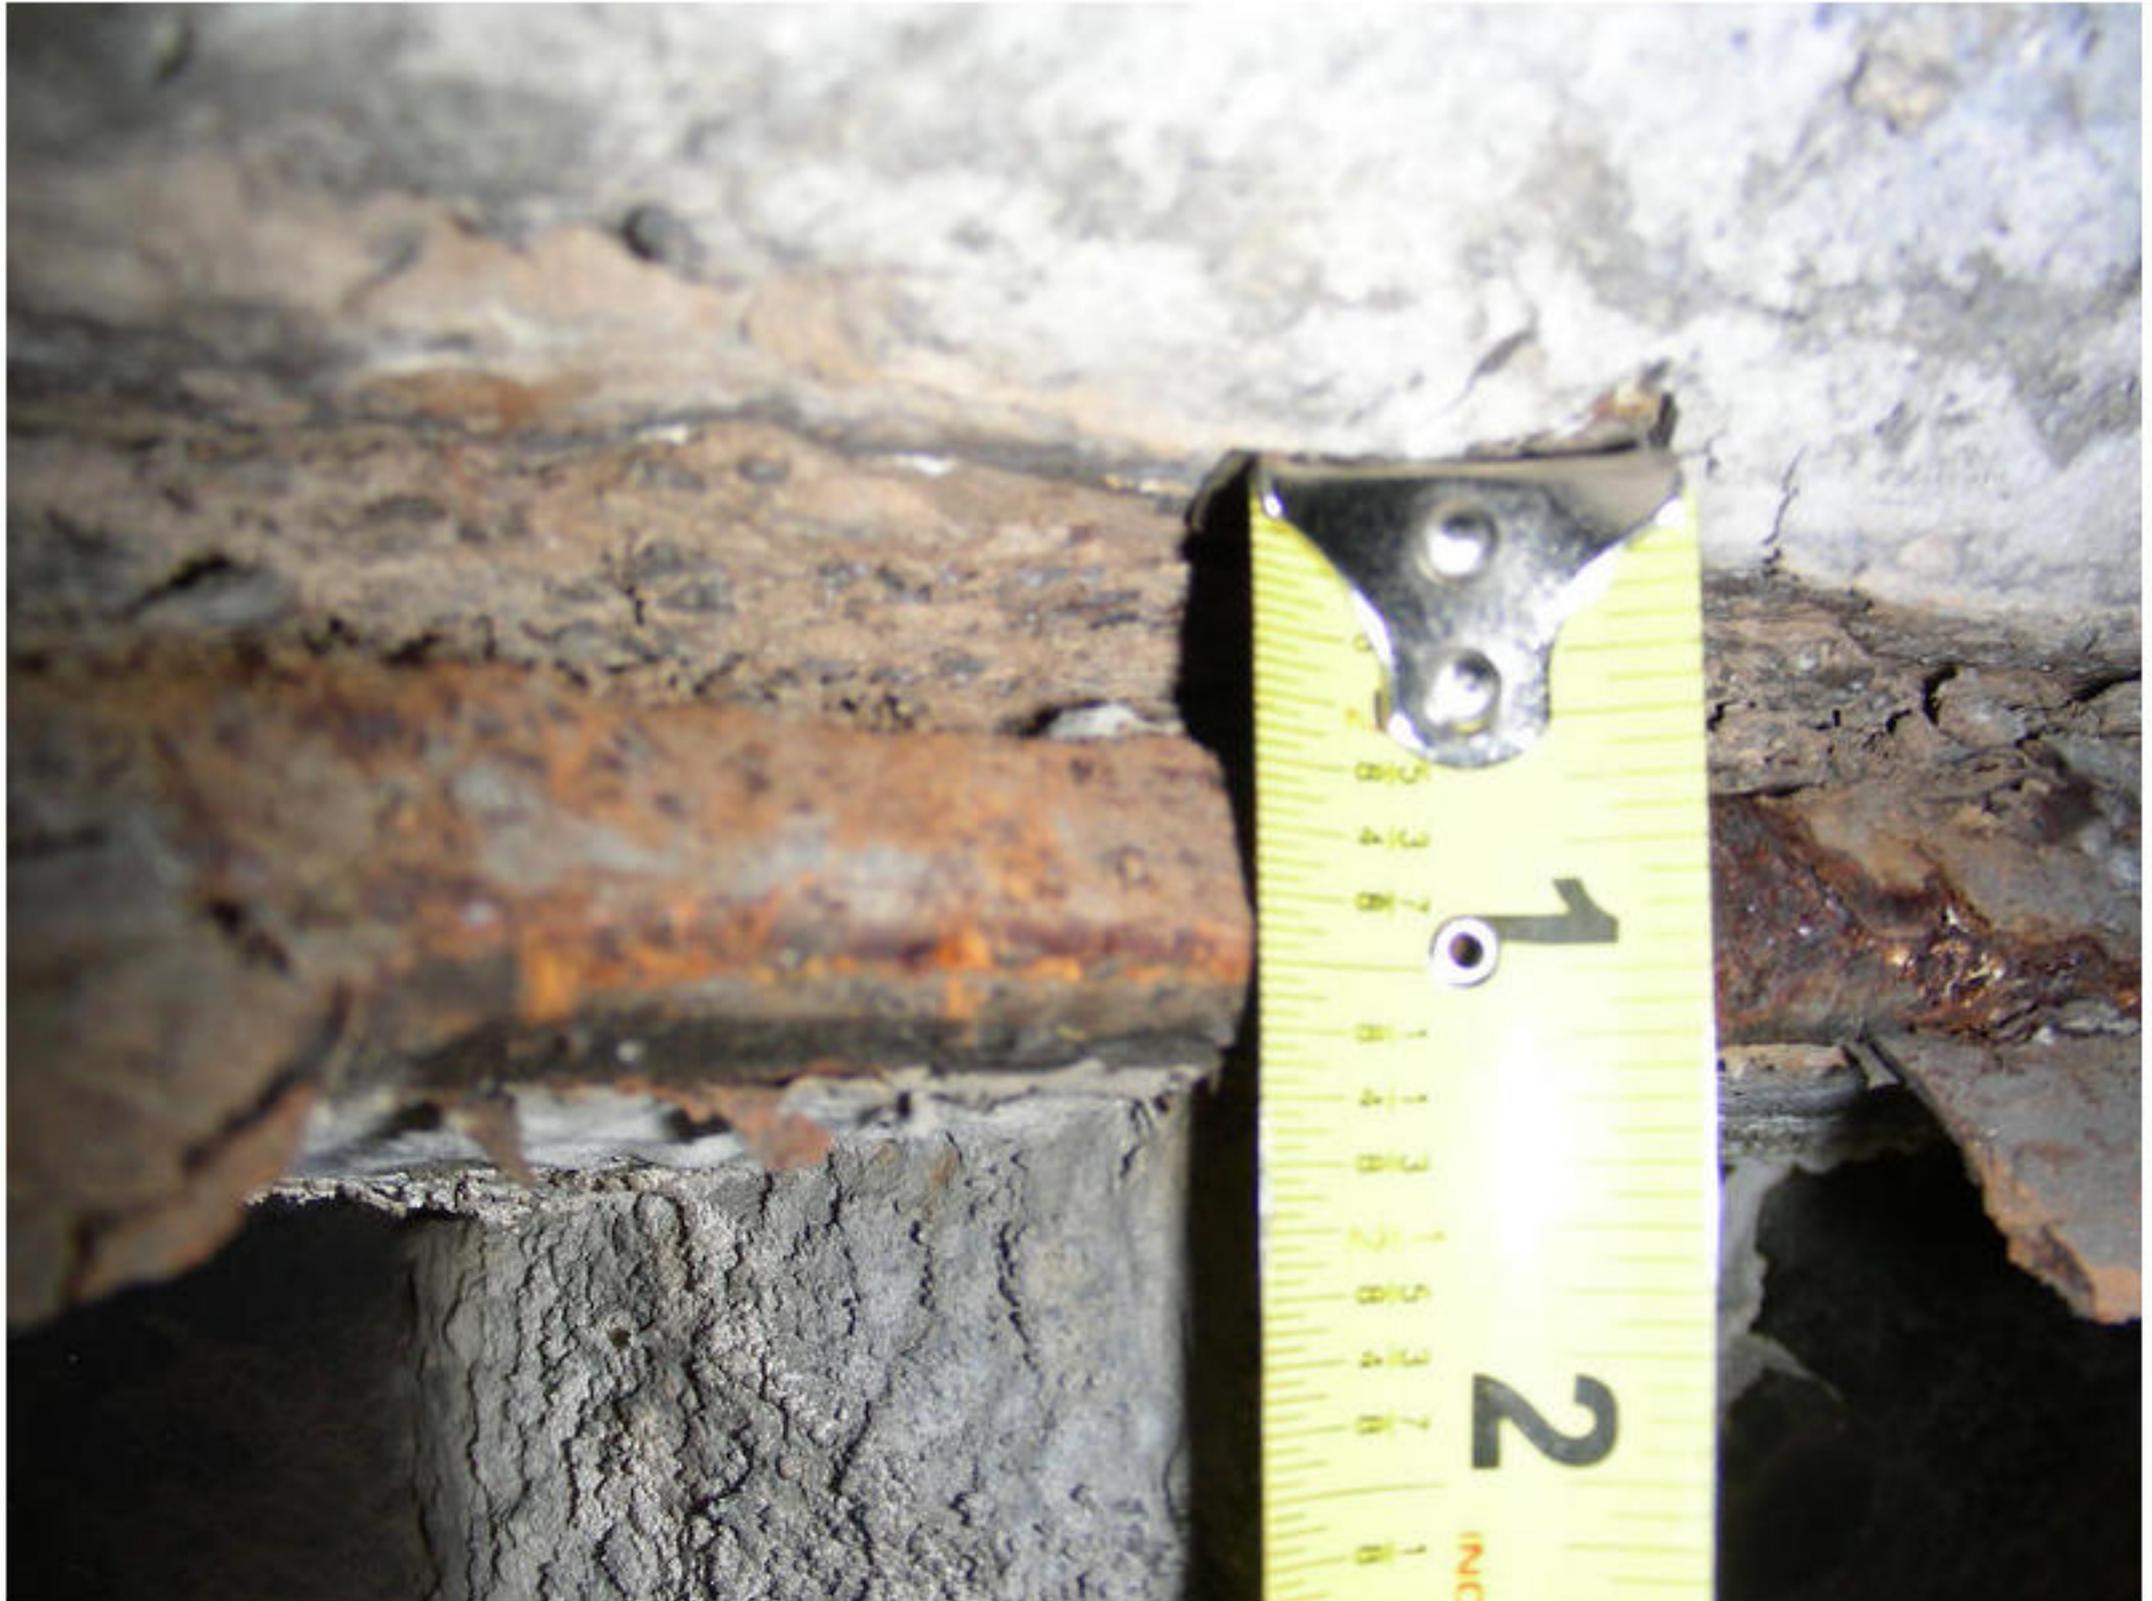
Photo No. 4  
Close-Up View of Typical Pack Rust Corrosion

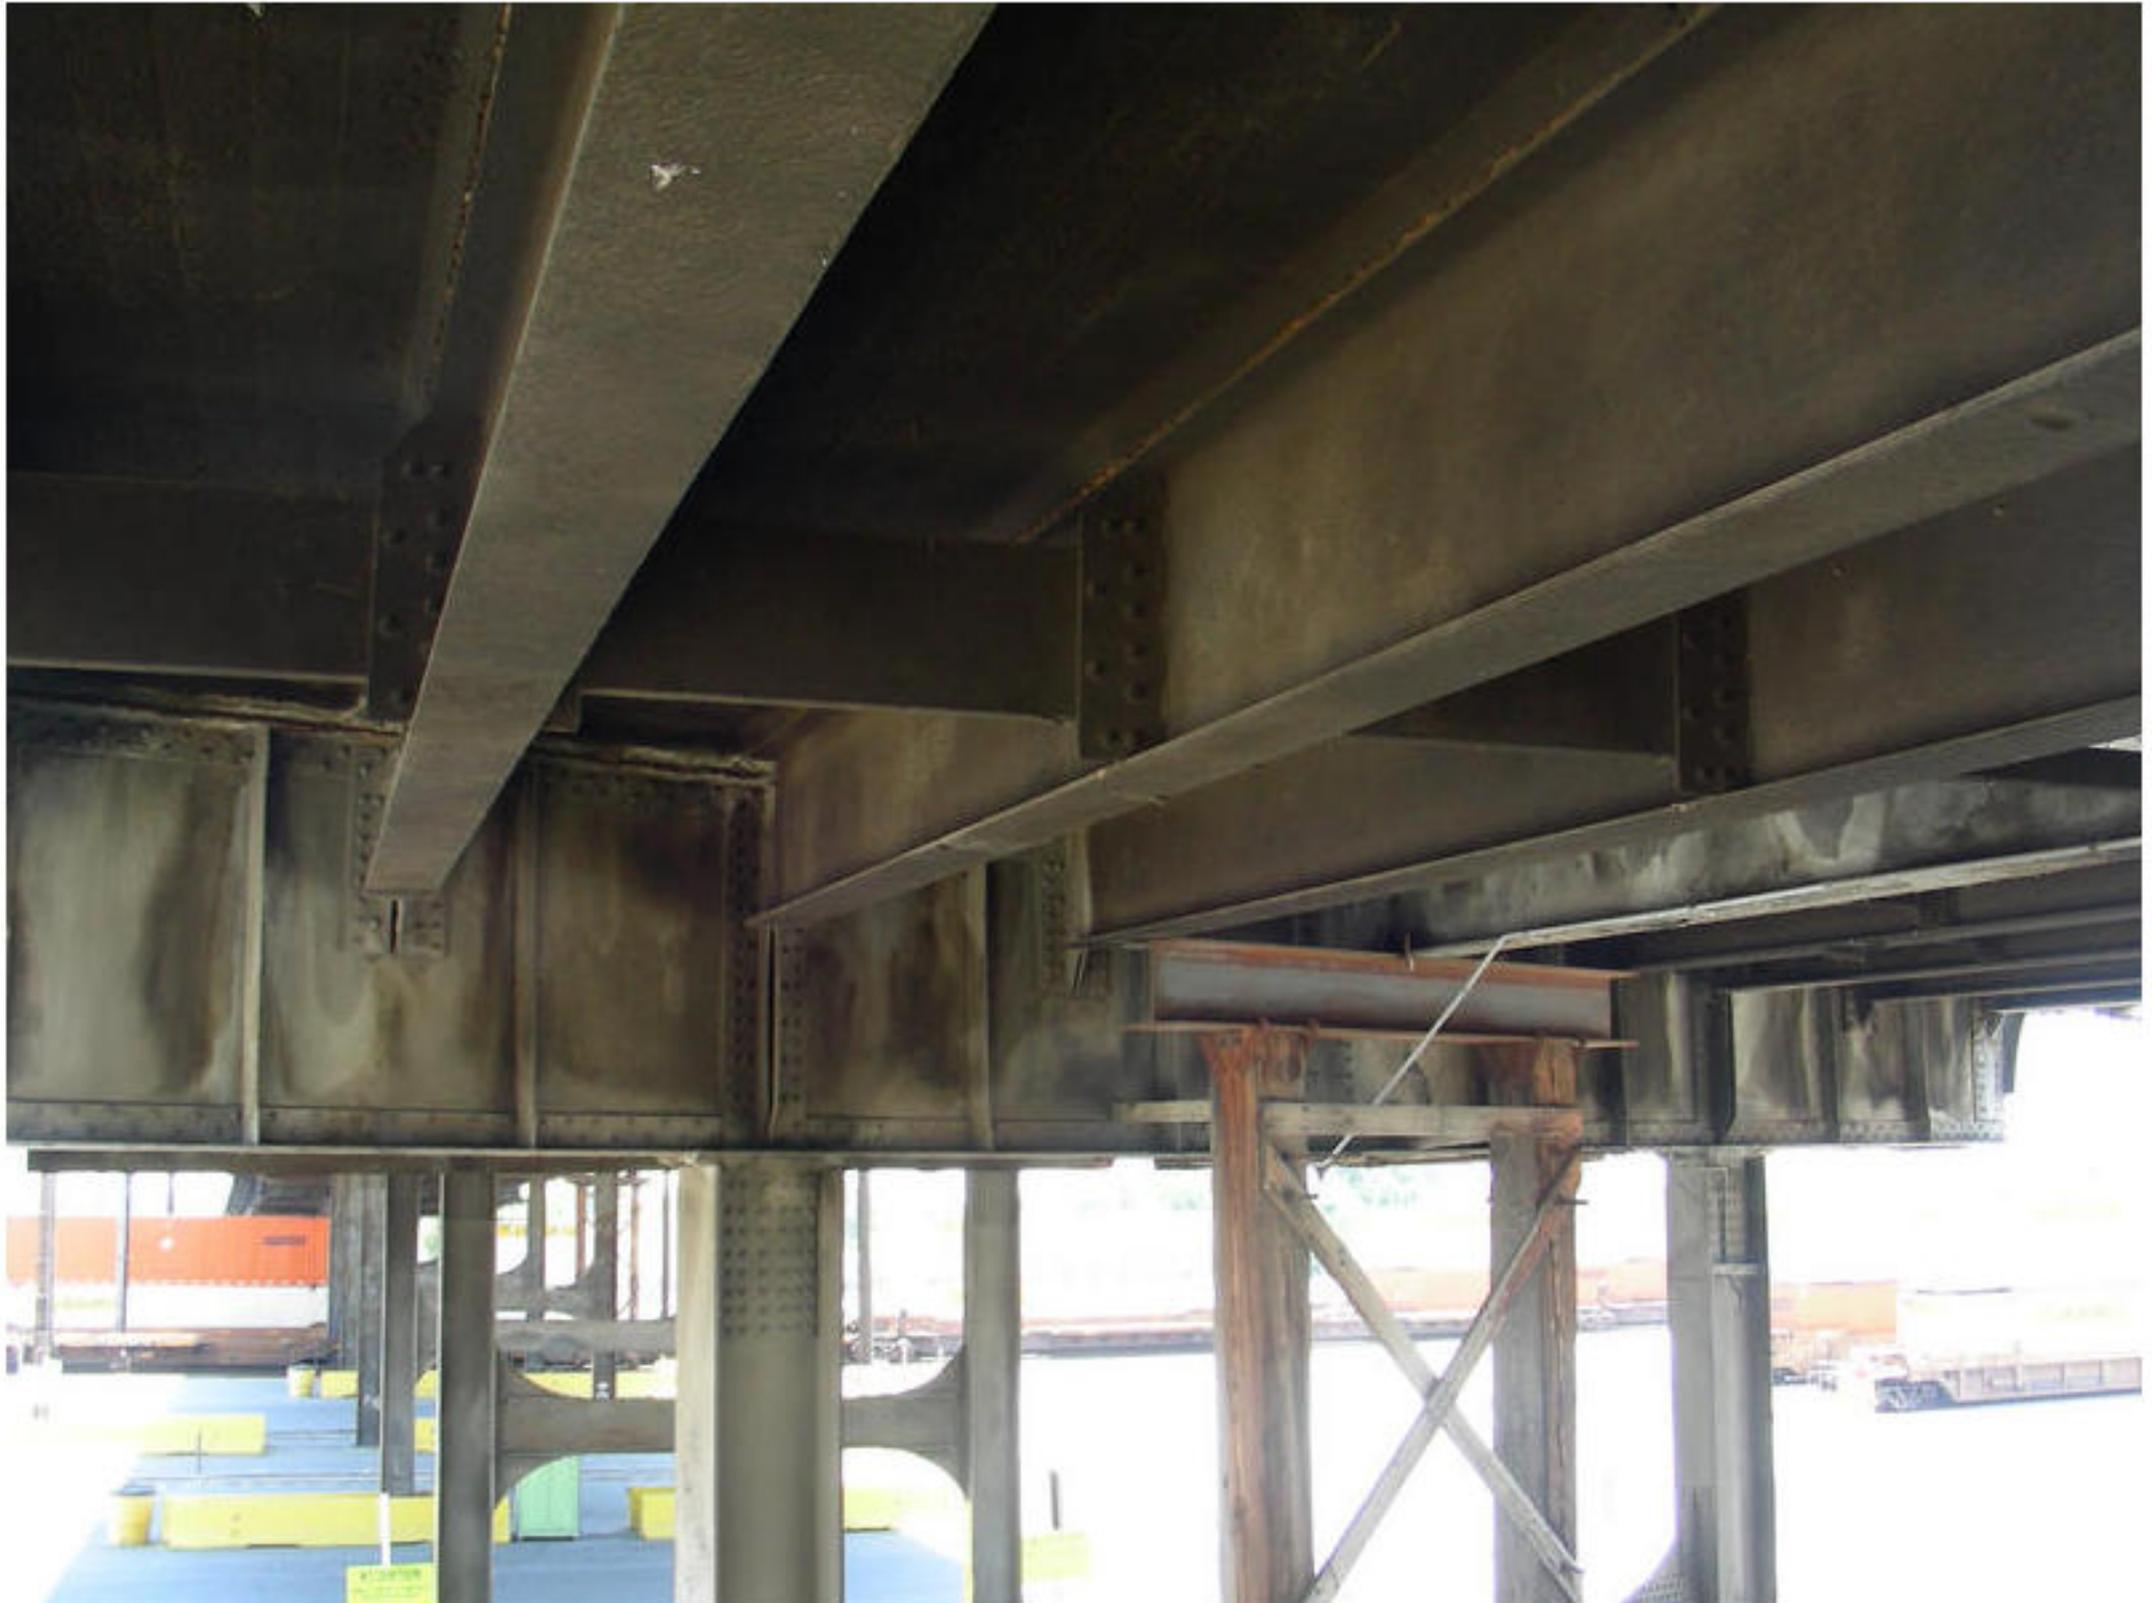
Bent #18 was also evaluated considering section loss at various locations of the top flange. The analysis, which assumed a top flange thickness of 12.5 mm, indicates that the bent cap is adequate to carry legal loads.

Photo No. 5  
View of Bent 18 from Span 18

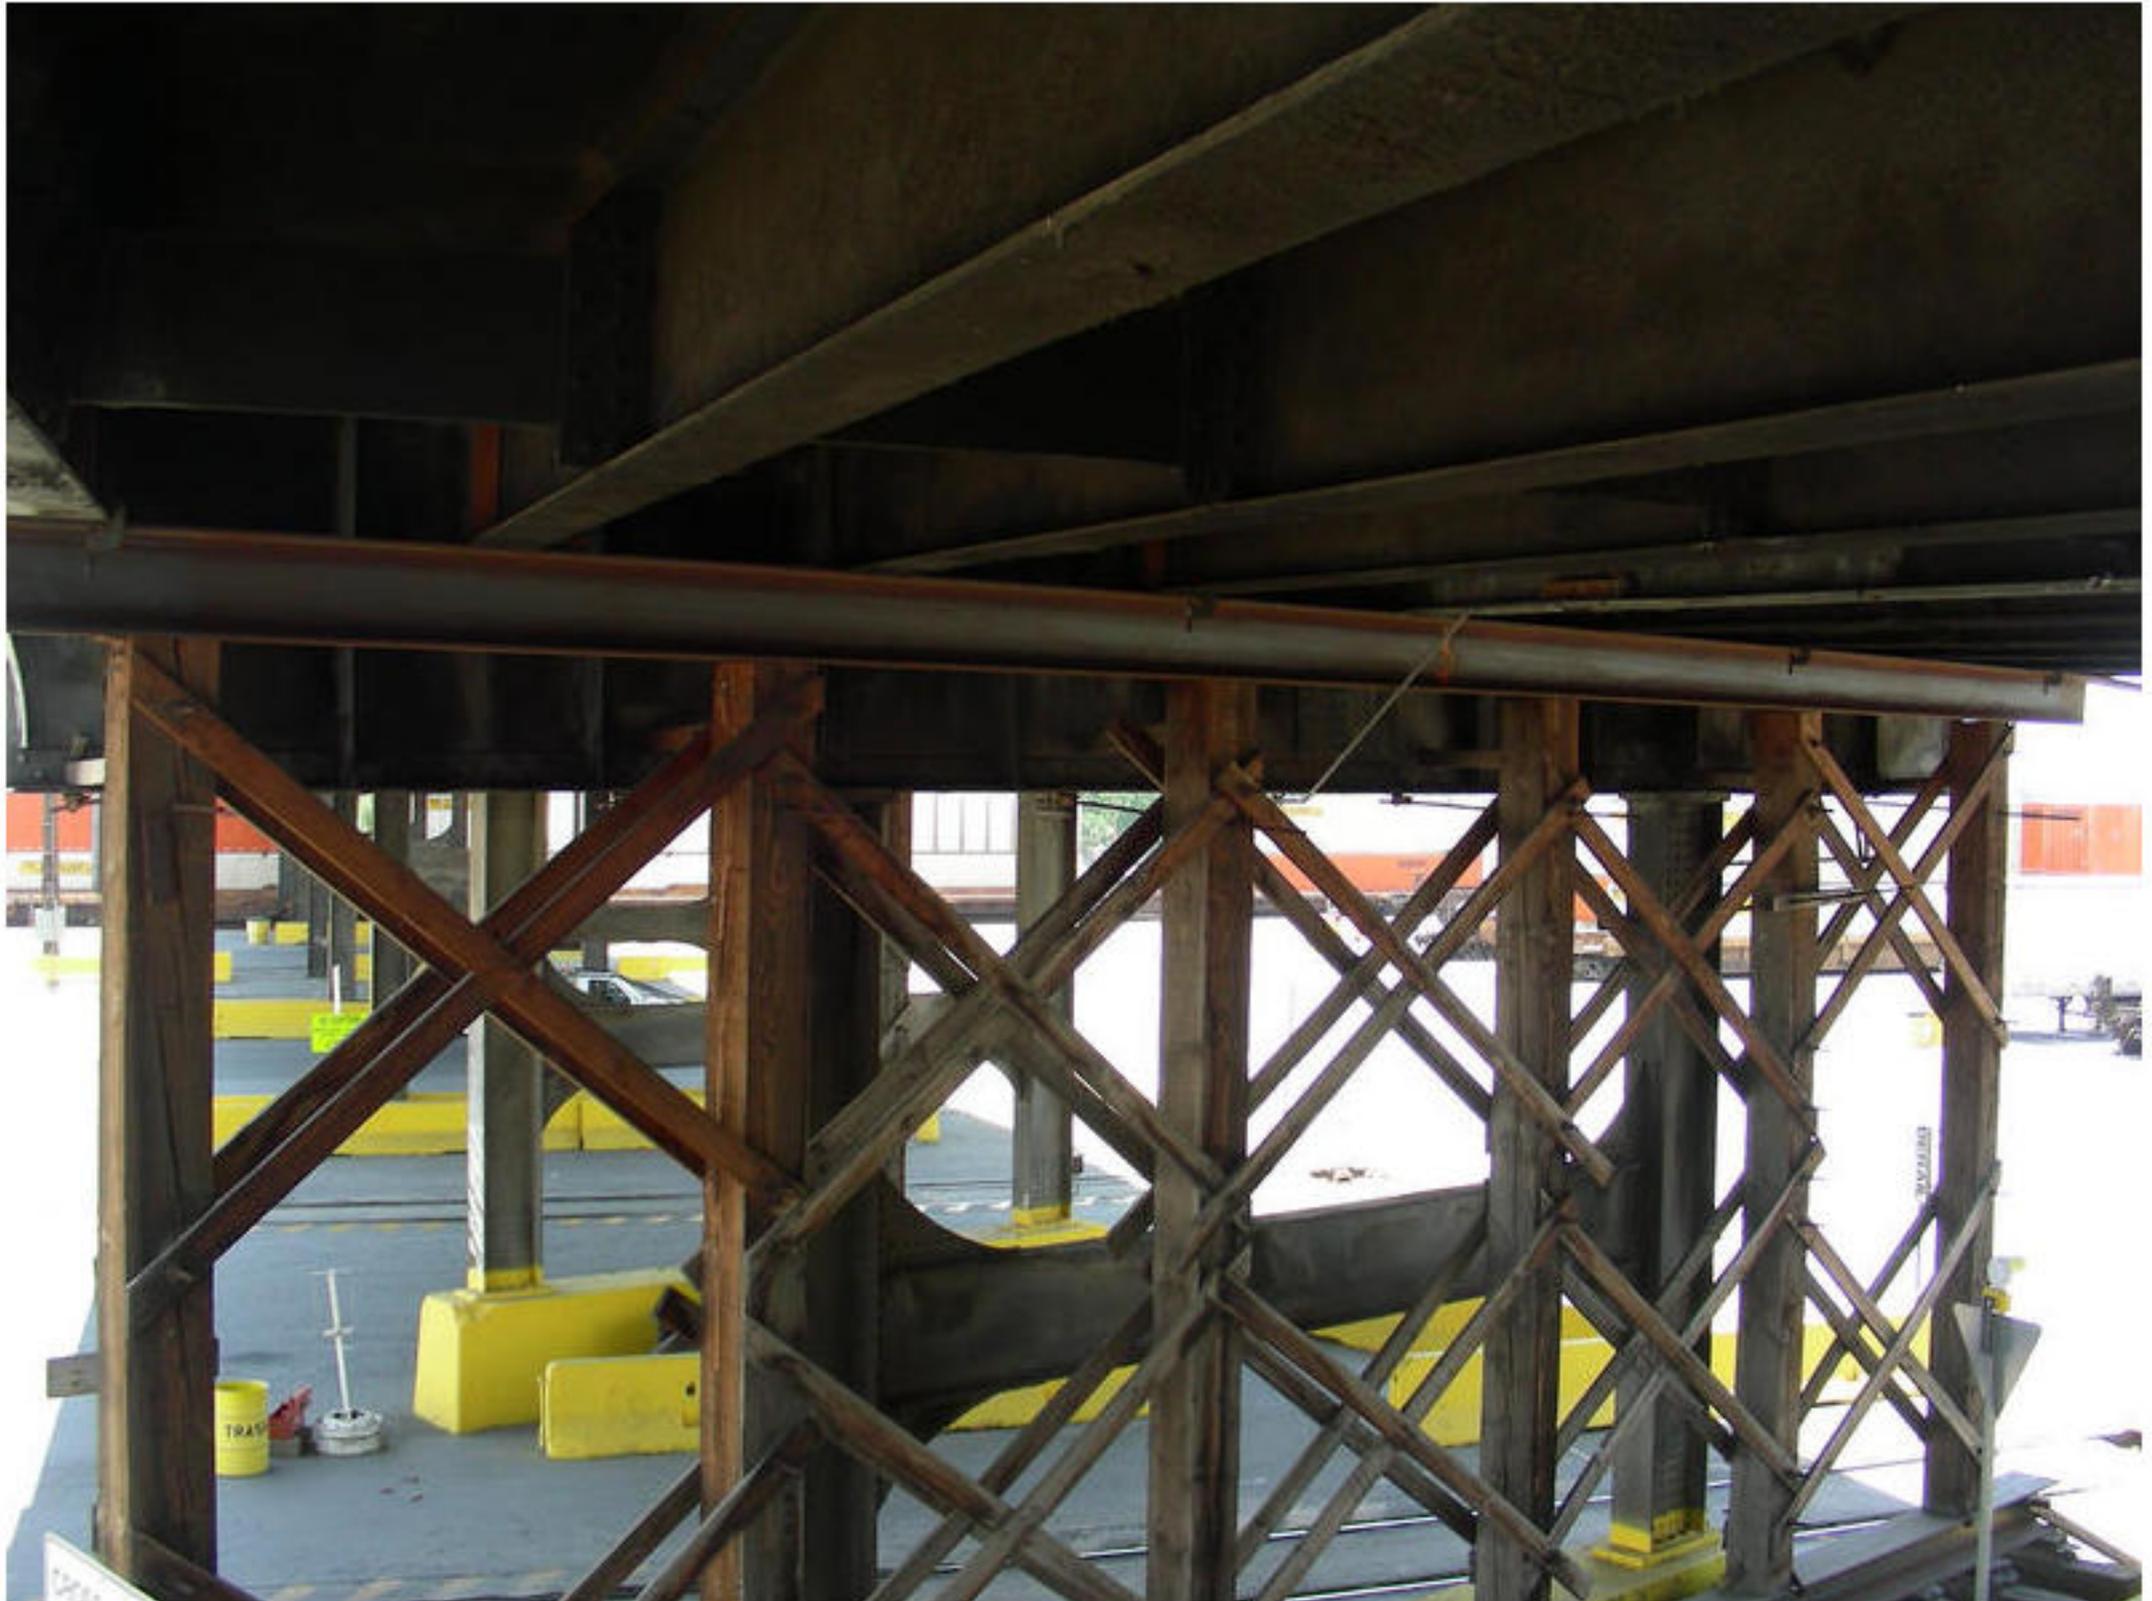
Photo No. 6  
View of Bent 19 from Span 19

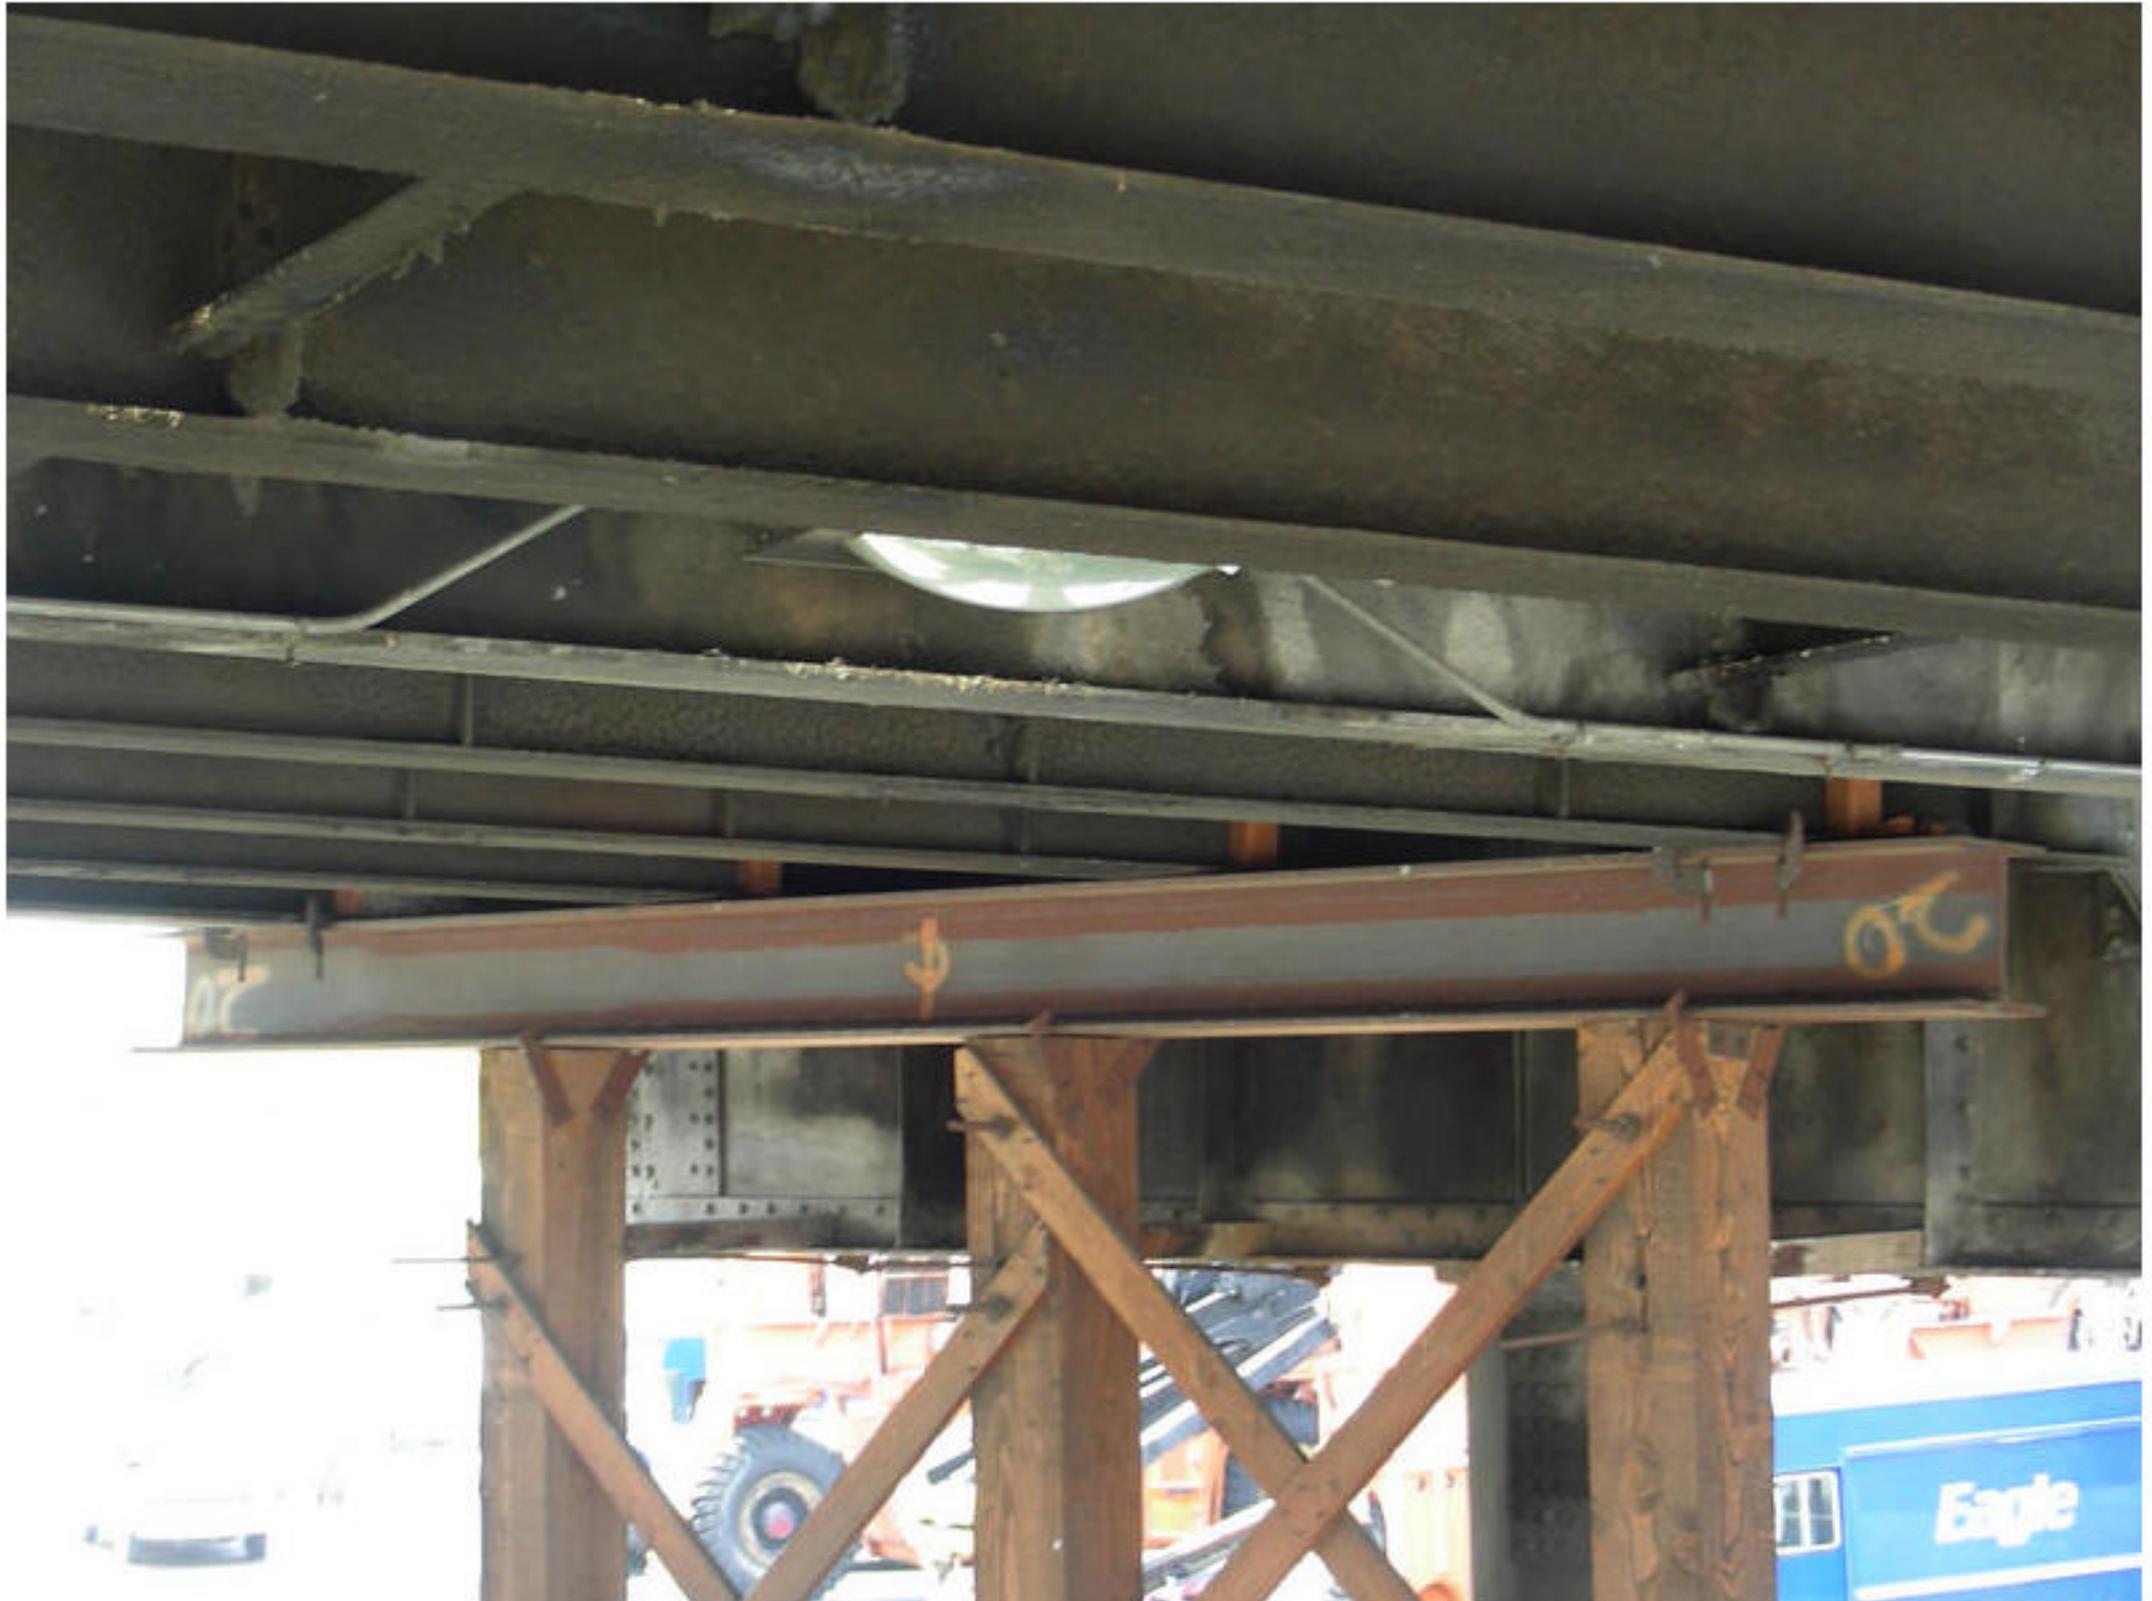
Photo No. 7  
View of Bent 20 from Span 19

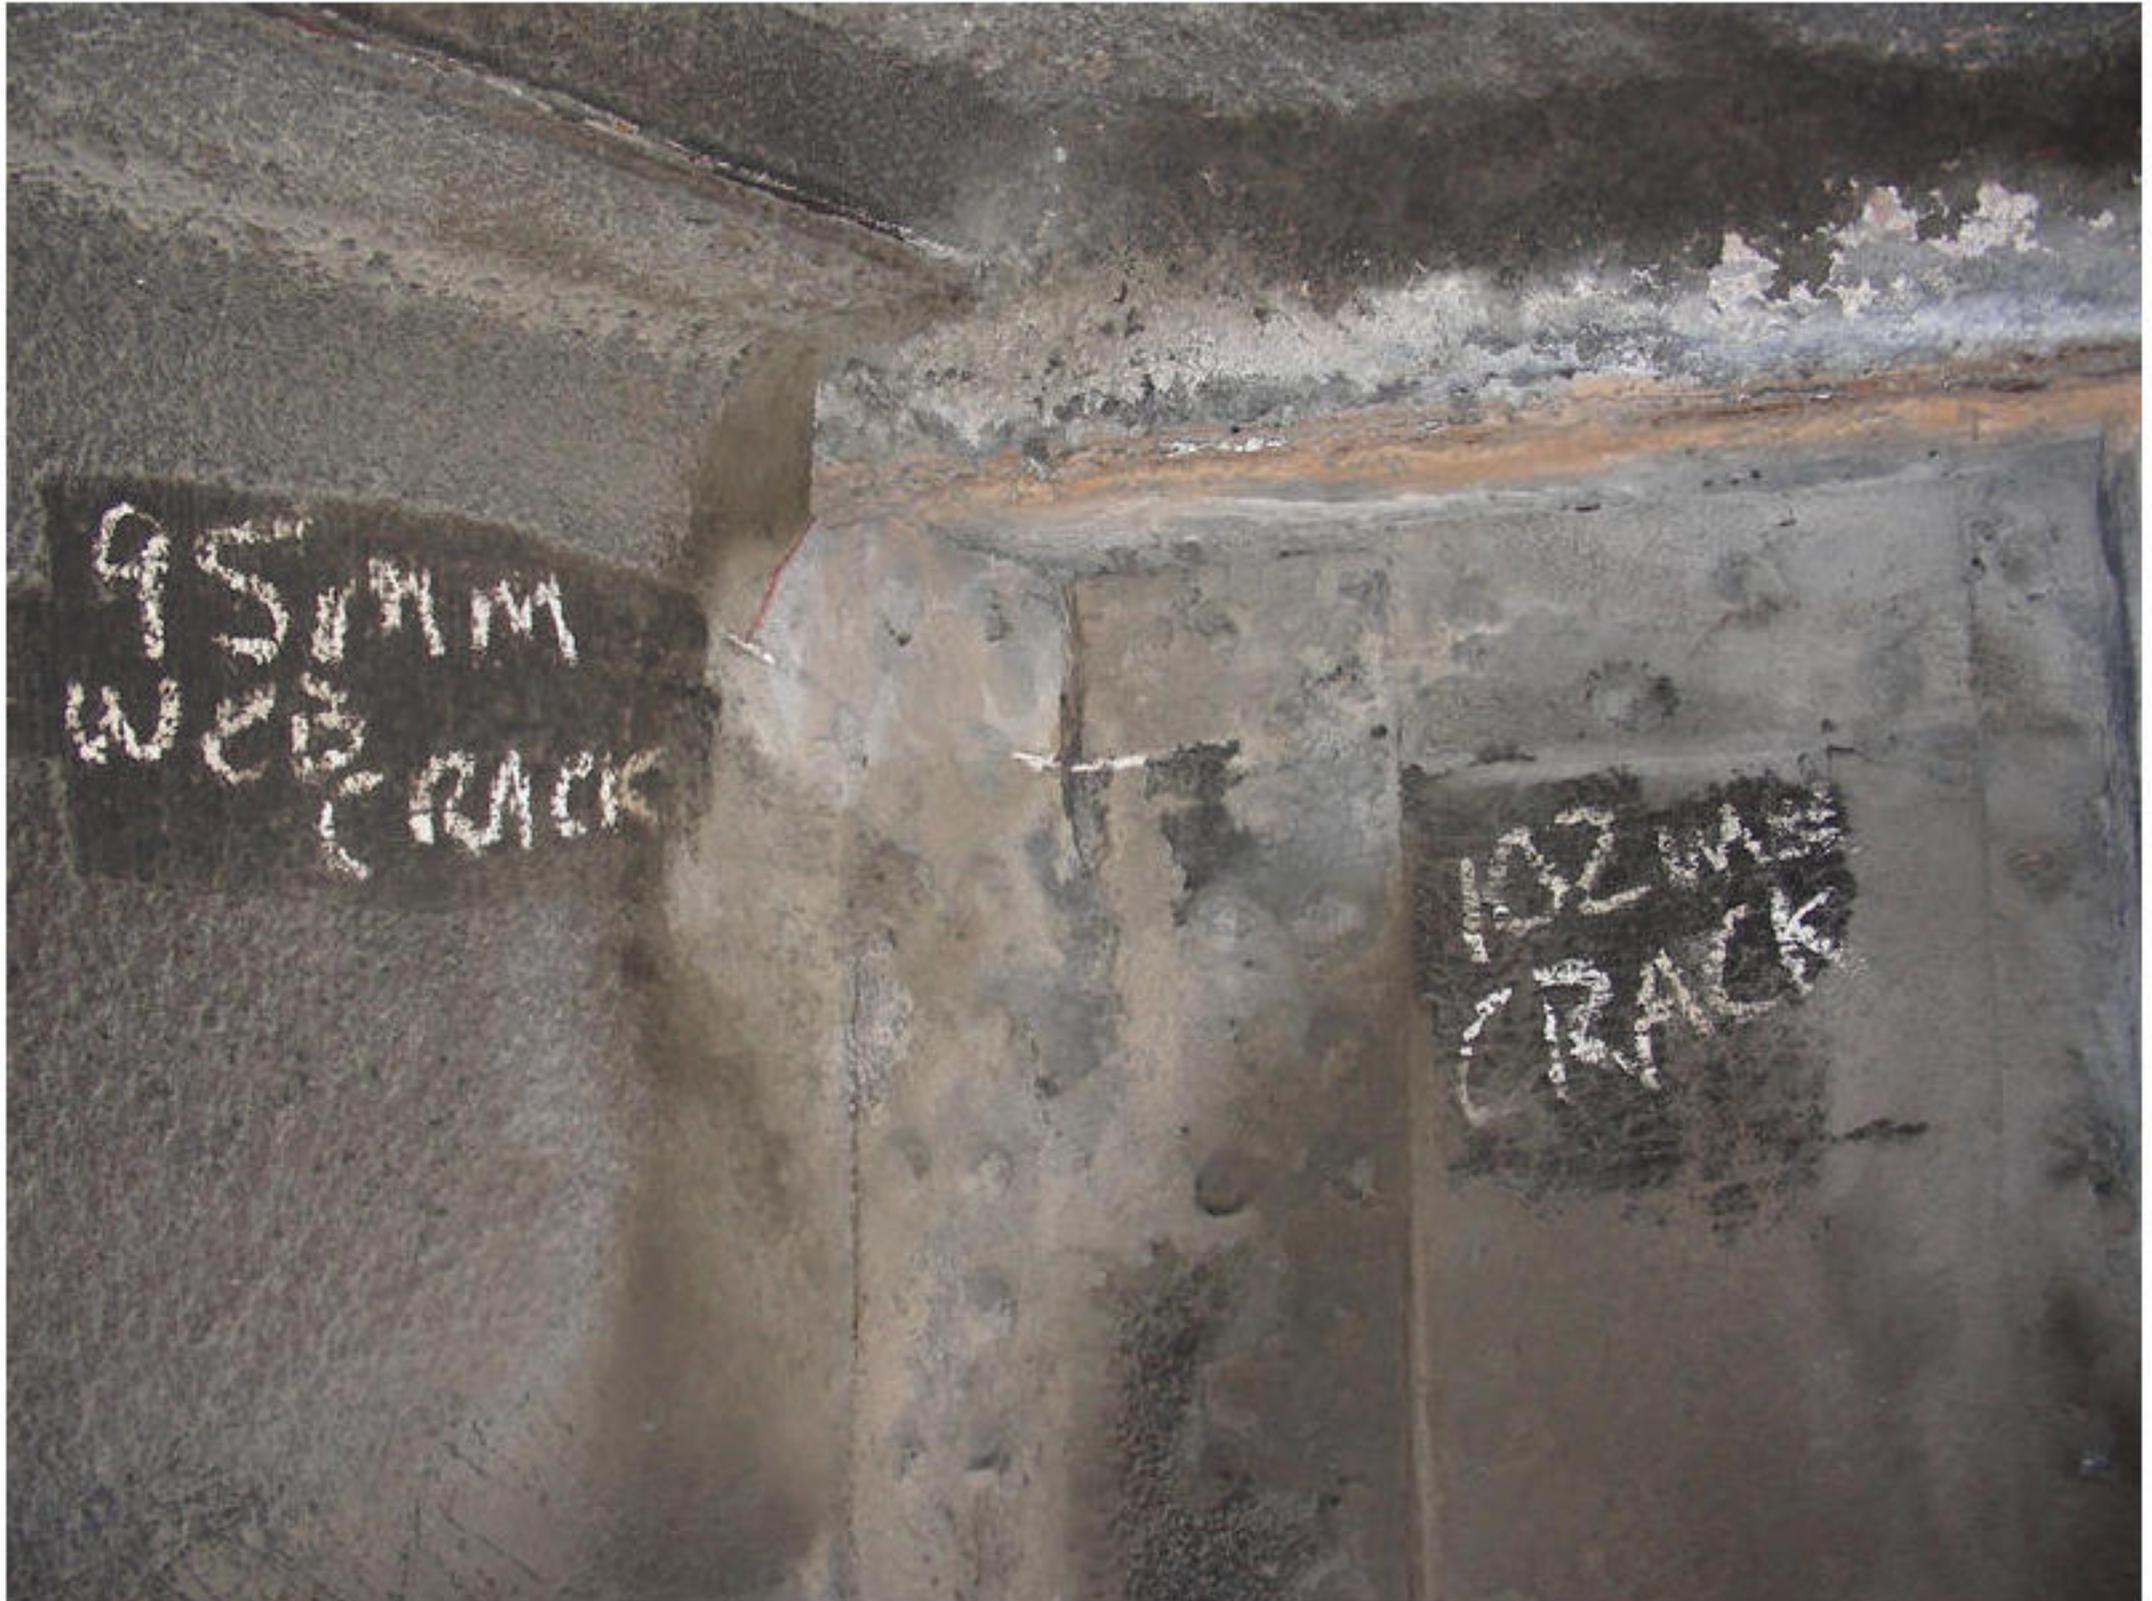
Photo No. 8  
View of Bent 19, Girder 2 in Span 19. Shown are Typical Web and Angle Connection Cracks.
