*California Department of Transportation  
Division of Maintenance*

*Structure Maintenance and Investigations*

CONDITION TEXT

To ease identification structure was renamed from MOUNT VERNON AVE OH to MOUNT VERNON AVE OH - 1934 to include year built to differentiate from the other structure with the same name built in 1958.

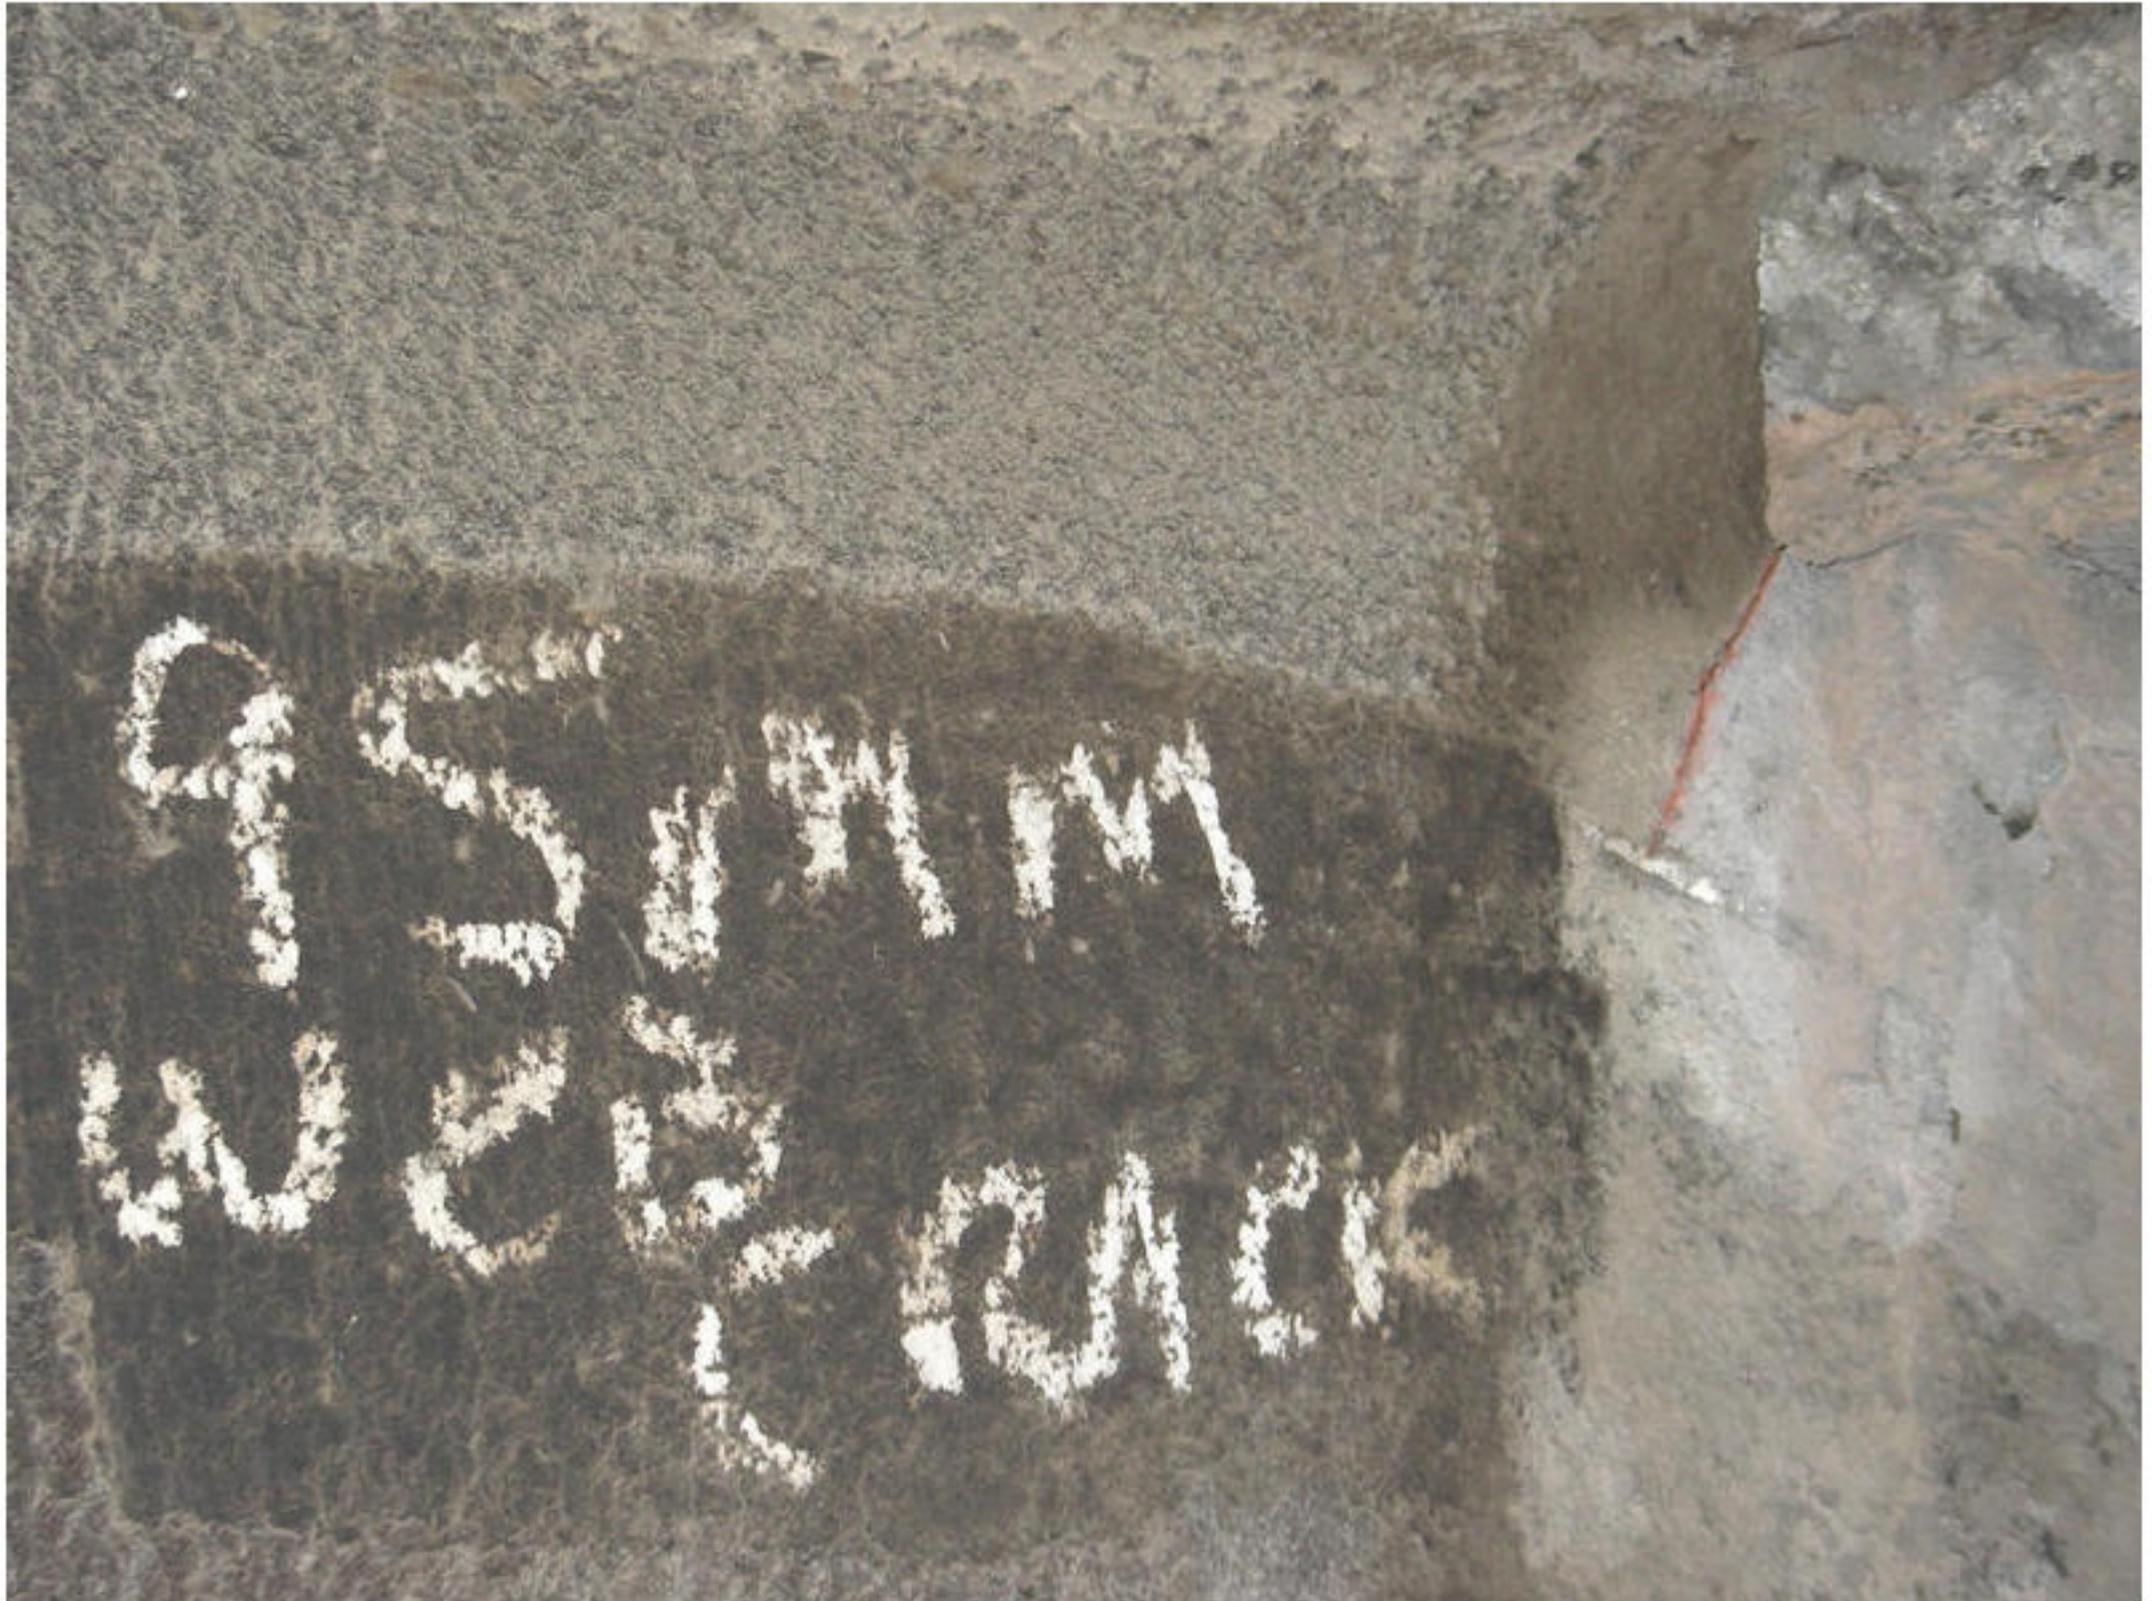
Photo No. 9  
Close-Up View of a Typical Girder Web Crack

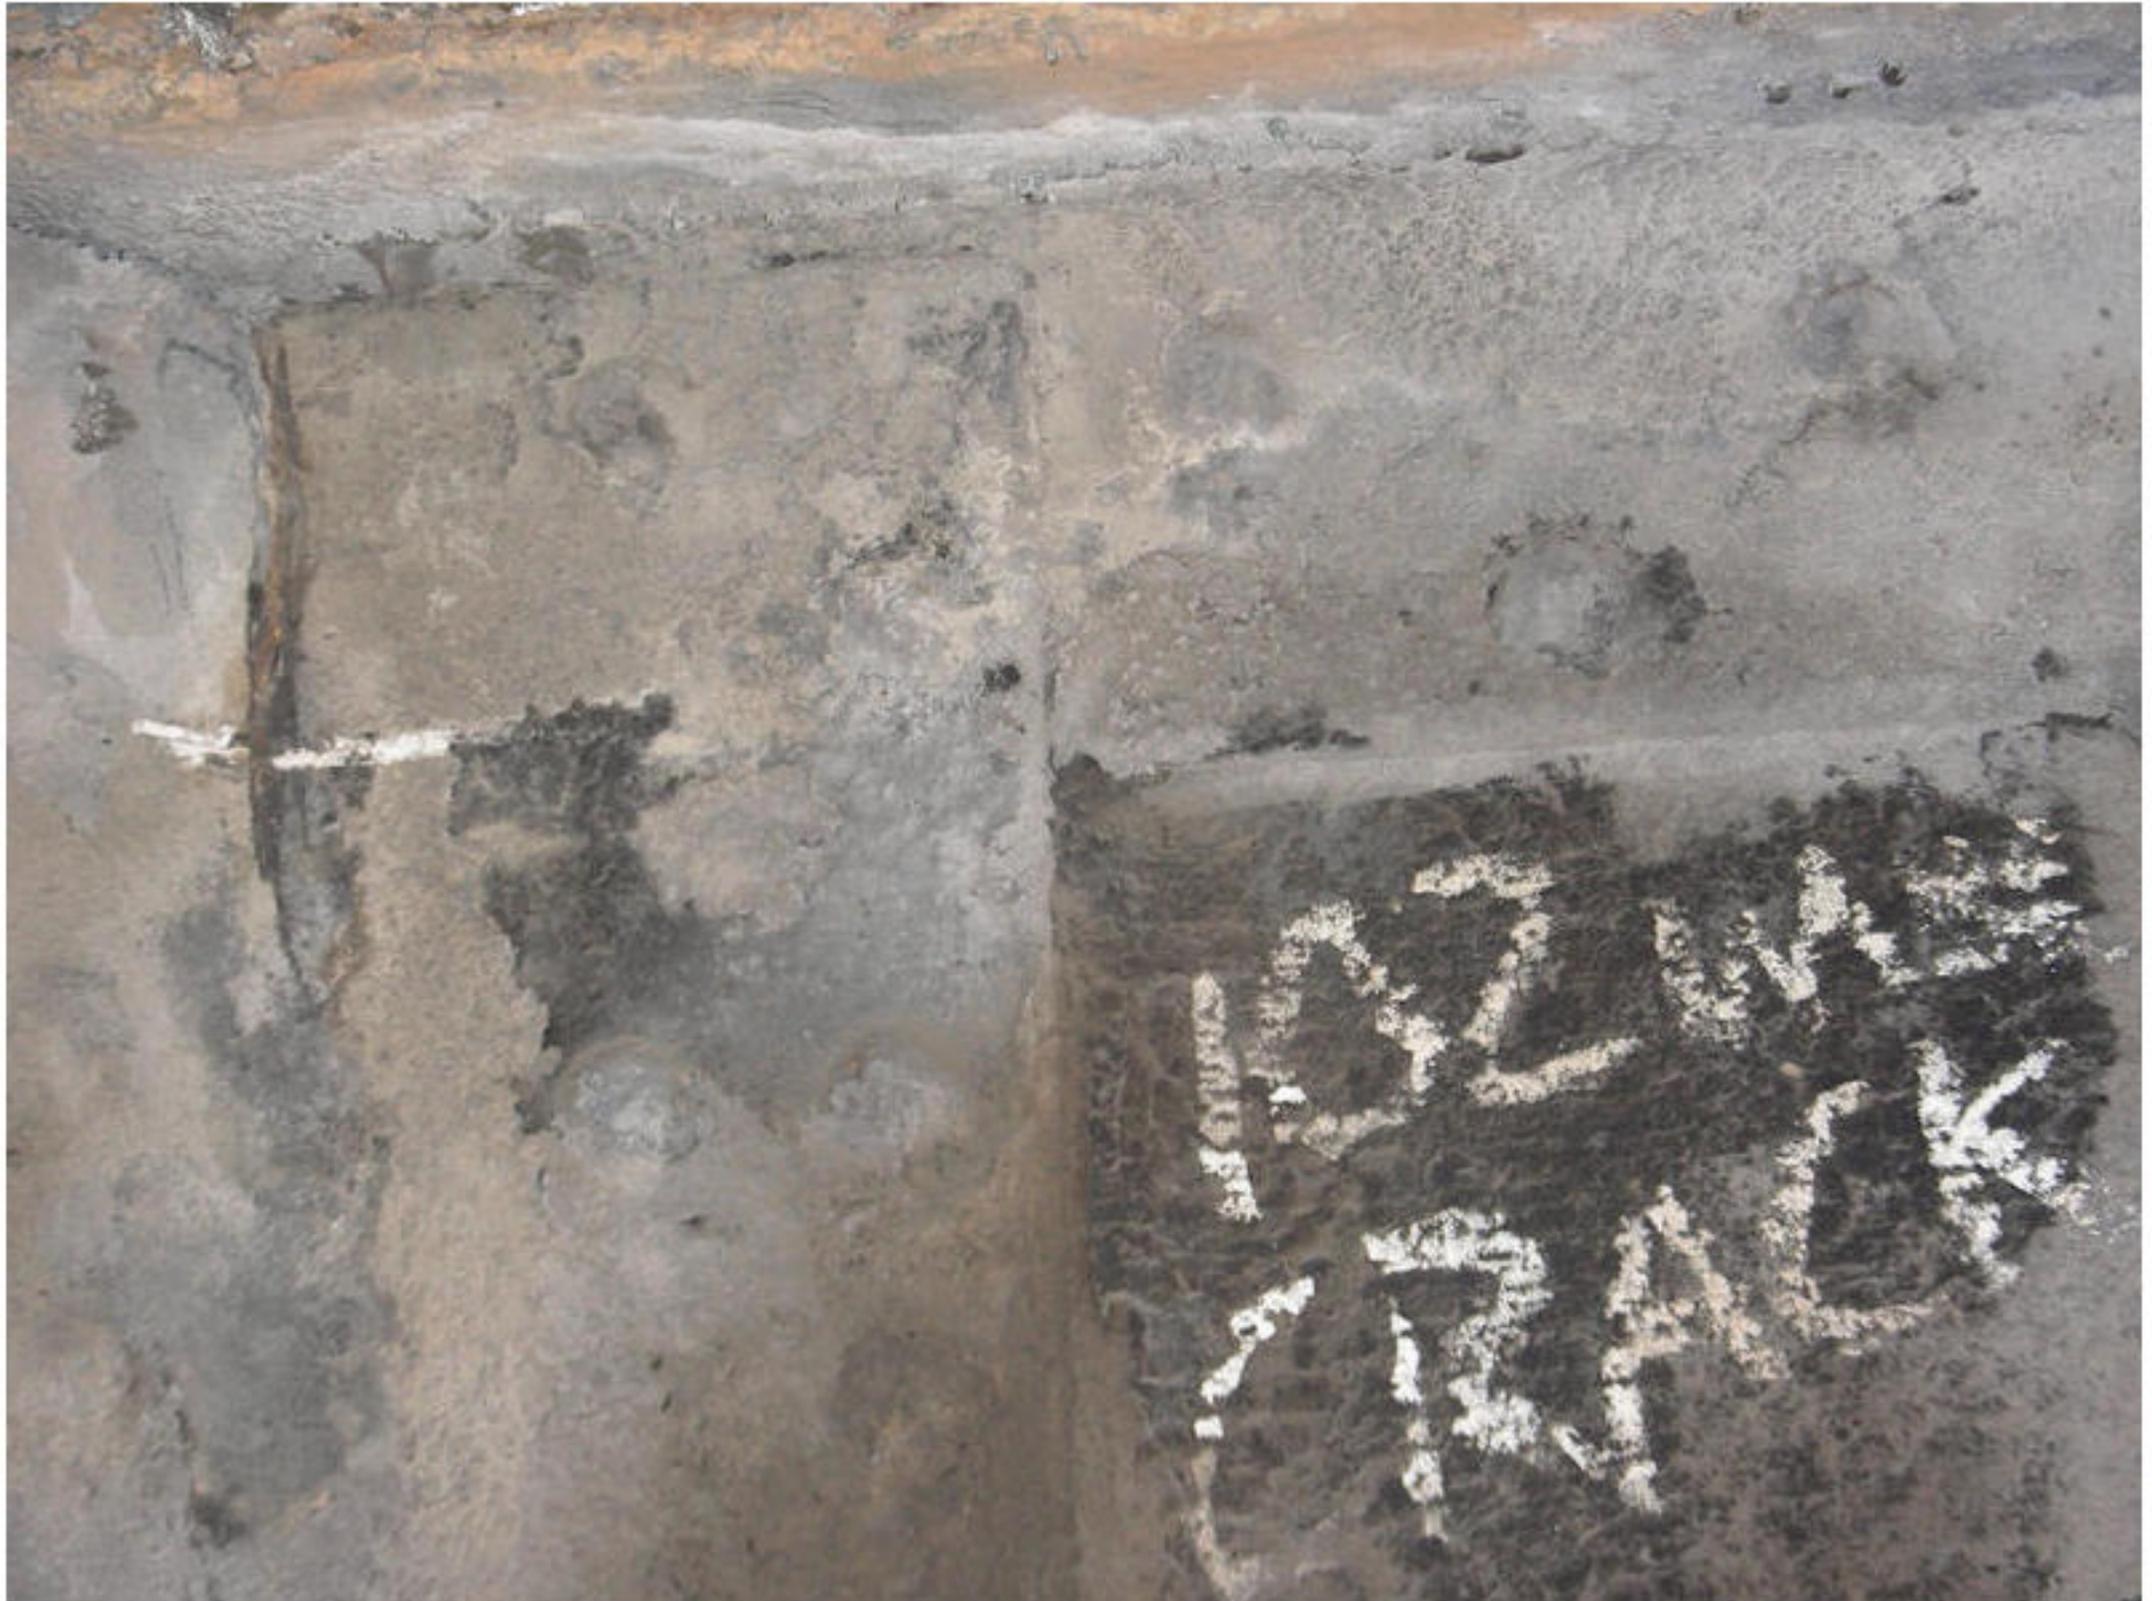
Photo No. 10  
Close-Up View of a Typical Angle Crack at the Girder to Bent Cap Connection
