**SUBSURFACE INVESTIGATION OF FAULTING
PARADISE HILLS PROJECT
BADGER CANYON AREA
CITY OF SAN BERNARDINO, CALIFORNIA
PREPARED FOR
INLAND COMMUNITIES CORPORATION
JOB NO. 05894-8**

JANUARY 31, 2006

Job No. 05894-8

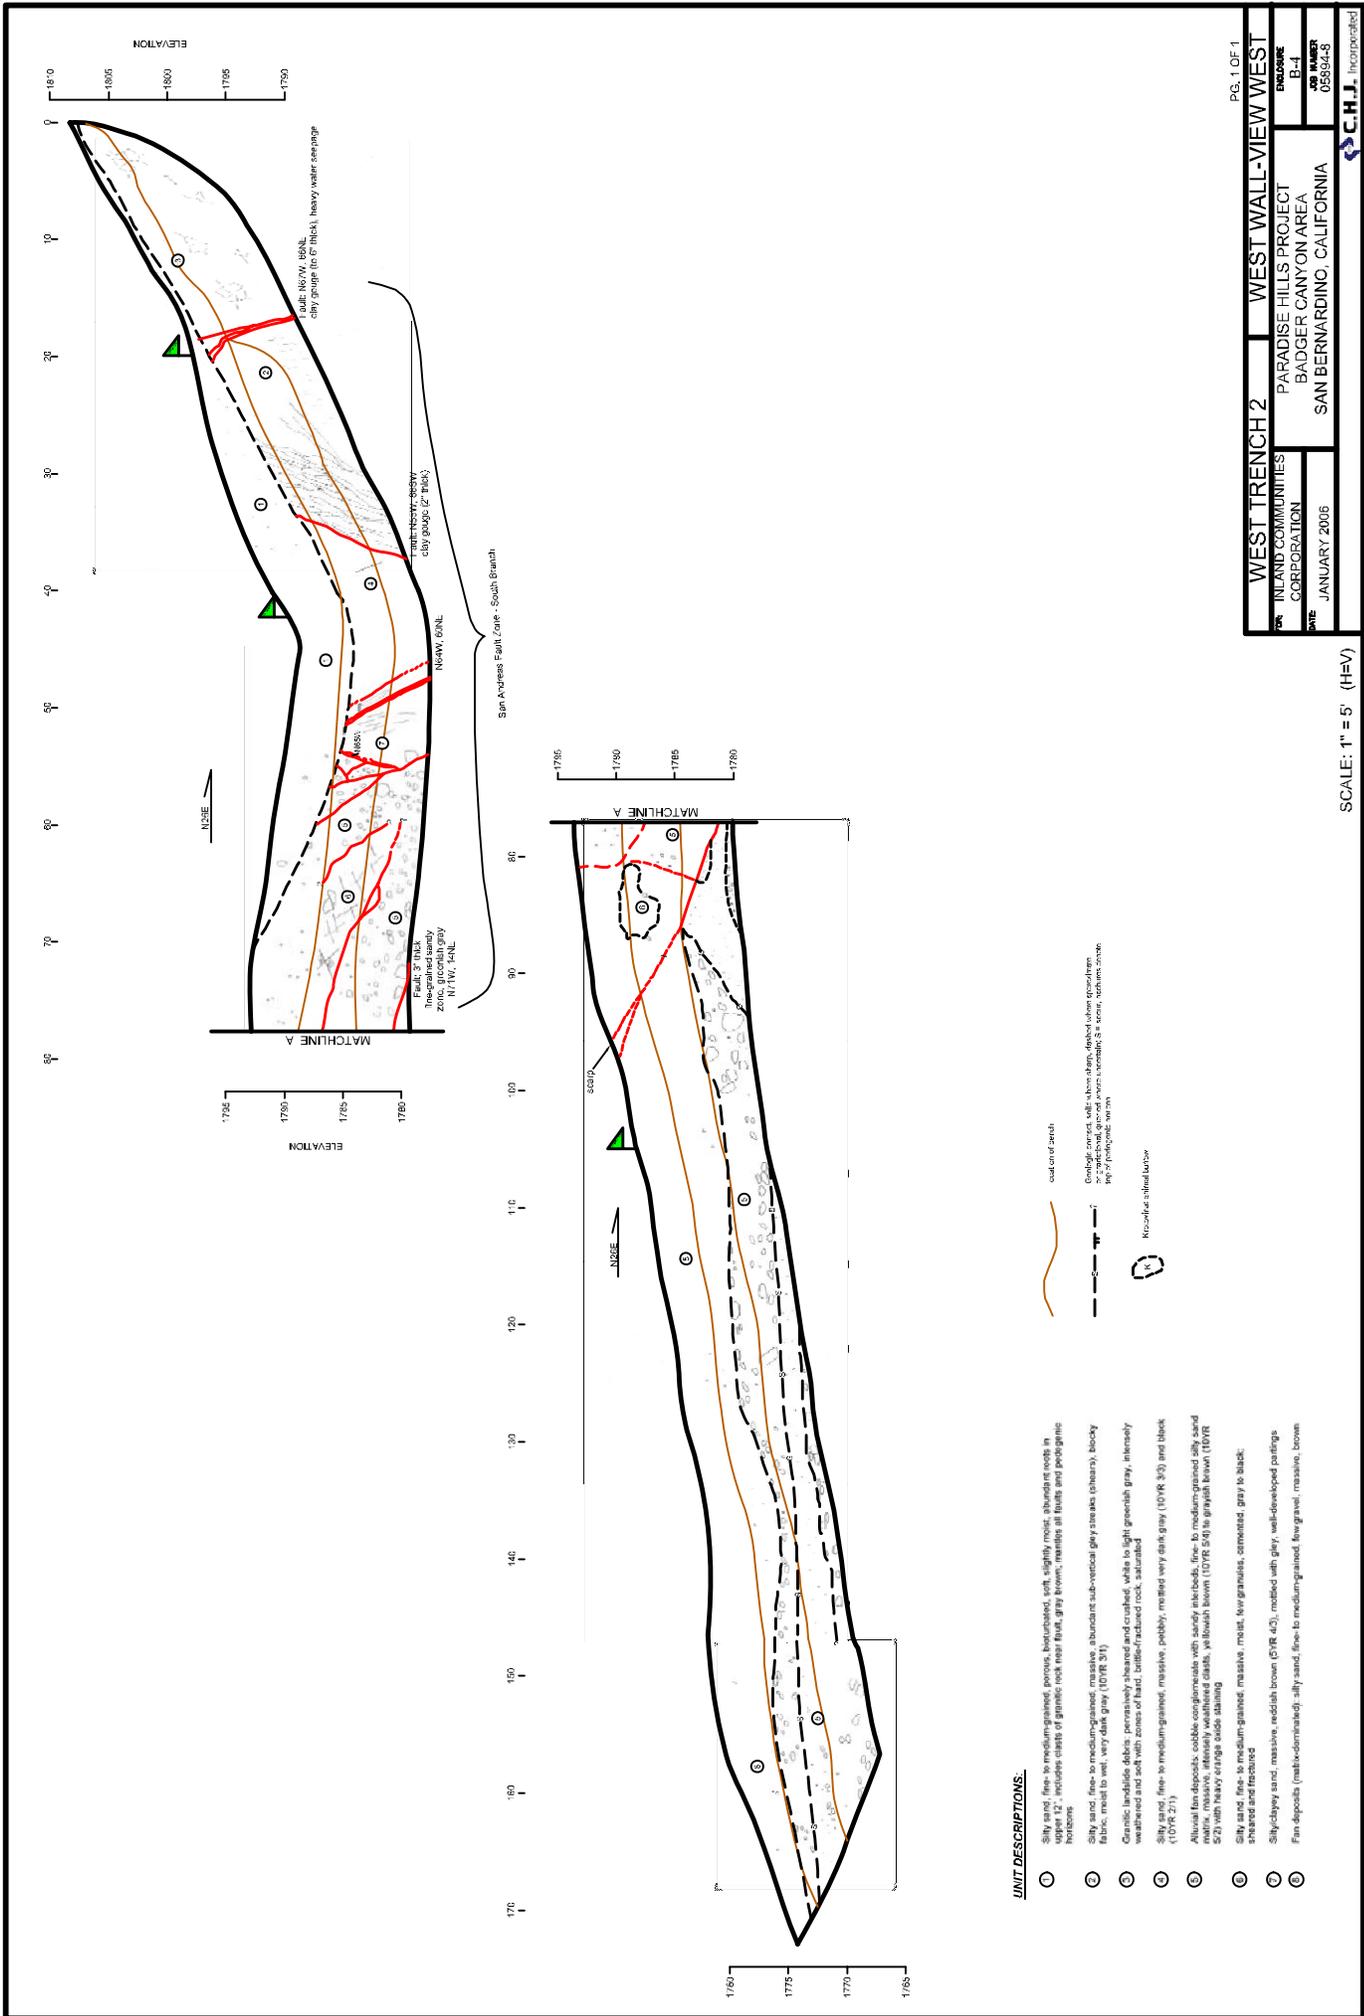
WEST TRENCH 2		WEST WALL-VIEW WEST	
INLAND COMMUNITIES CORPORATION		PARADISE HILLS PROJECT BADGER CANYON AREA SAN BERNARDINO, CALIFORNIA	
DATE	JANUARY 2006	PROJECT NUMBER	058394-S
PG. 1 OF 1		C.H.J. Incorporated

- granitic landslide materials at the base of the trench exposure in the scarp face in fault contact with massive, sheared, fault zone sediments,
- a colluvium-filled graben, coinciding with a linear topographic trough, bounded to the north by a zone of very-closely spaced, south-dipping shears and fractures, and to the south by north-dipping faults,
- a progression of north-dipping faults of apparent thrust offset with southward shallowing dips, separating materials of the fault zone from alluvial-fan deposits to the south, and
- alluvial-fan deposits (Qyfl) locally faulted and warped in the southern reach of the fault zone along low-angle thrust faults.

The northern limit of surface deformation associated with the South Branch SAFZ at the location of WT-2 was not observed as this trench did not extend north of the topographic scarp. The southern limit of surface deformation is indicated by the location of the toe of a topographic scarp and the presence of continuous, flat-lying units of the alluvial-fan materials near Station 96. The zone of deformation is inferred to be at least 100 feet wide at this location, as the northern limit was not observed, but is implied by the presence of bedrock in the scarp face as observed in WT-1A.

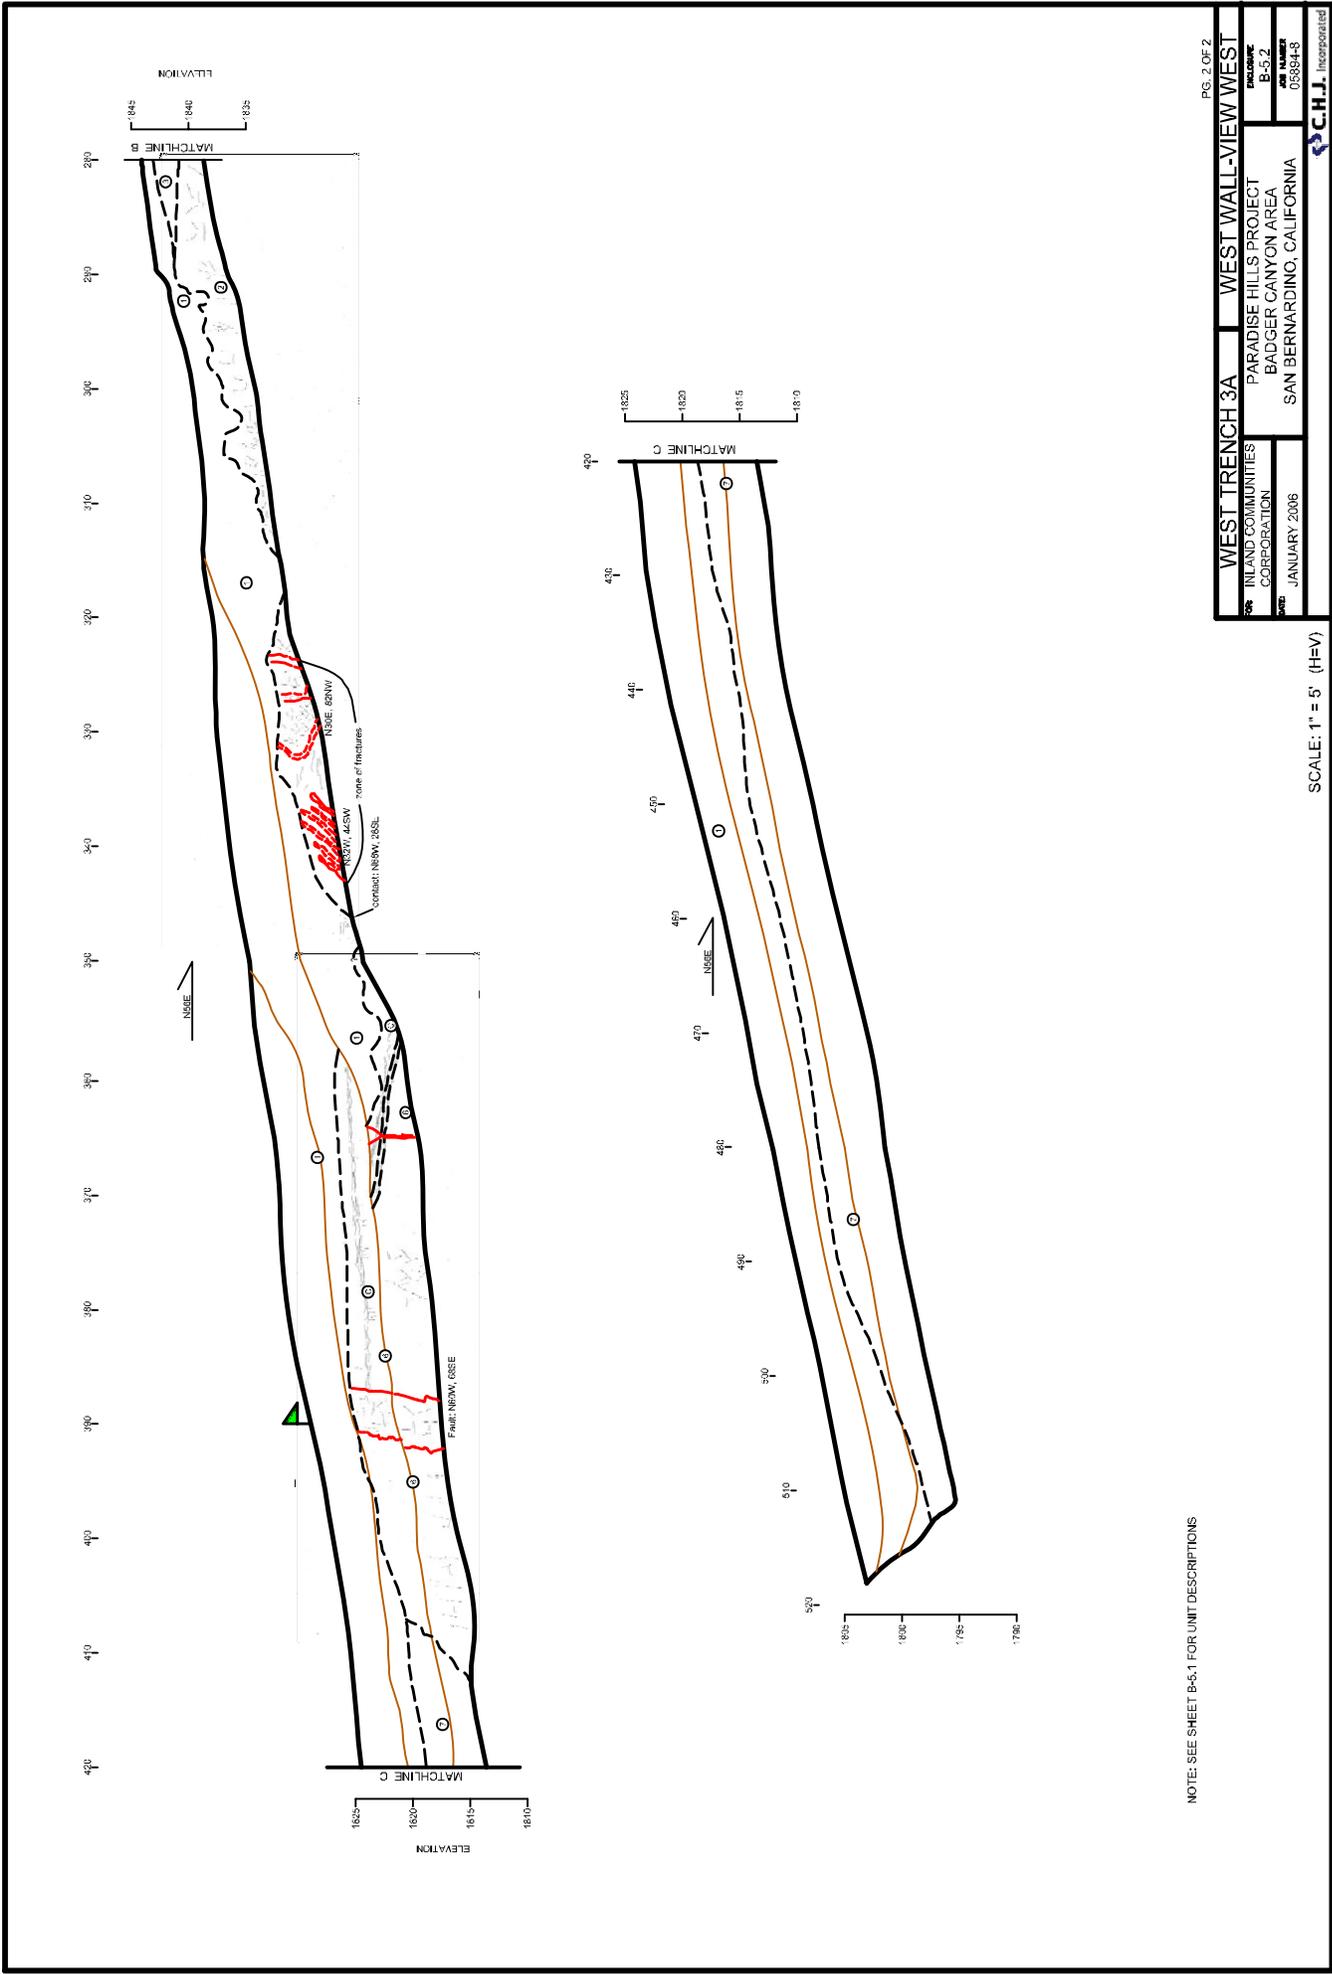
WEST TRENCH 3A		WEST WALL-VIEW WEST	
FOR: INLAND COMMUNITIES CORPORATION	DATE: JANUARY 2006	PROJECT: PARADISE HILLS PROJECT	PROJECT NUMBER: B-5.2
		LOCATION: BADGER CANYON AREA	JOB NO: 03684-S
		LOCATION: SAN BERNARDINO, CALIFORNIA	DESIGNED BY: CH.J.

WT-3A extends southeastward down a narrow bedrock ridge (exposing pervasively fractured granitic landslide deposits) and into an alluviated bench, and terminates north of the South Branch SAFZ. The alluvium consists of massive, fine- to medium-grained, silty sand deposited onto the southward-dipping landslide deposit surface and was saturated at a depth of approximately 10 feet below ground surface (bgs). Caving and raveling of the trench walls south of Station 420 occurred subsequent to logging of the exposure. Abundant fractures and shear surfaces were observed within the landside materials that locally included deformed mafic and aplitic dikes; however, through-going, tectonic-fault-related features were not observed. A 24-inch-wide zone of cemented, fractured rock bounded by residuum derived from granitic material was observed at Station 390. This feature was surveyed and noted as a possible continuation of the Mill Creek fault based on its location along the trend of this fault.

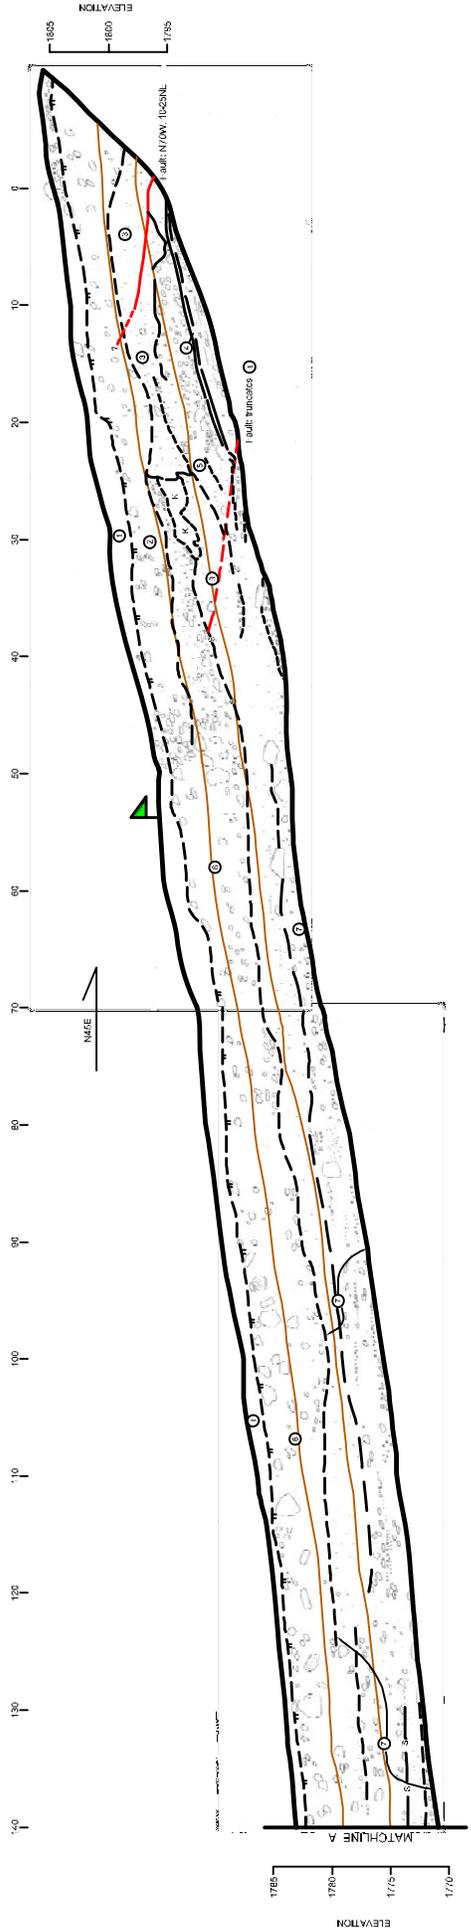
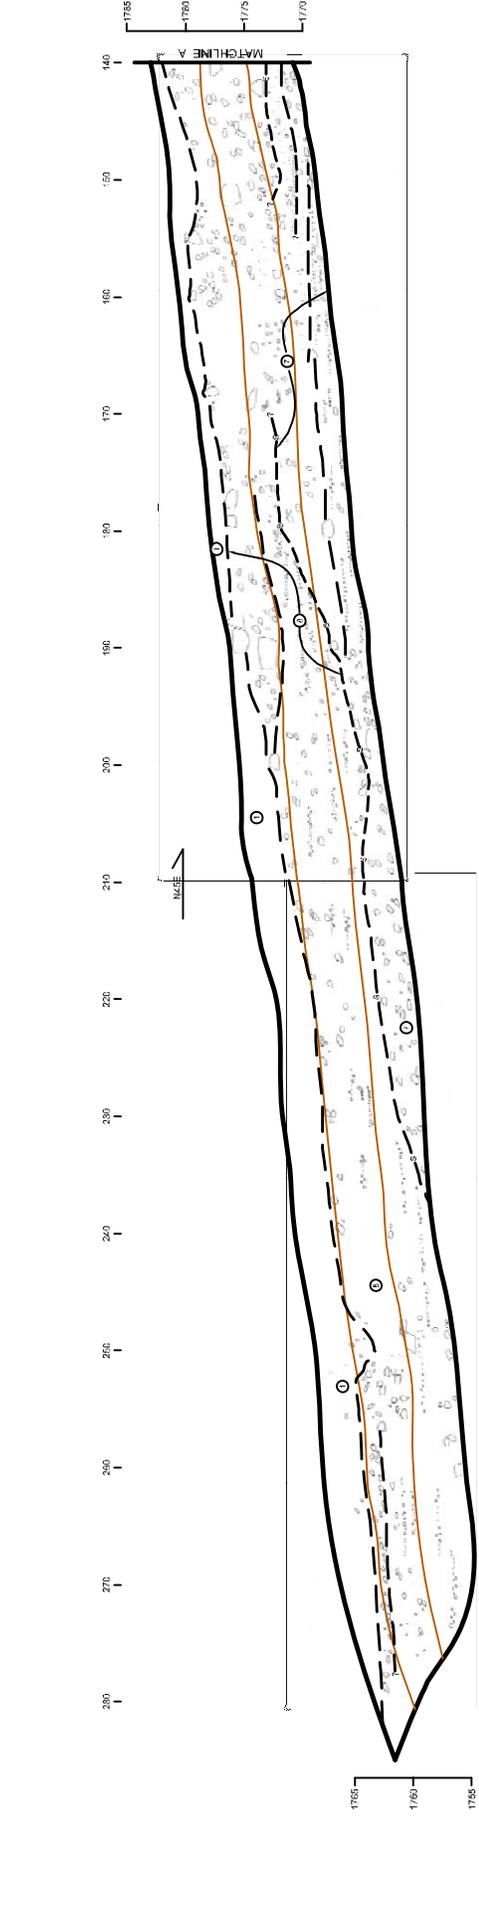
WEST TRENCH 3C	WEST WALL-VIEW WEST
INLAND COMMUNITIES CORPORATION JANUARY 2006	PARADISE HILLS PROJECT BADGER CANYON AREA SAN BERNARDINO, CALIFORNIA 056394-8

The northern limit of surface deformation associated with the South Branch SAFZ at the location of WT-3C was not observed, as this trench exposes the southern limit of the fault zone. The southern limit of surface deformation at the location of WT-3C is indicated by the location of the toe of the topographic scarp at Station 54 and the presence of continuous, flat-lying units of the alluvial-fan materials south of Station 54.

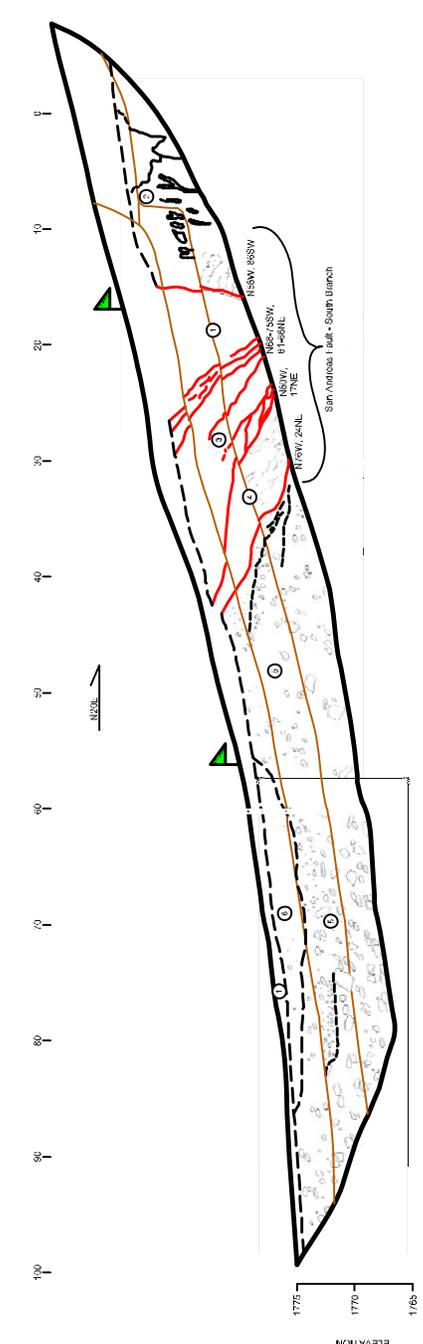
WEST TRENCH 7B		WEST WALL-VIEW WEST	
FOR	INLAND COMMUNITIES CORPORATION	PROJECT	PARADISE HILLS PROJECT
DATE	JANUARY 2006	AREA	BADGER CANYON AREA
		LOCATION	SAN BERNARDINO, CALIFORNIA
		JOB NUMBER	05884-3
			C.H.J. Incorporated

Based on the well-defined geomorphic expression of the linear trough of the South Branch SAFZ south of the caving trench section of WT-7A, we located the north end of WT-7B to avoid caving conditions and expose the South Branch SAFZ. WT-7B is approximately 100 feet long and trends southward from the South Branch SAFZ down a scarp face and into alluvial-fan deposits mapped by Miller et al. (2001) as Qof3. The trench exposed a fault zone with strikes that vary from approximately N58W to N80W, which includes the following features:

The northern limit of surface deformation associated with the South Branch SAFZ was not observed in the WT-7 alignment, as these trenches did not expose bedded sediments that could preclude the presence of such features. The southern limit of surface deformation is indicated by the location of the toe of a topographic scarp and the presence of continuous, flat-lying units of alluvial-fan materials near WT-7B,
