**Phase I and Phase II Environmental
Site Assessments**

PHASE I ENVIRONMENTAL SITE ASSESSMENT
Open Land
Palm Avenue/Industrial Parkway
San Bernardino California

January 2007

PHASE I ENVIRONMENTAL SITE ASSESSMENT
45 Acre Parcel at the Northeast Corner of
Palm Avenue and Industrial Parkway
San Bernardino, CA

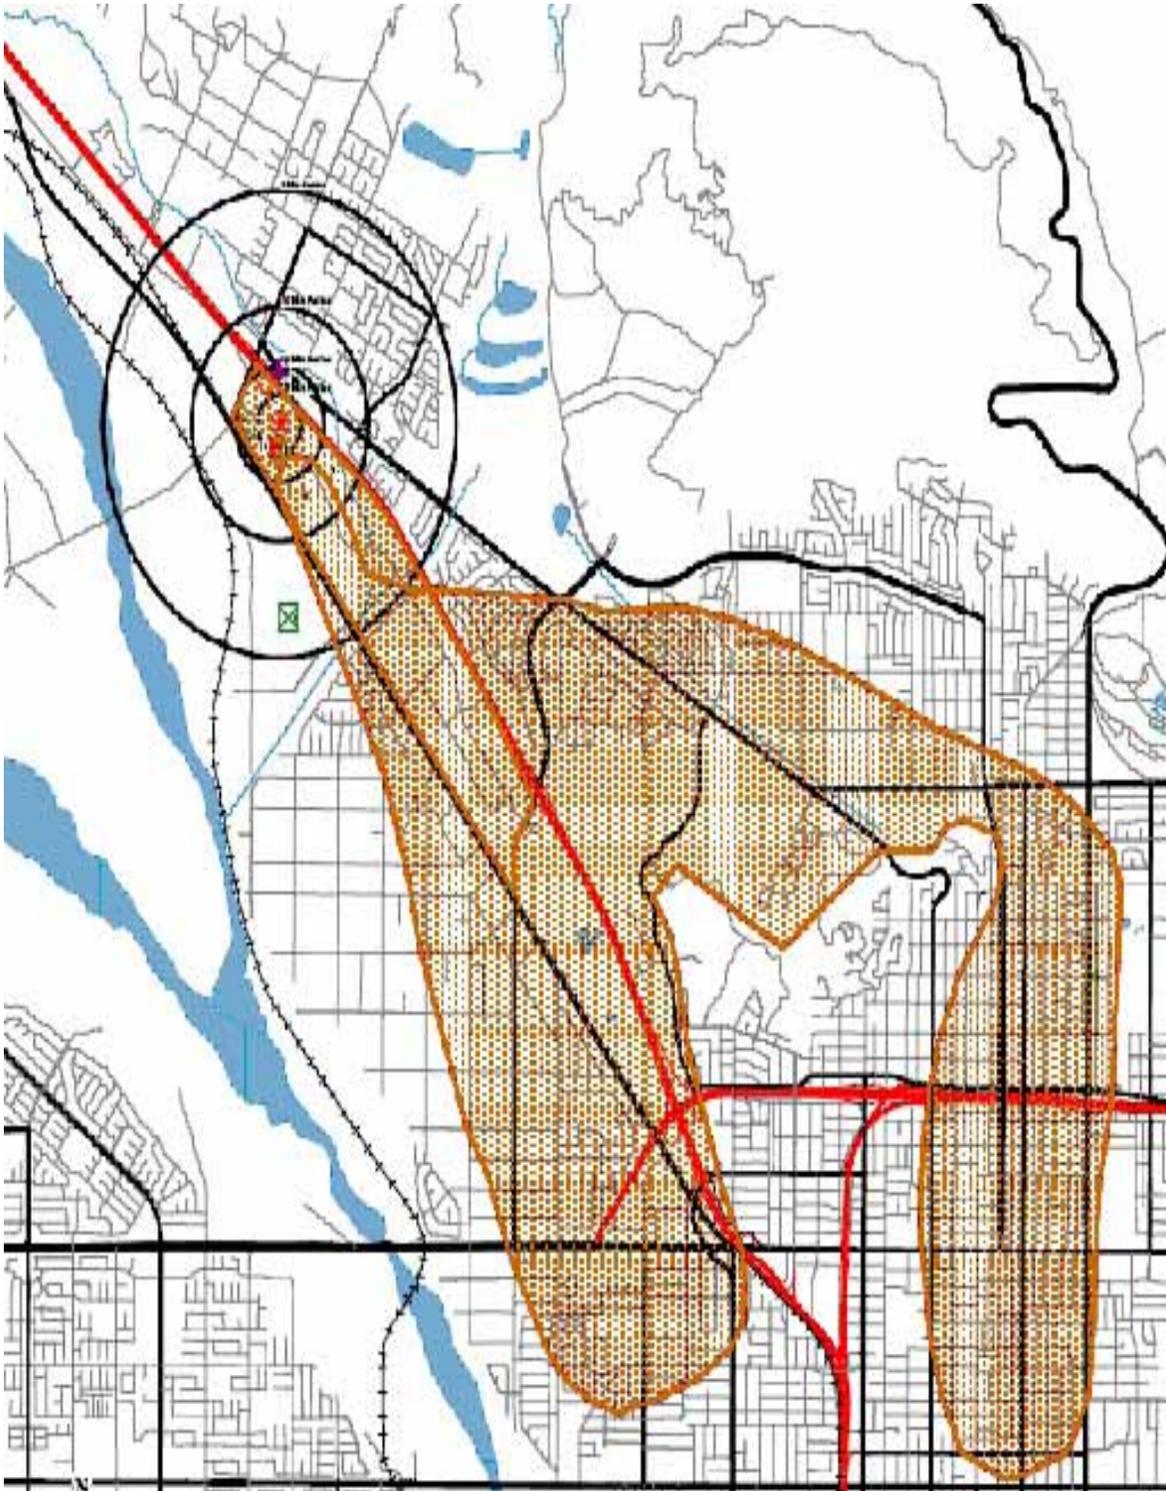
Figure 4- Groundwater Contamination Plume Map

- The site is located at or very near the source of the NewMark Groundwater Contamination Superfund site. The source of that superfund site has not been found and the responsible parties not identified. While the site was part of the former Camp Ono, activities on site or in the immediate site vicinity could have contributed to the release of solvents to groundwater;
- Evidence of indiscriminate dumping of debris and fill dirt was observed on site. Such materials can contain hazardous materials;
- Stormwater runoff from the adjacent 215 Freeway flows onto the property. It has been shown elsewhere that stormwater runoff from freeways can contain hydrocarbons, metals and other hazardous materials.

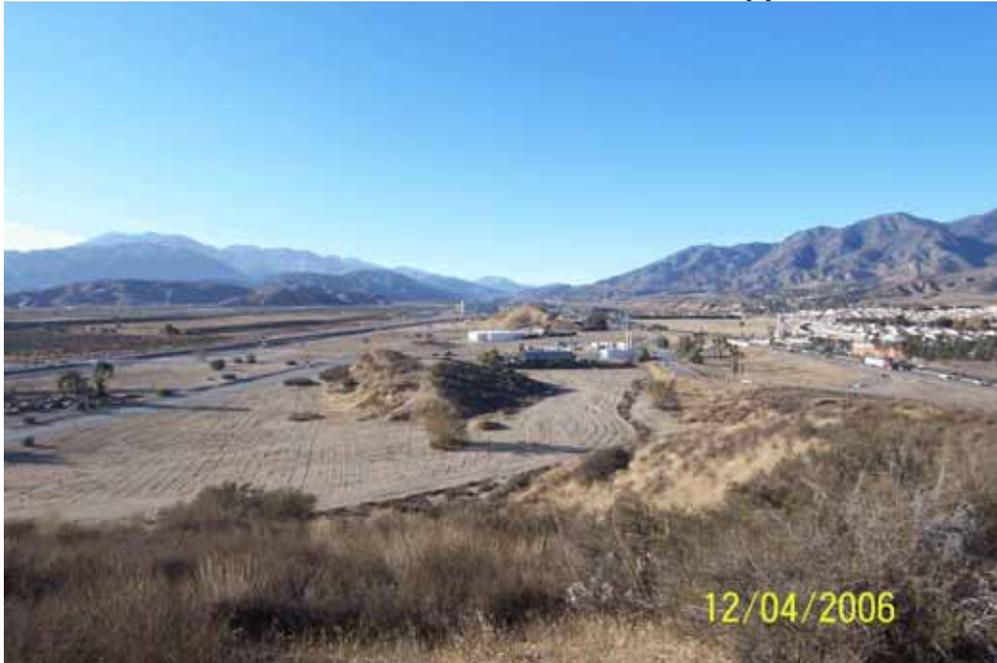
Photograph 1: A View of The large area of what appears to be recently worked fill dirt, as viewed from the top of the larger hill on the subject property

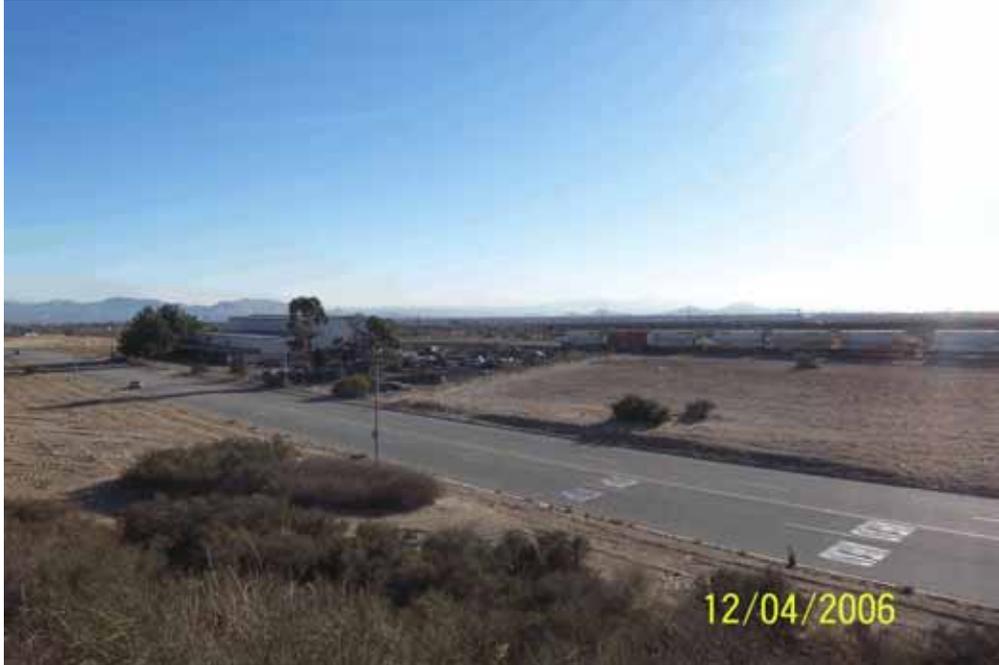
Photograph 2: A view of The portion of the subject property shown as "Lot For Sale" on the site plan

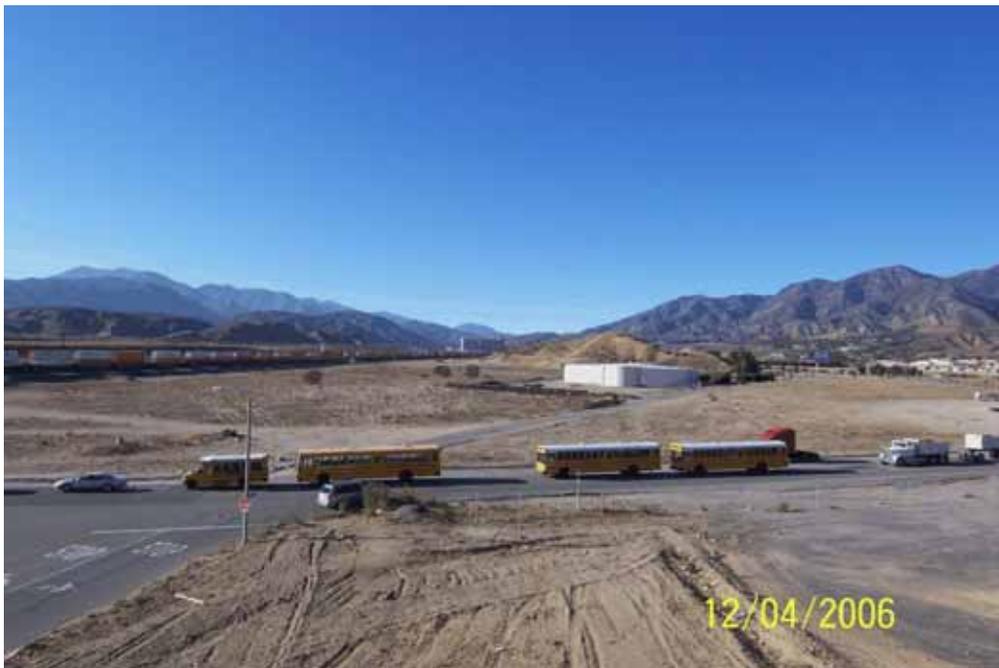
Photo 3: The Fred G. Walter and Son machine shop across Industrial Parkway from the subject property and the railroad tracks beyond

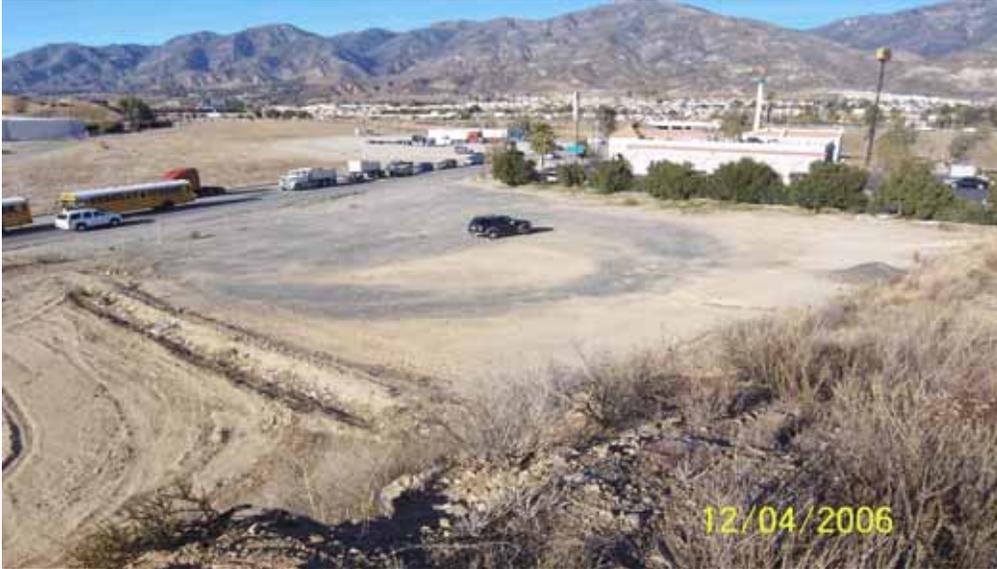
Photo 4: The "lot For Sale" on the subject property at the bottom of the photo, Palm Avenue, and water tanks and railroad tracks beyond

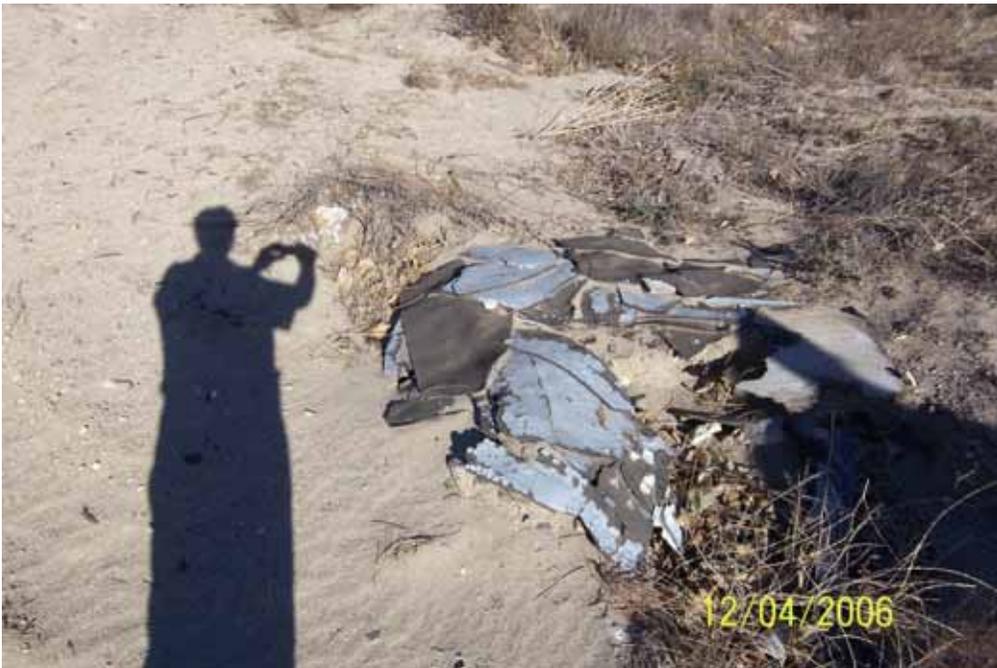
Photo 6: One of several piles of demolition debris we observed, this with roofing materials which may contain asbestos (the silver paint and the roofing)

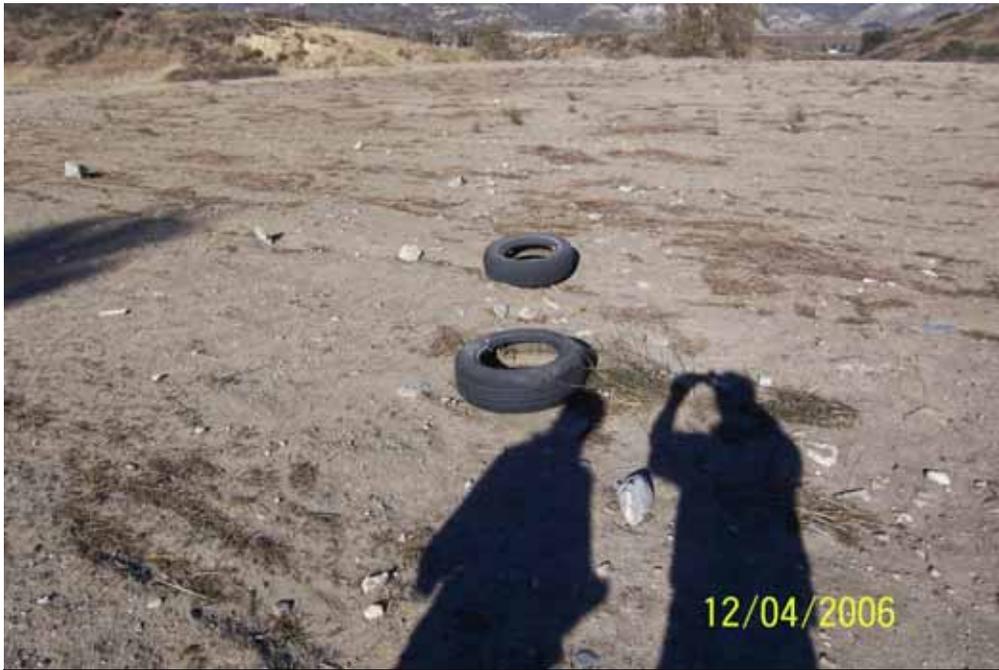
Photo7: Some of the old tires we observed dumped onto the subject property

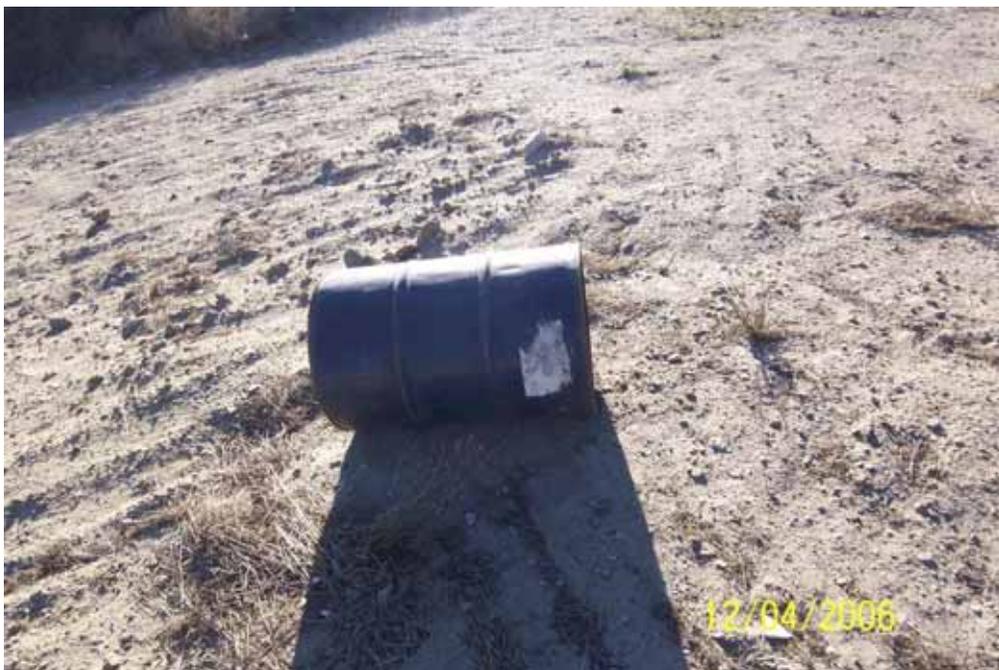
Photo 8: One of the empty drums we observed dumped onto the subject property

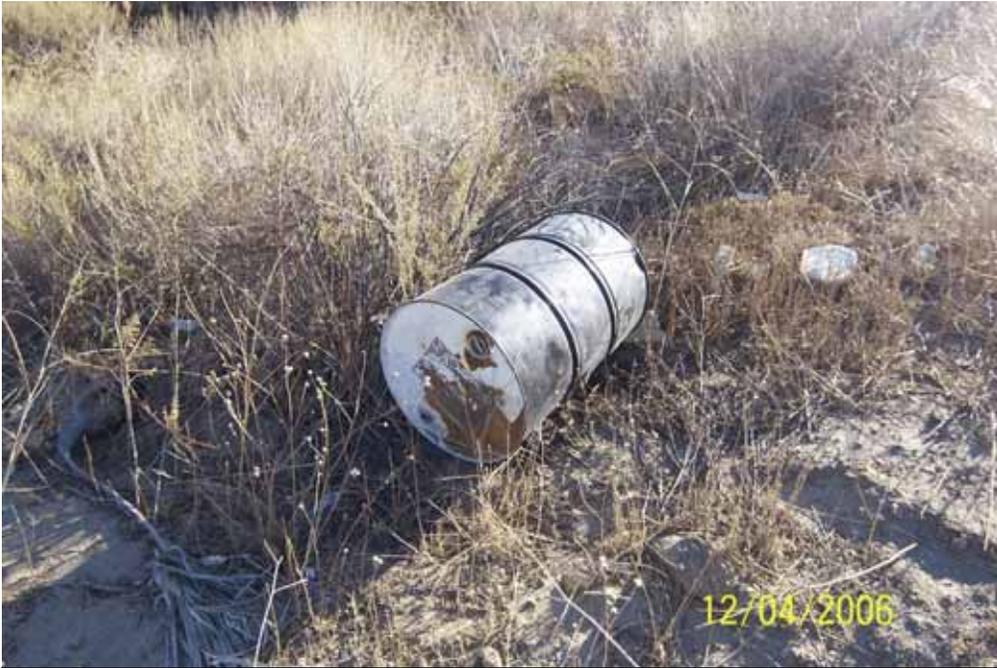
Photo 9: Another drum dumped onto the subject property

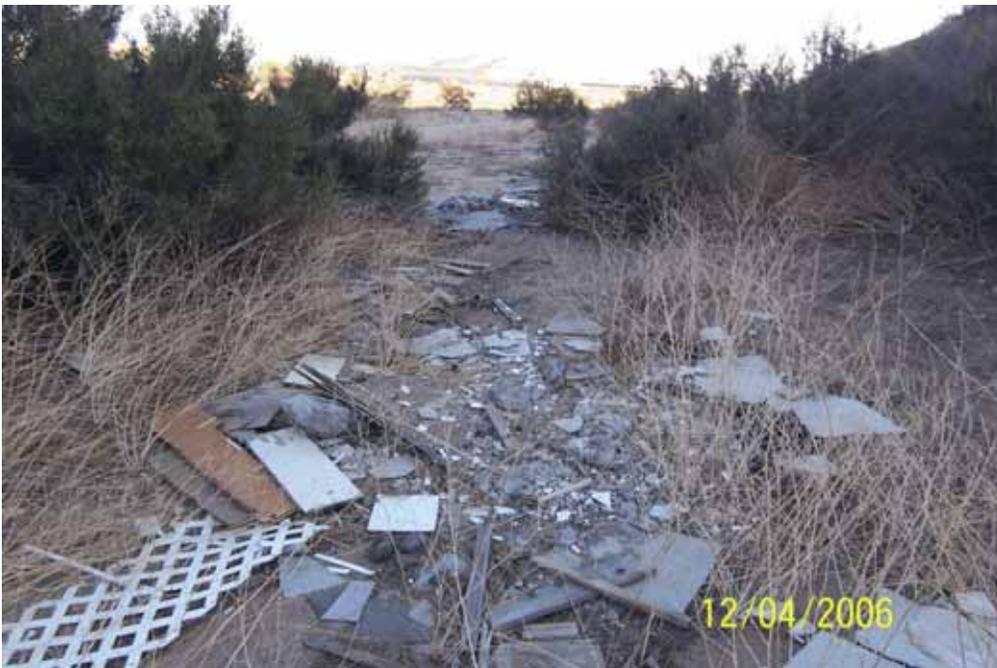
Photo 10: Demolition debris

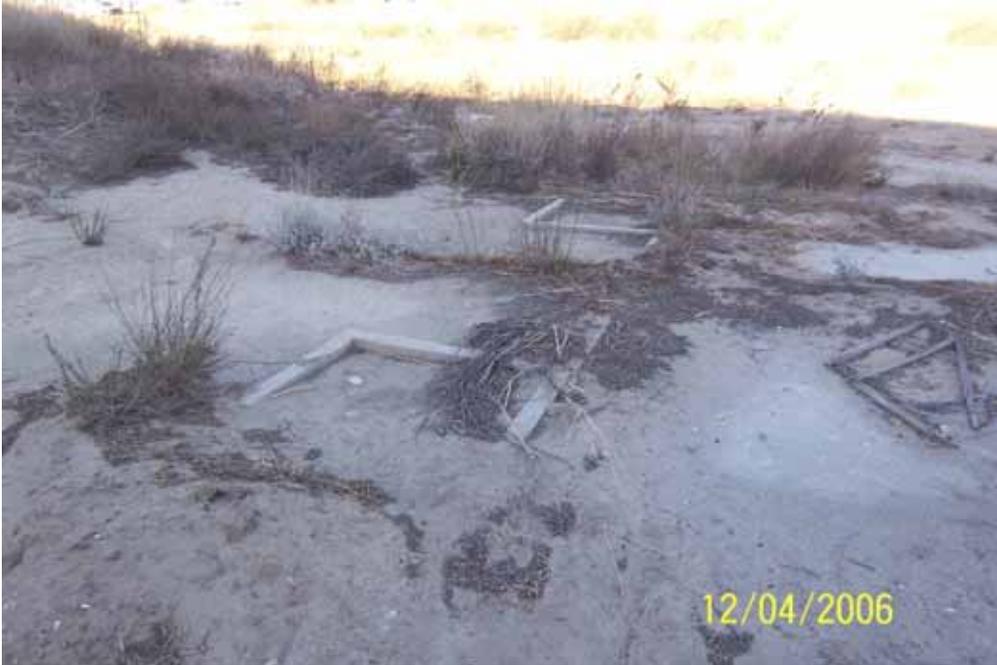
Photo 11: The partially buried old building foundation on the east side of the base of the large hill on the subject property

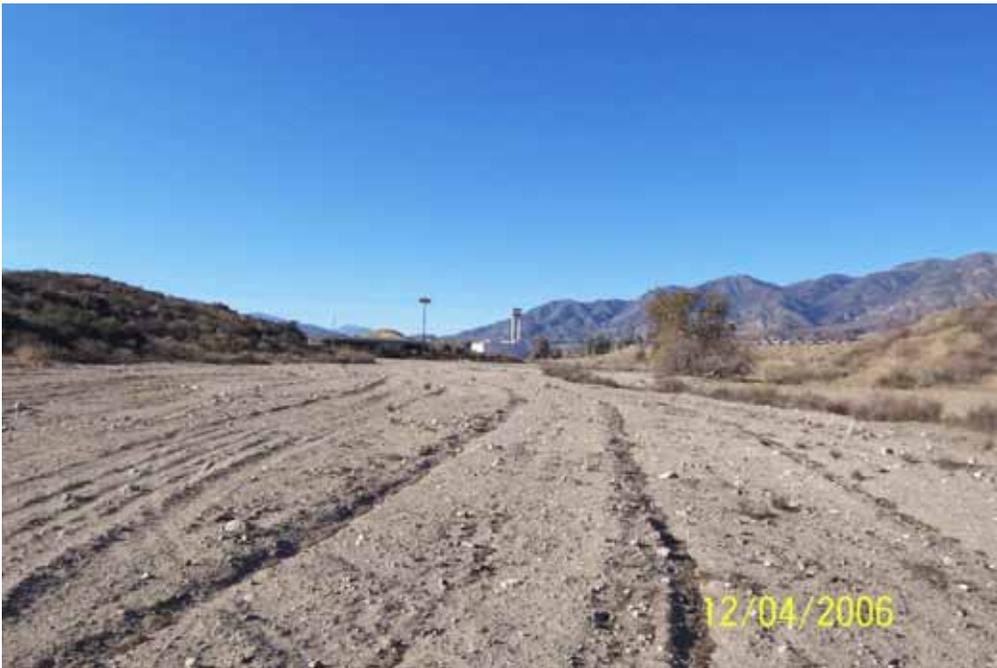
Photo 12: The graded / filled area along the 215 Freeway

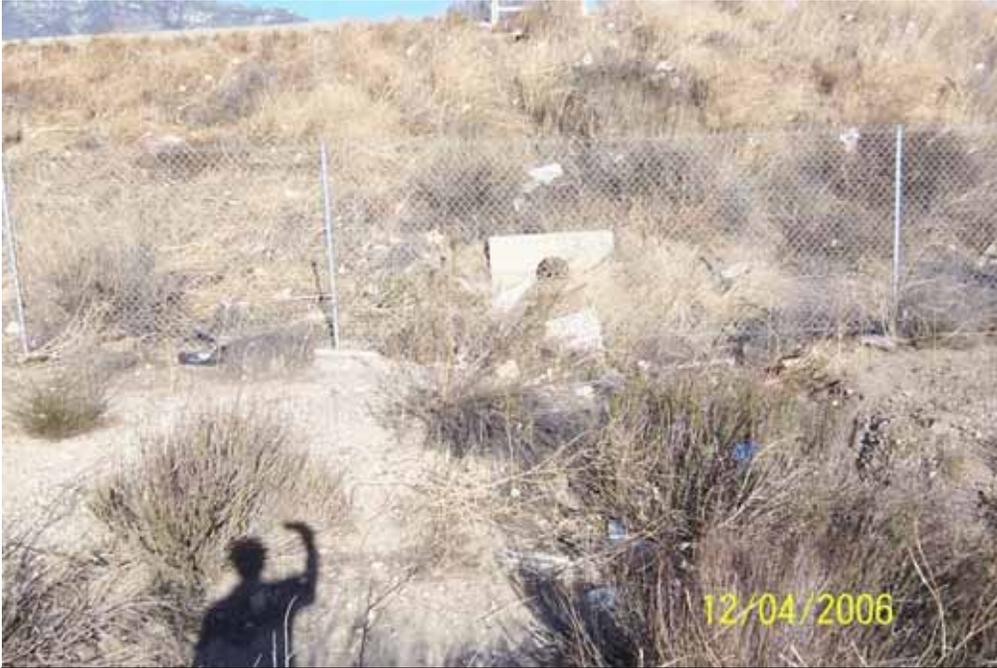
Photo 13: One of the storm water drains from the 215 Freeway which drains onto the subject property

- Areas of indiscriminate dumping of debris that could contain hazardous materials
- Storm water runoff from the adjacent 215 Freeway.

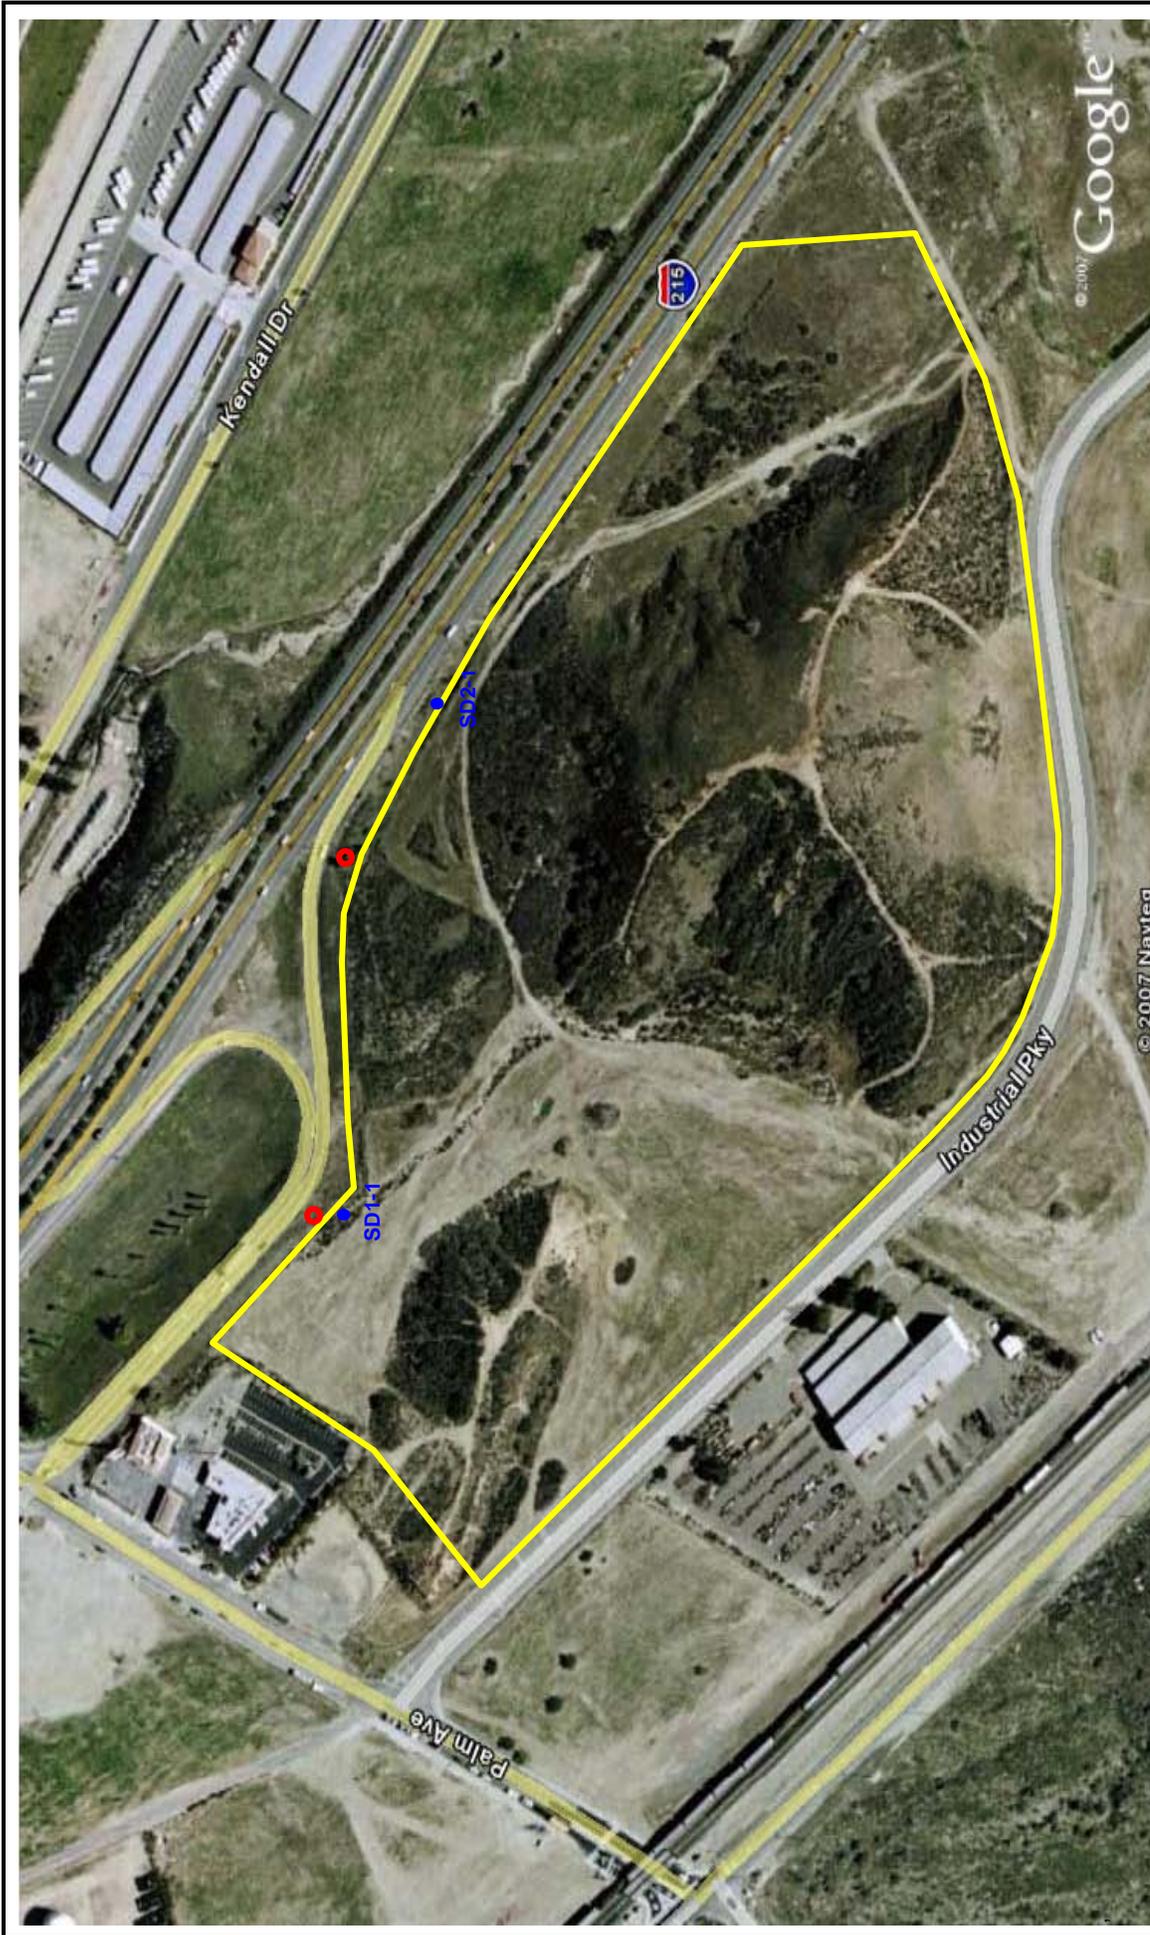
- Legend**
- Off-site storm drain location
 - Shallow soil sample location and designation
 - Approximate site boundary

PROJECT NO. 100025001	SOIL SAMPLE LOCATION MAP PALM AVENUE AND INDUSTRIAL PARKWAY SAN BERNARDINO, CALIFORNIA	FIGURE
	DATE 5/07		2

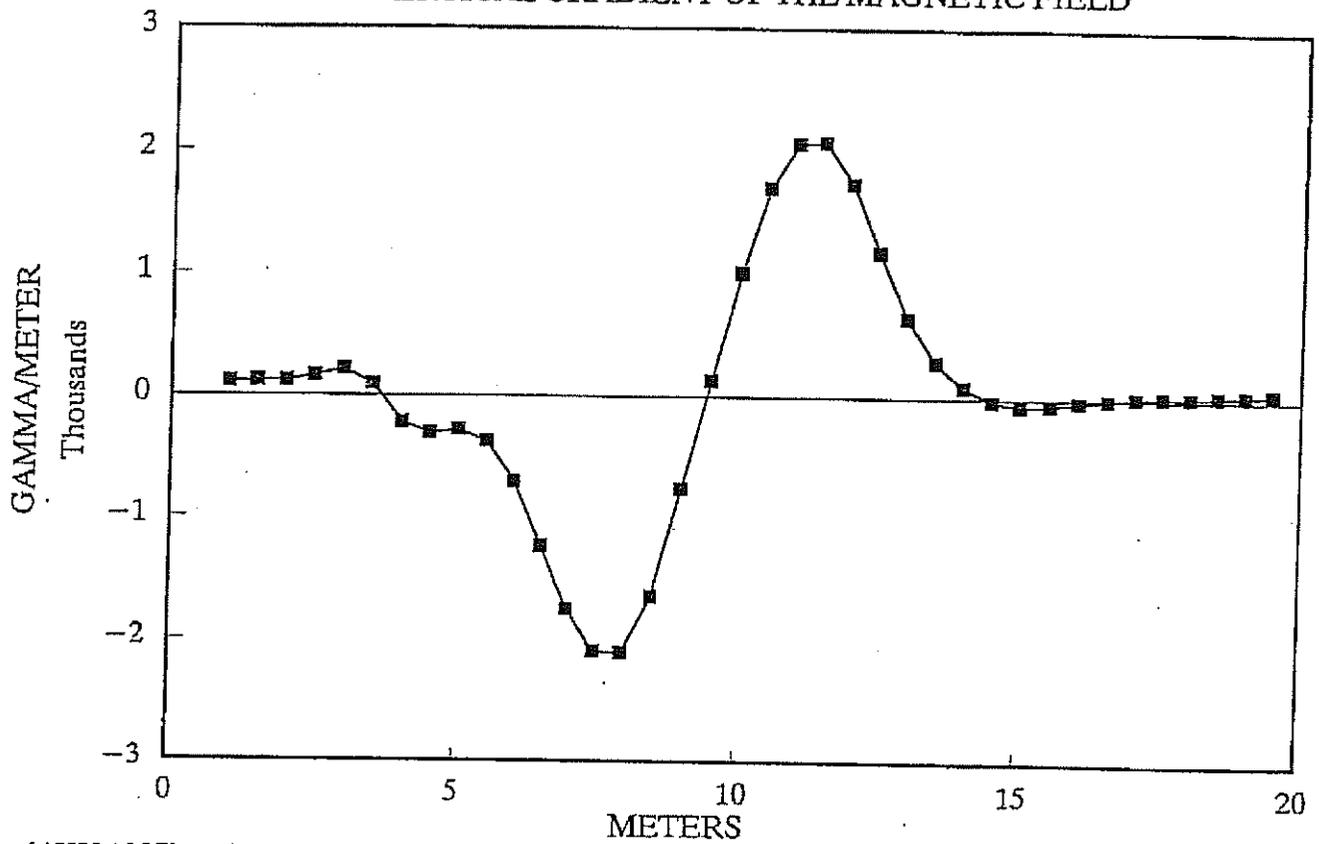
(40W,100S) - (20W,100S)

The data show that the target trench does not exist within the survey area. The area is characterized by a limited number of scattered shallow buried ferrous objects. Each site encompasses only a small area and is likely not significant in itself. Three utilities passing through the survey area demonstrate the systems ability to detect buried ferrous objects of small size.
