Delineation of Jurisdictional Wetlands and Waters

Spring Trails Specific Plan (Access Roads), San Bernardino County, California

June 9, 2009

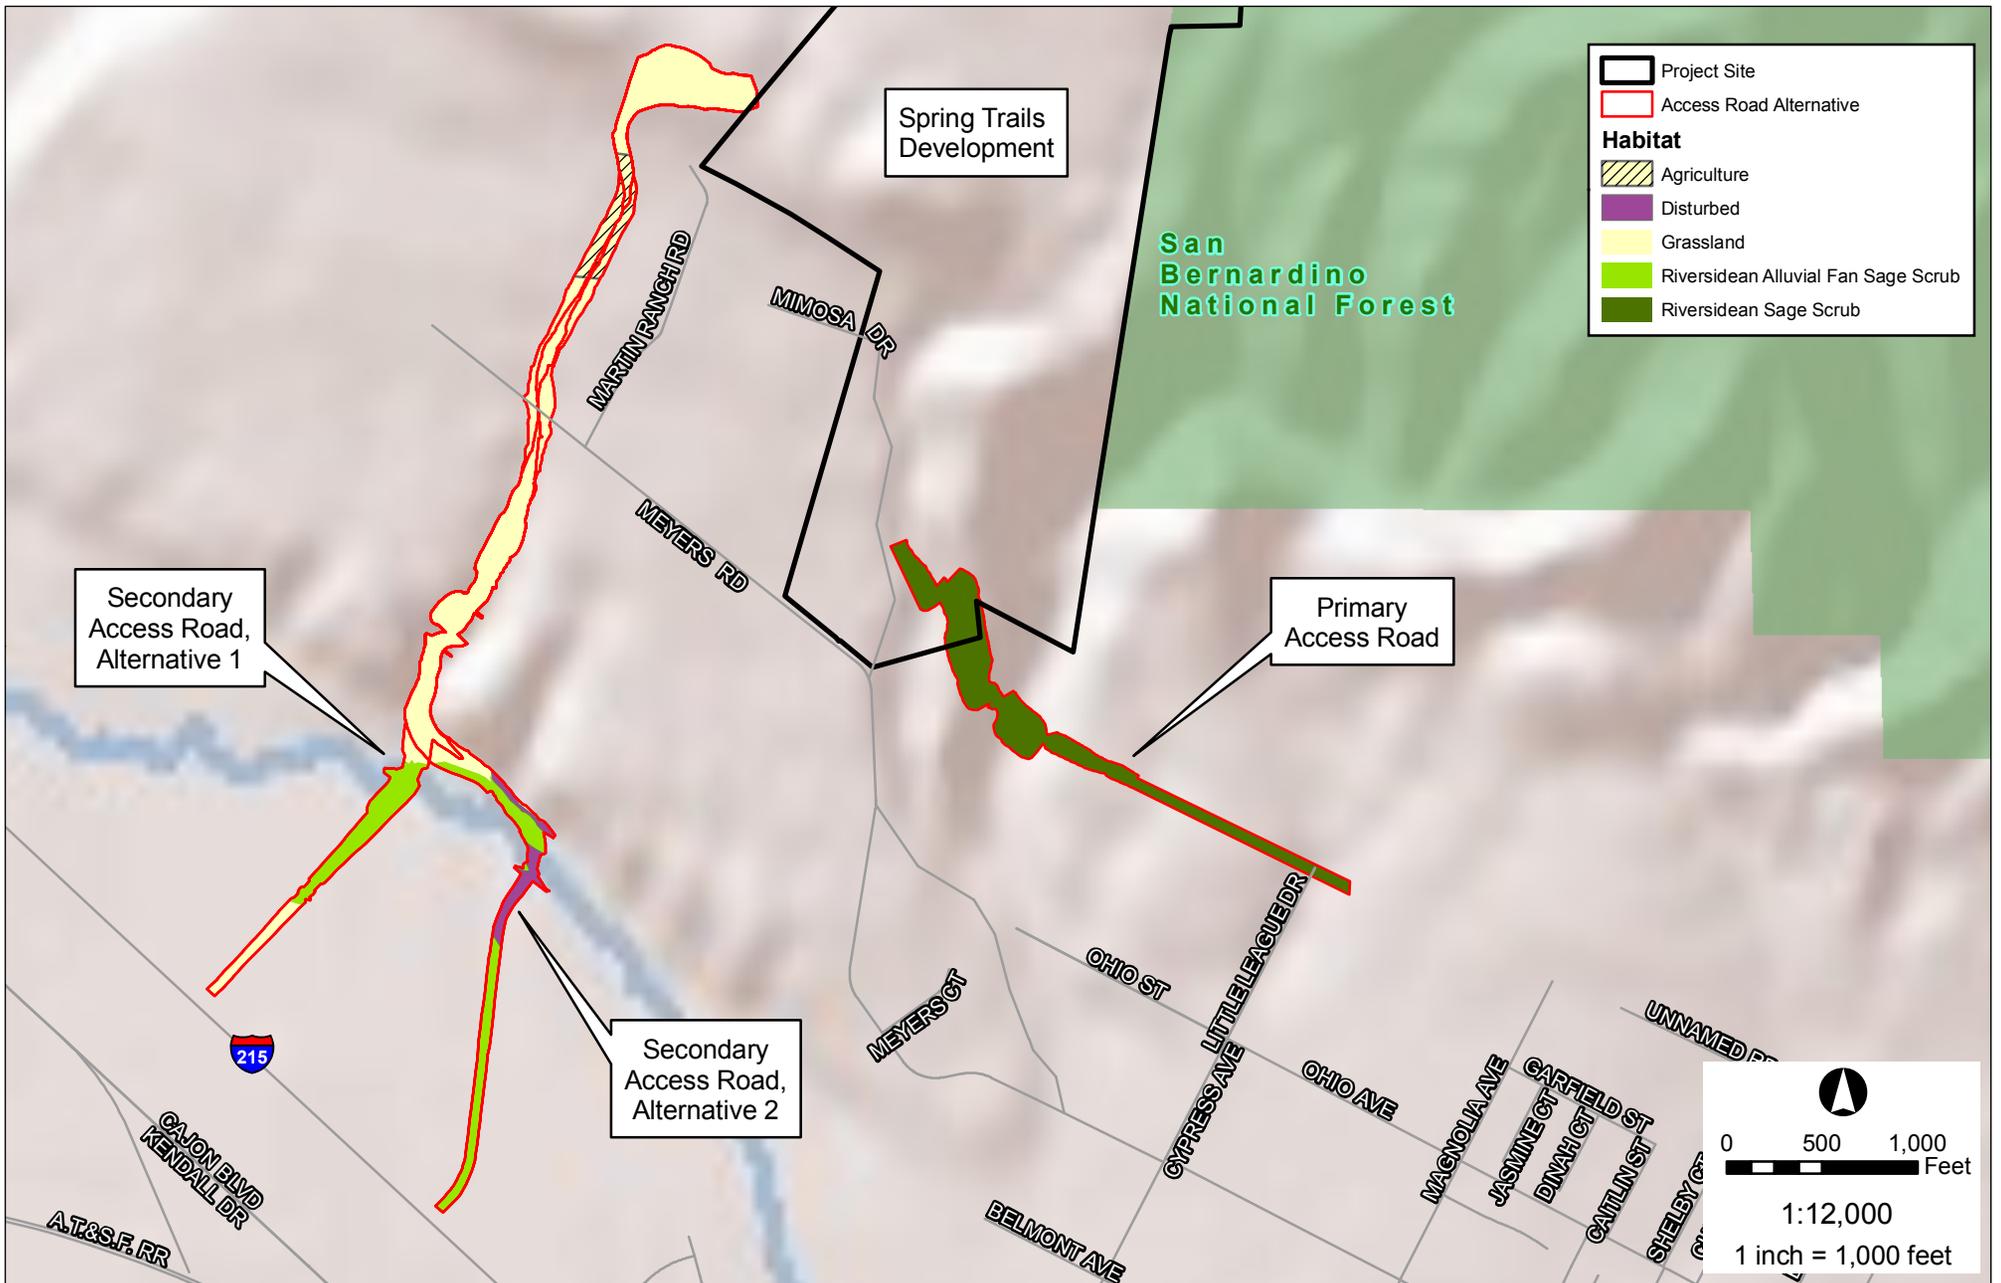
FIGURE 3

The proposed access roads support disturbed Riversidean sage scrub, Riversidean alluvial fan sage scrub, sycamore alluvial woodland, non-native grassland, eucalyptus woodland, agriculture, and disturbed vegetation communities. Figure 3 shows the location of the vegetation classifications within the project site. Riversidean alluvial fan sage scrub, Riversidean sage scrub, and non-native grassland were the predominant vegetation communities found within or along the drainage features, and are further described below.

Vegetation Communities within Project Site

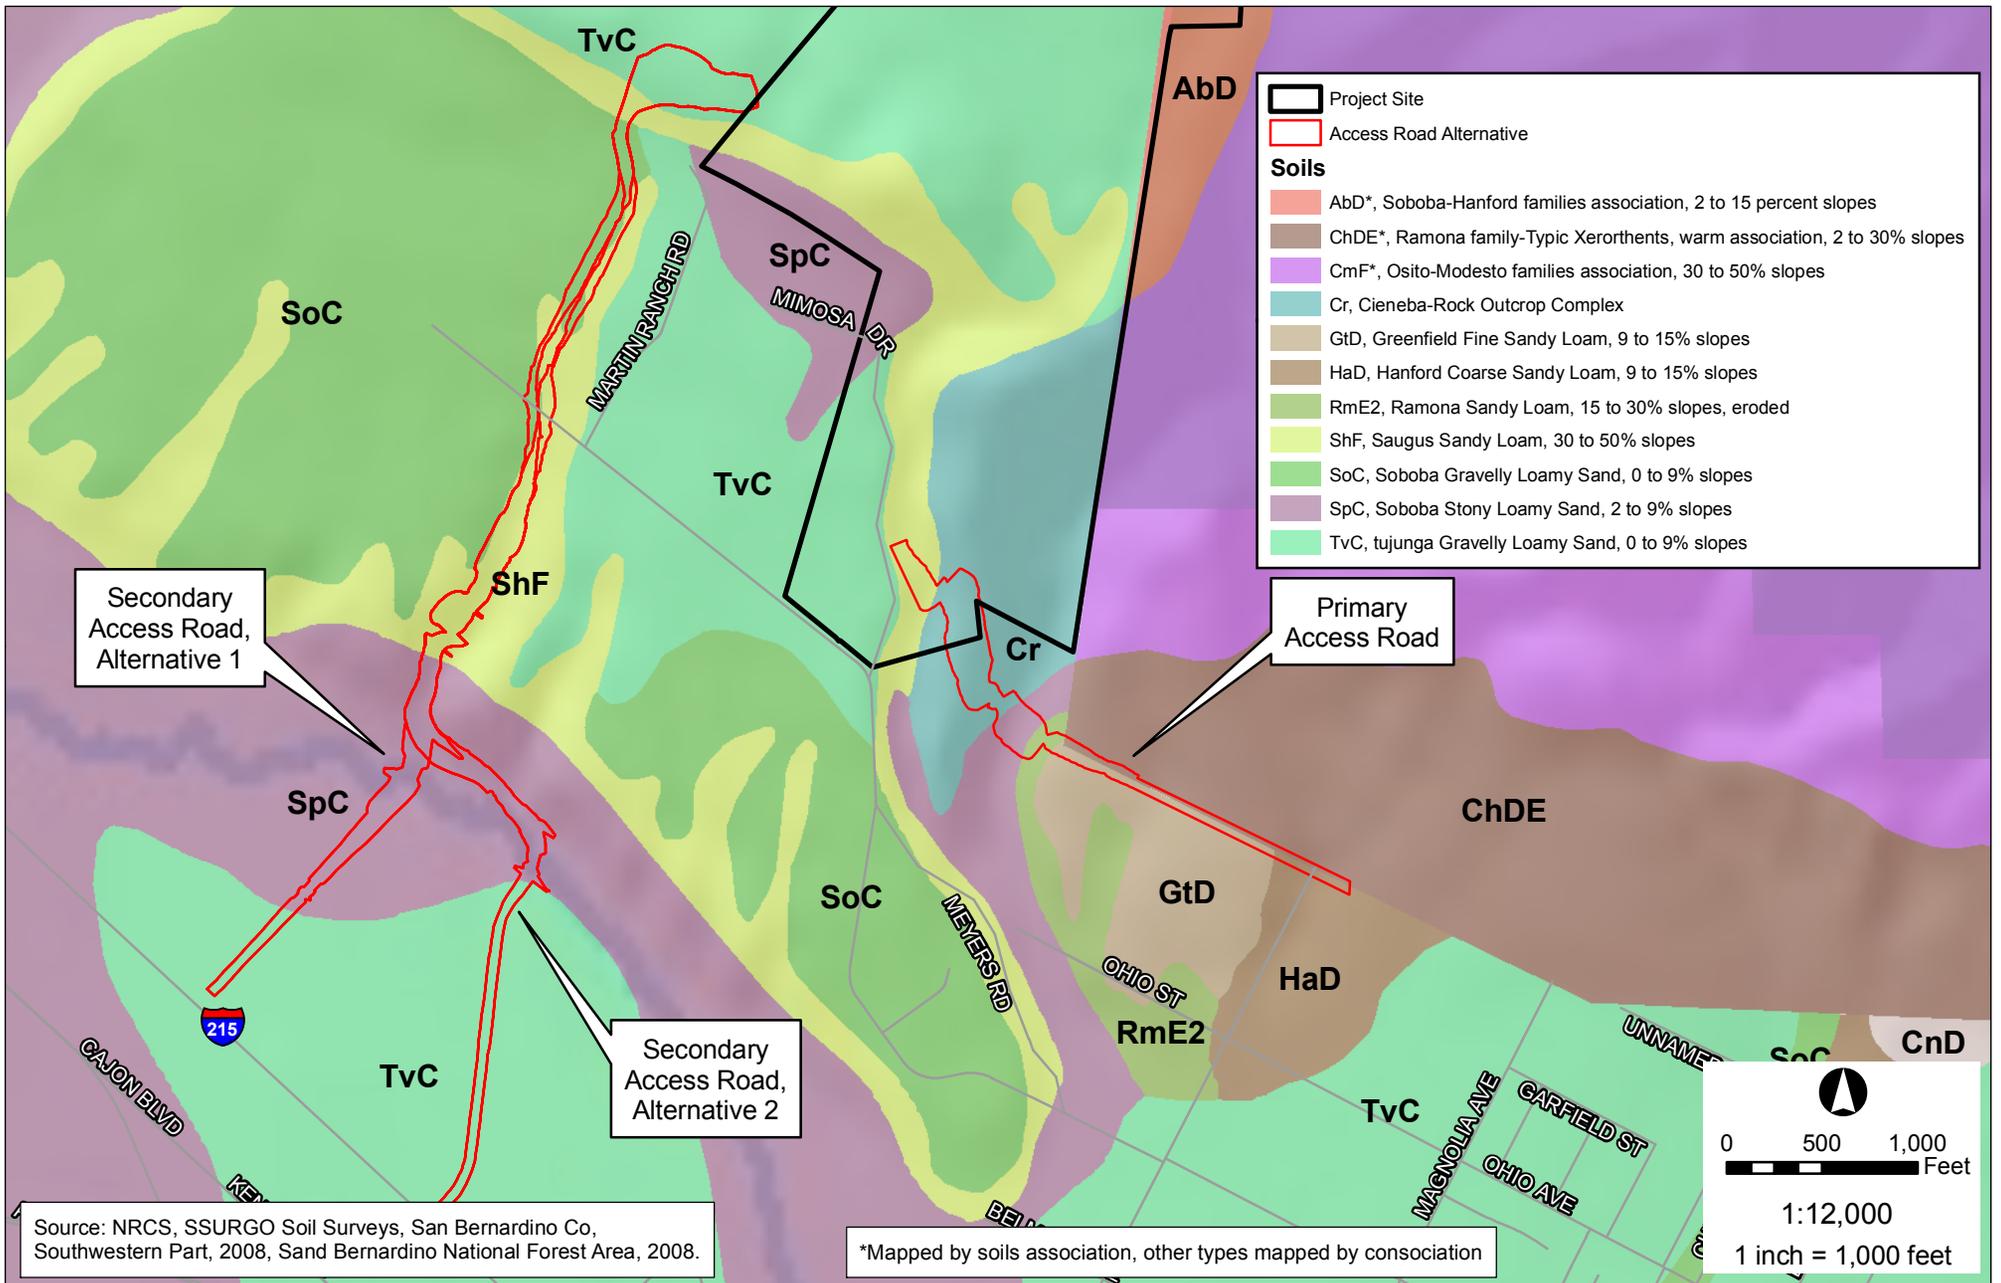
FIGURE 4
Soil types

Based on the Natural Resources Conservation Service (NRCS) Soil Surveys for San Bernardino County, Southwestern Part and San Bernardino National Forest (USDA 2008), the access road alignments contain eleven distinct soil mapping units: Ramona family, Soboba-Hanford family, Osito-Modesto family, Cieneba-Rock outcrop complex, Greenfield fine sandy loam, Hanford coarse sandy loam, Ramona sandy loam, Saugus sandy loam, Soboba gravelly loamy sand, Soboba stony loamy sand, and Tujung gravelly loamy sand (Figure 4). General characteristics associated with these soils types are described below.

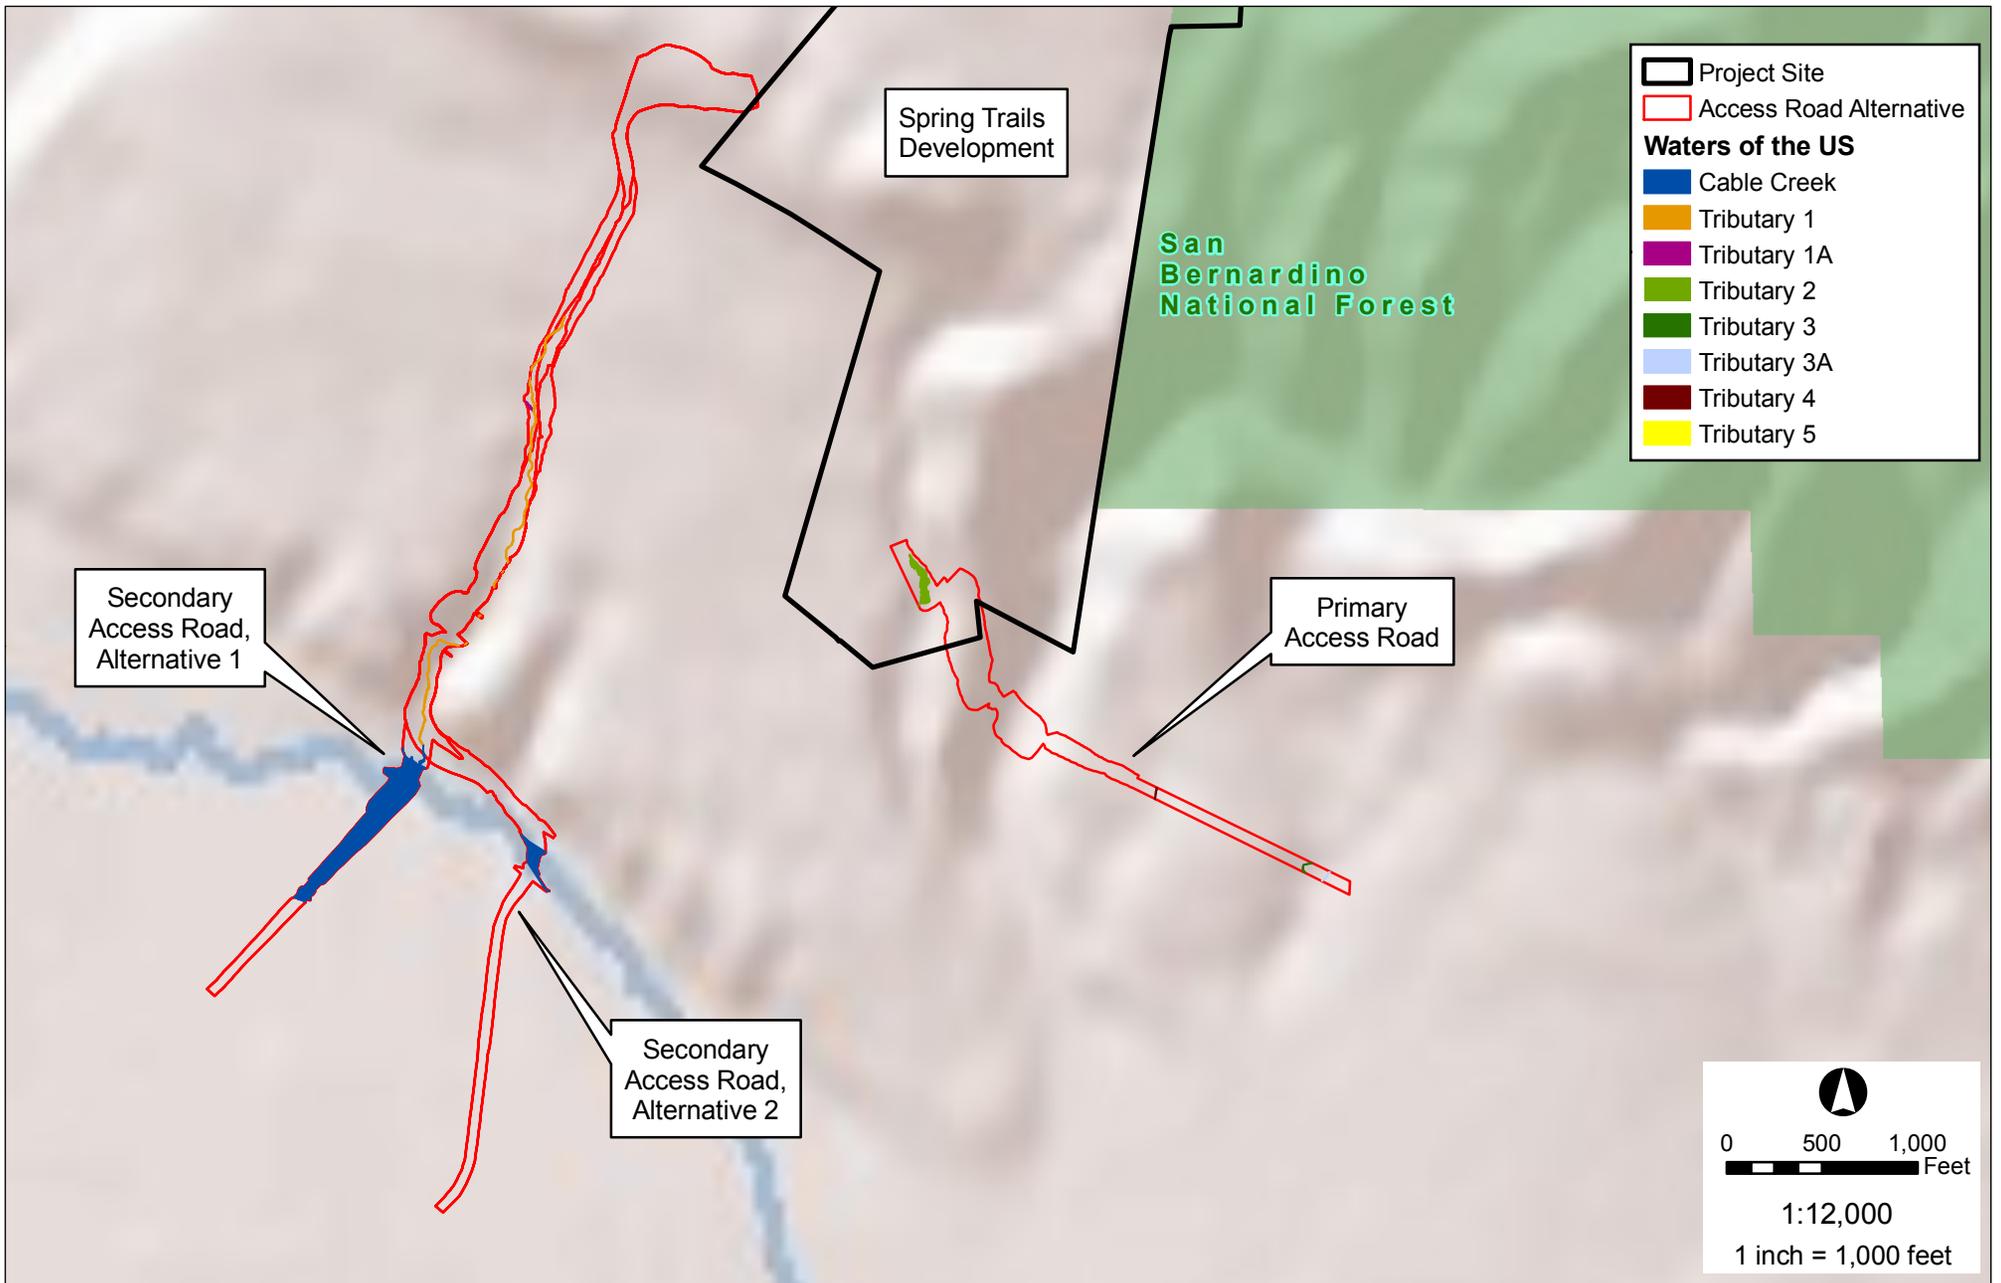
FIGURE 5

Potential Corps and RWQCB Jurisdictional Areas within the Project Site

The jurisdictional delineation field survey results conclude that approximately 3.19 acres within the proposed primary and secondary access road alignments could be under the jurisdiction of the USACE and RWQCB. These results are summarized in Table 1.

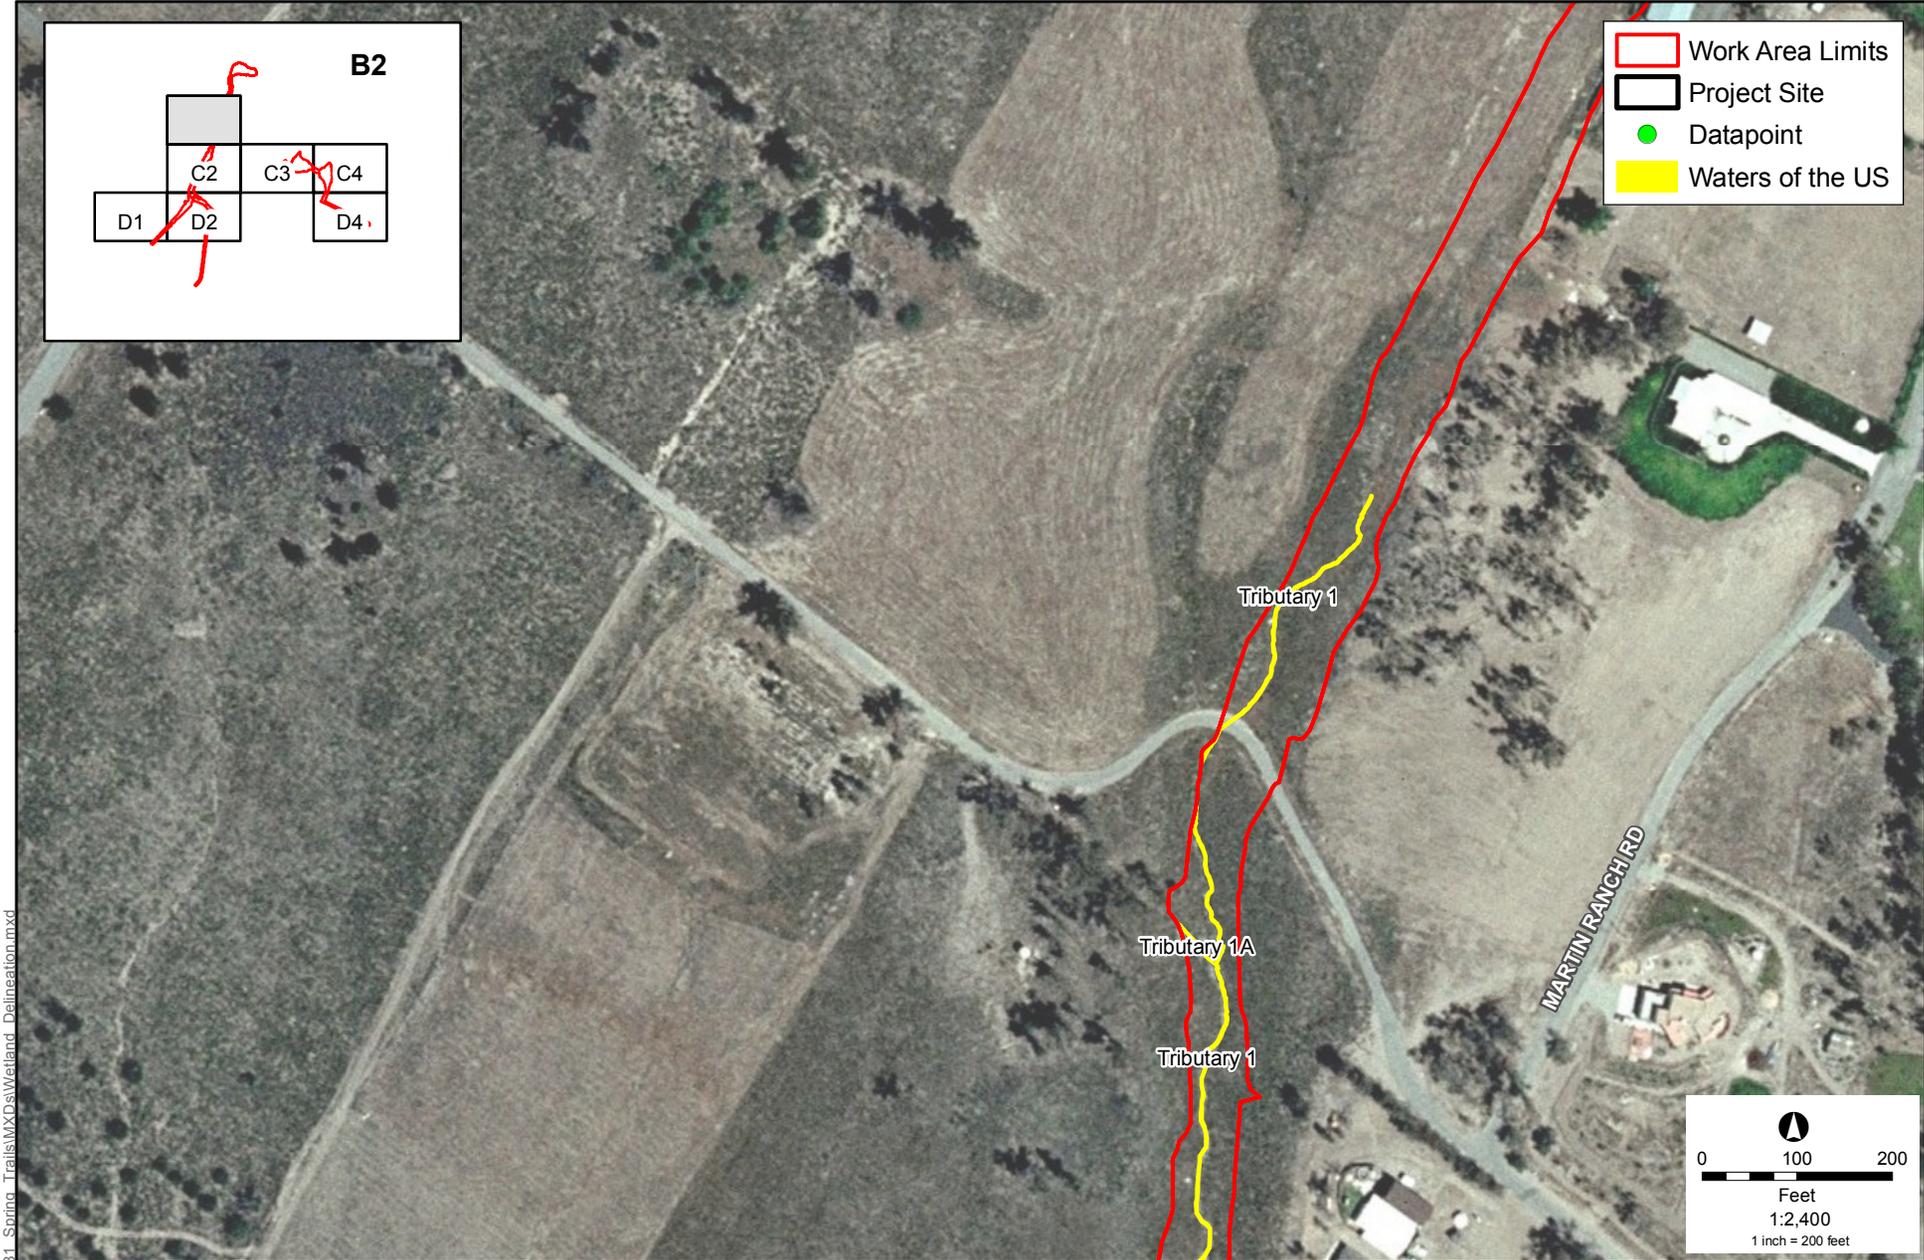
Figure 6a
Wetland Delineation

Tributary 1 is a drainage feature that is a tributary to Cable Creek and is located in the central portion of the secondary access road alignment (Figures 5, 6a, and 6b). The source of water into Tributary 1 is anticipated to be from off-site urban runoff and local topography. The dominant vegetation along the

The OHWM for the active channel measures approximately three feet to 15 feet wide, with an average width of approximately five feet. Approximately 0.254 acre within the proposed secondary access road alignments could fall under the jurisdiction of the USACE and RWQCB. The top of the banks extend an additional one foot on each side of the OHWM. Approximately 0.355 acre of this tributary could fall under CDFG jurisdiction.

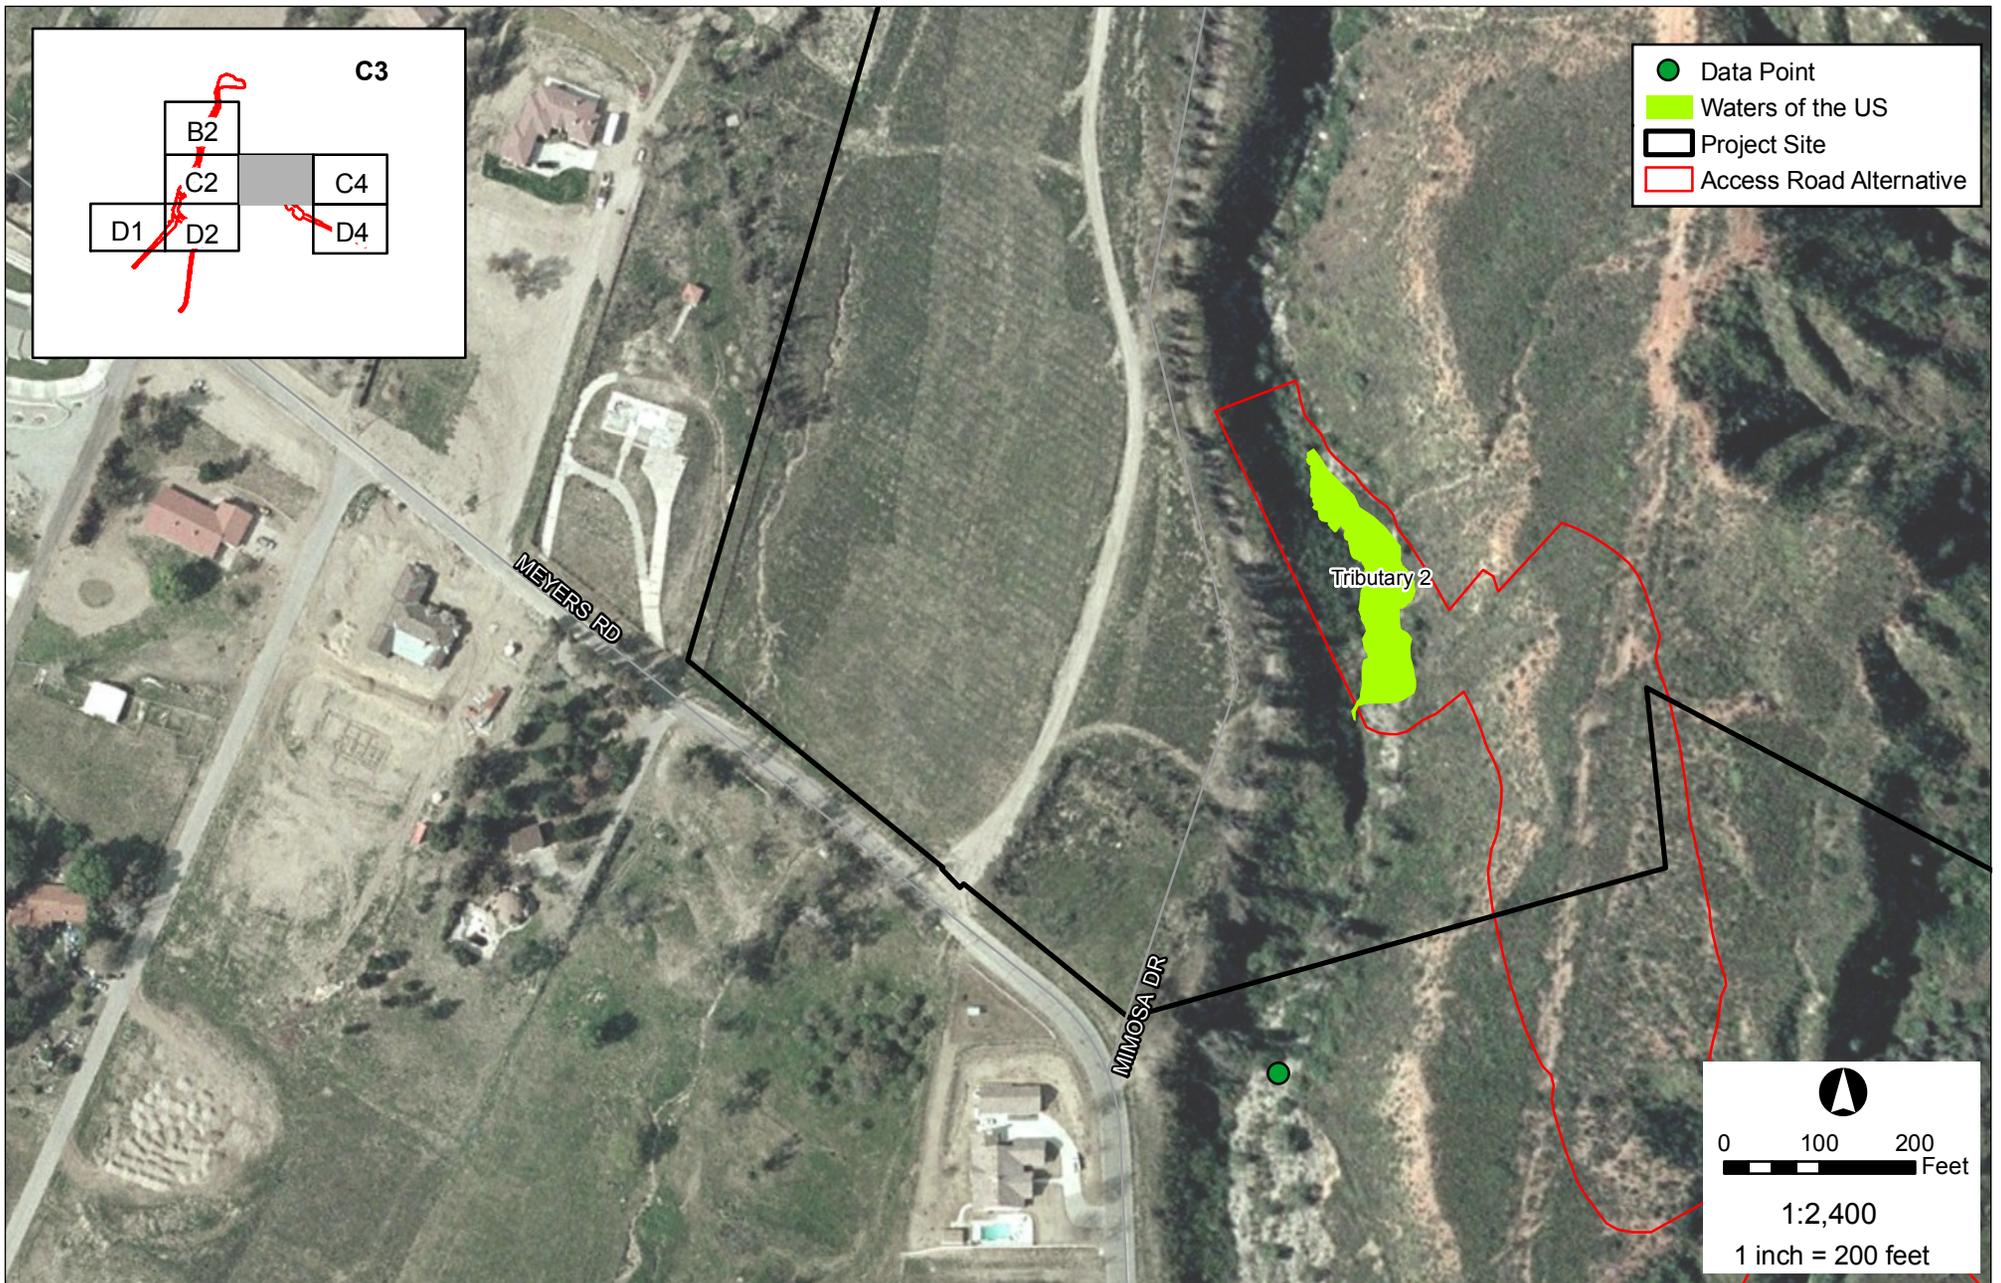
FIGURE 6c

Tributary 2 is a drainage feature that is a tributary to Cable Creek, and is located in the western portion of the primary access road alignment (Figure 5 and Figure 6c). The source of water into Tributary 2 appears to be the upstream watershed directly north of the tributary, it may receive a small amount of urban runoff. The vegetation within the active channel consists of a Sycamore alluvial woodland community. The dominant species observed include willows, western sycamore, and tree tobacco. Other species present included mulefat (*Baccharis salidifolia*) and curly dock (*Rumex crispus*) (Photos 12 through 14). Approximately 0-1 inch of surface water was present during the wetland delineation survey, in small channels within the banks of the wash area.

The OHWM for the active channel measures approximately three to four feet wide, with an average width of approximately 3.5 feet. Approximately 0.251 acre within the proposed primary access road alignment could fall under the jurisdiction of the USACE and RWQCB. The top of the banks extend an additional 2.5 feet on each side of the OHWM. Approximately 0.281 acre of this tributary could fall under CDFG jurisdiction.

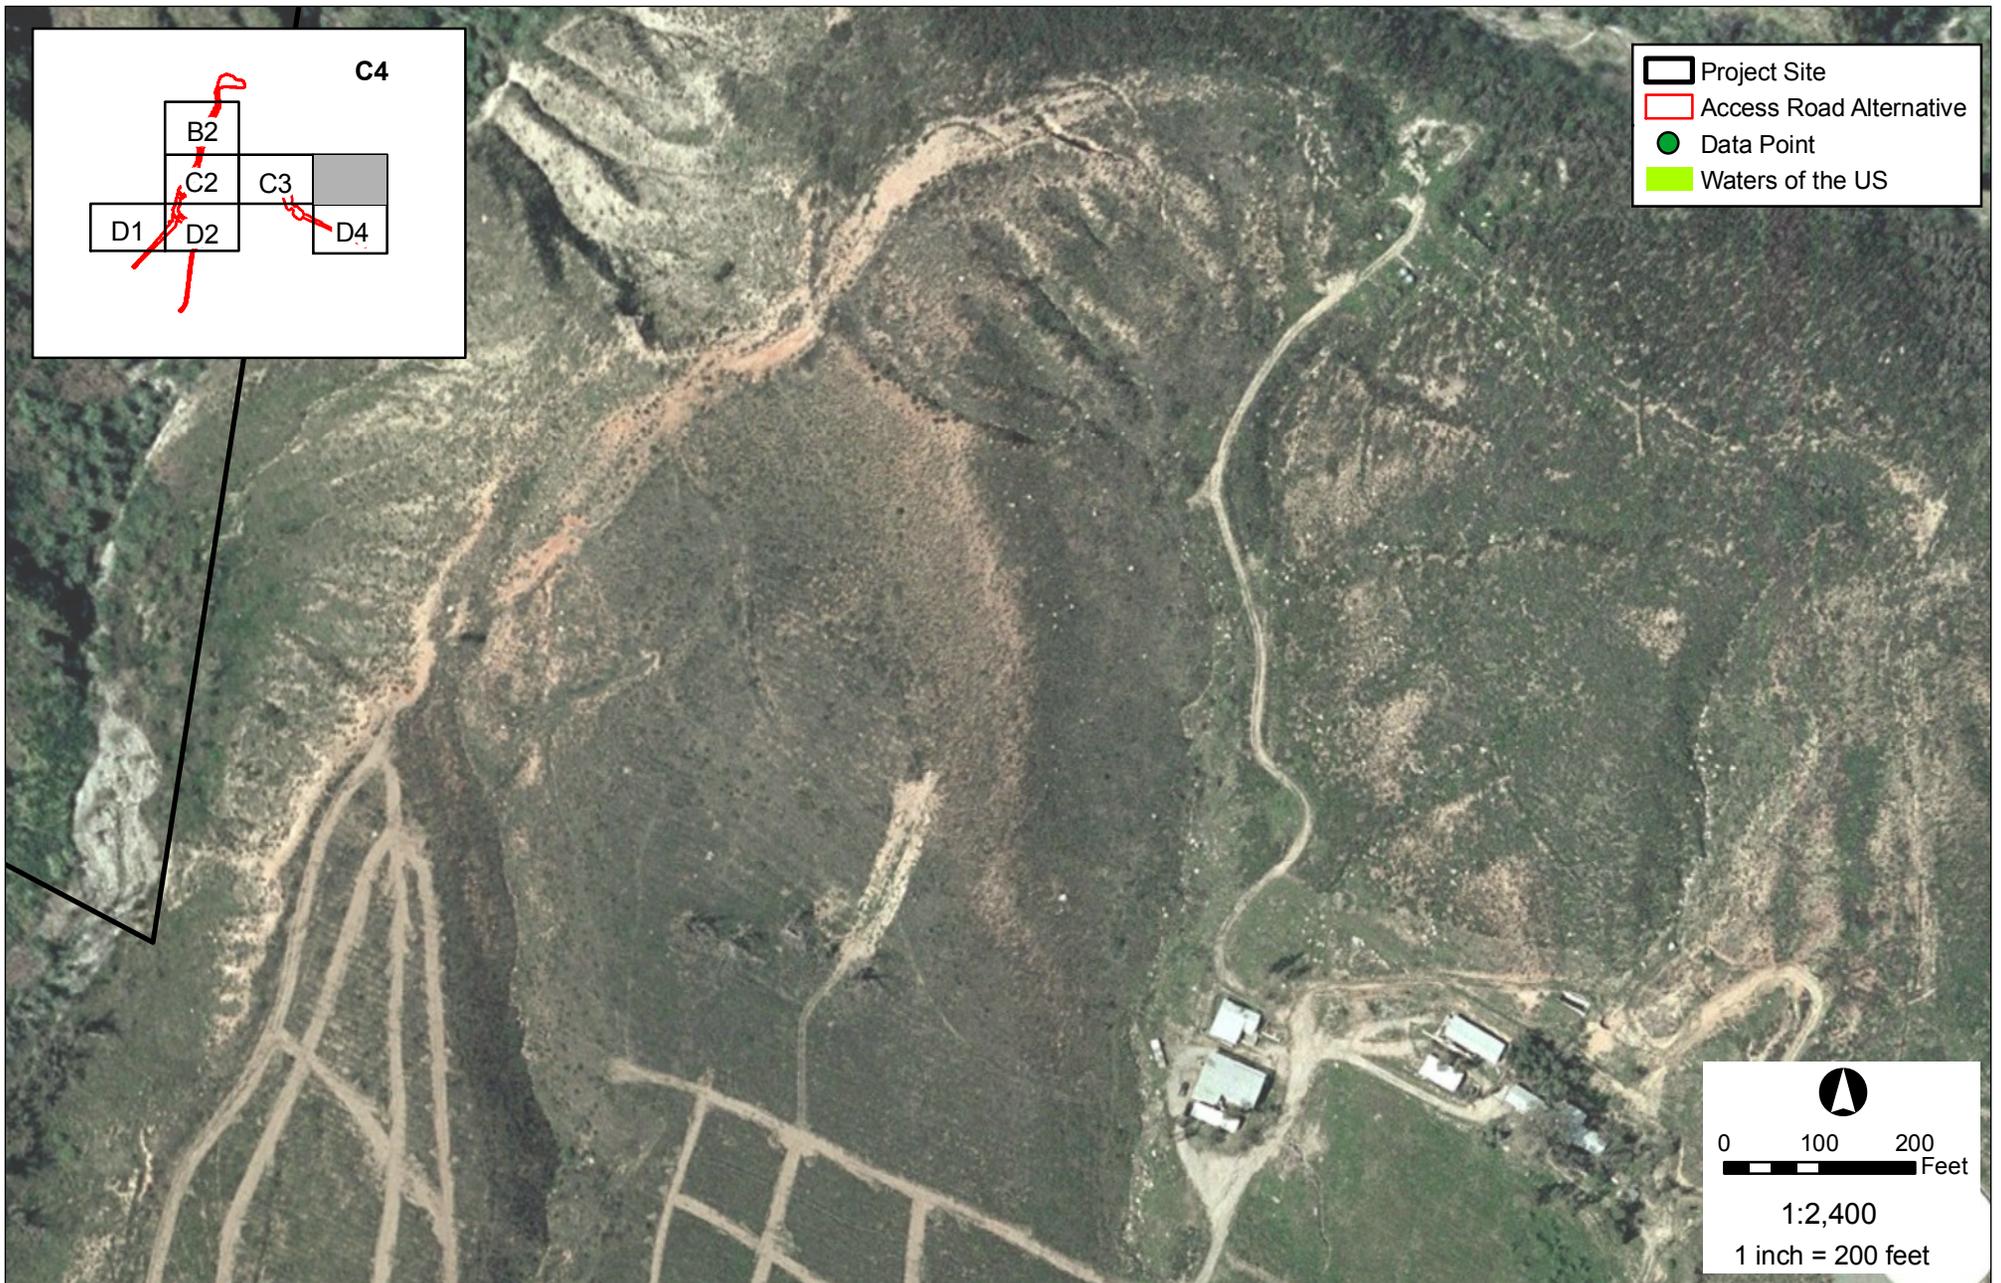
FIGURE 6d

Tributary 4 is another drainage feature that emerges from Meyers Canyon, flows southerly through the central portion of the primary access road alignment, and then drains into Cable Creek (Figures 5, 6d, and 6g). The source of water into Tributary 4 is local topography and a small amount from off-site urban runoff. The vegetation along the banks of this tributary consists of Riversidean sage scrub, the dominant species observed being black mustard, California sunflower, yellow star thistle and California sagebrush (Photos 18 and 19).

Tributary 5 is a drainage feature that flows southerly to Cable Creek, and is located in the central portion of the primary access road alignment (Figure 5 and Figure 6d). The source of water into Tributary 5 is from the up-stream watershed that is directly north of the creek channel. The vegetation within the active channel consists of a Sycamore Alluvial Woodland community. The dominant species observed include eucalyptus, western sycamore, and mulefat. Other species present included black mustard, erodium, and cheat grass (Photos 20 through 22).

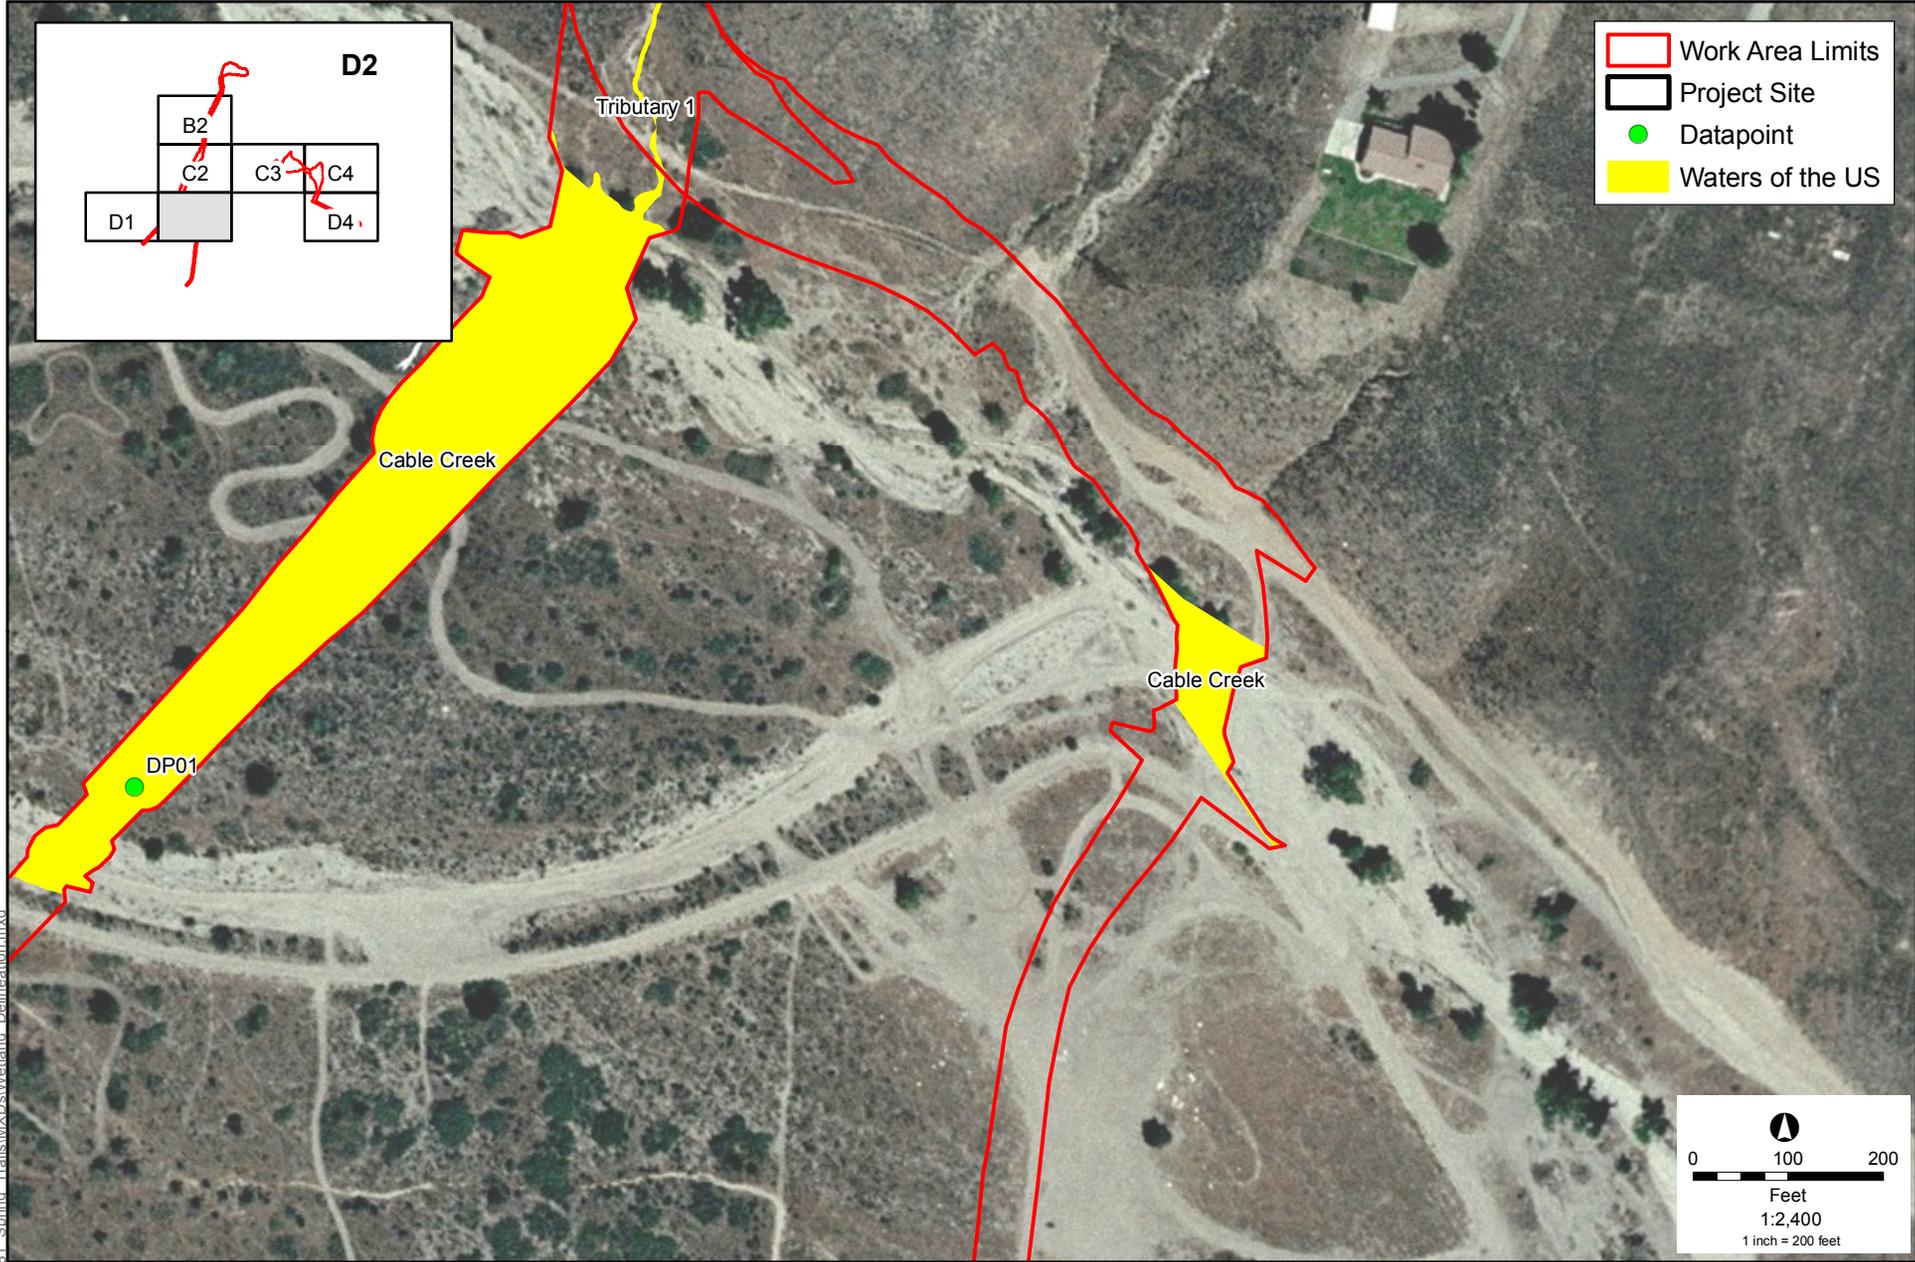
Figure 6f
Wetland Delineation

Cable Creek is an intermittent stream that flows from west to east. It is tributary to Cajon Creek, Lytle Creek, and the Santa Ana River, a perennial Relatively Permanent Water (RPW) that flows to the Pacific Ocean, a traditional navigable water (TNW). The majority of surface flows originate from the San Bernardino Mountains, outside the Bunker Hill and Lytle Creek basins. Both Alternatives 1 and 2 of the secondary access road alignments cross Cable Creek. Also, Alternative I, of the secondary access road, receives storm water runoff directly from Highway 215 via a concrete culvert (see Figure 6f and Photo 1).

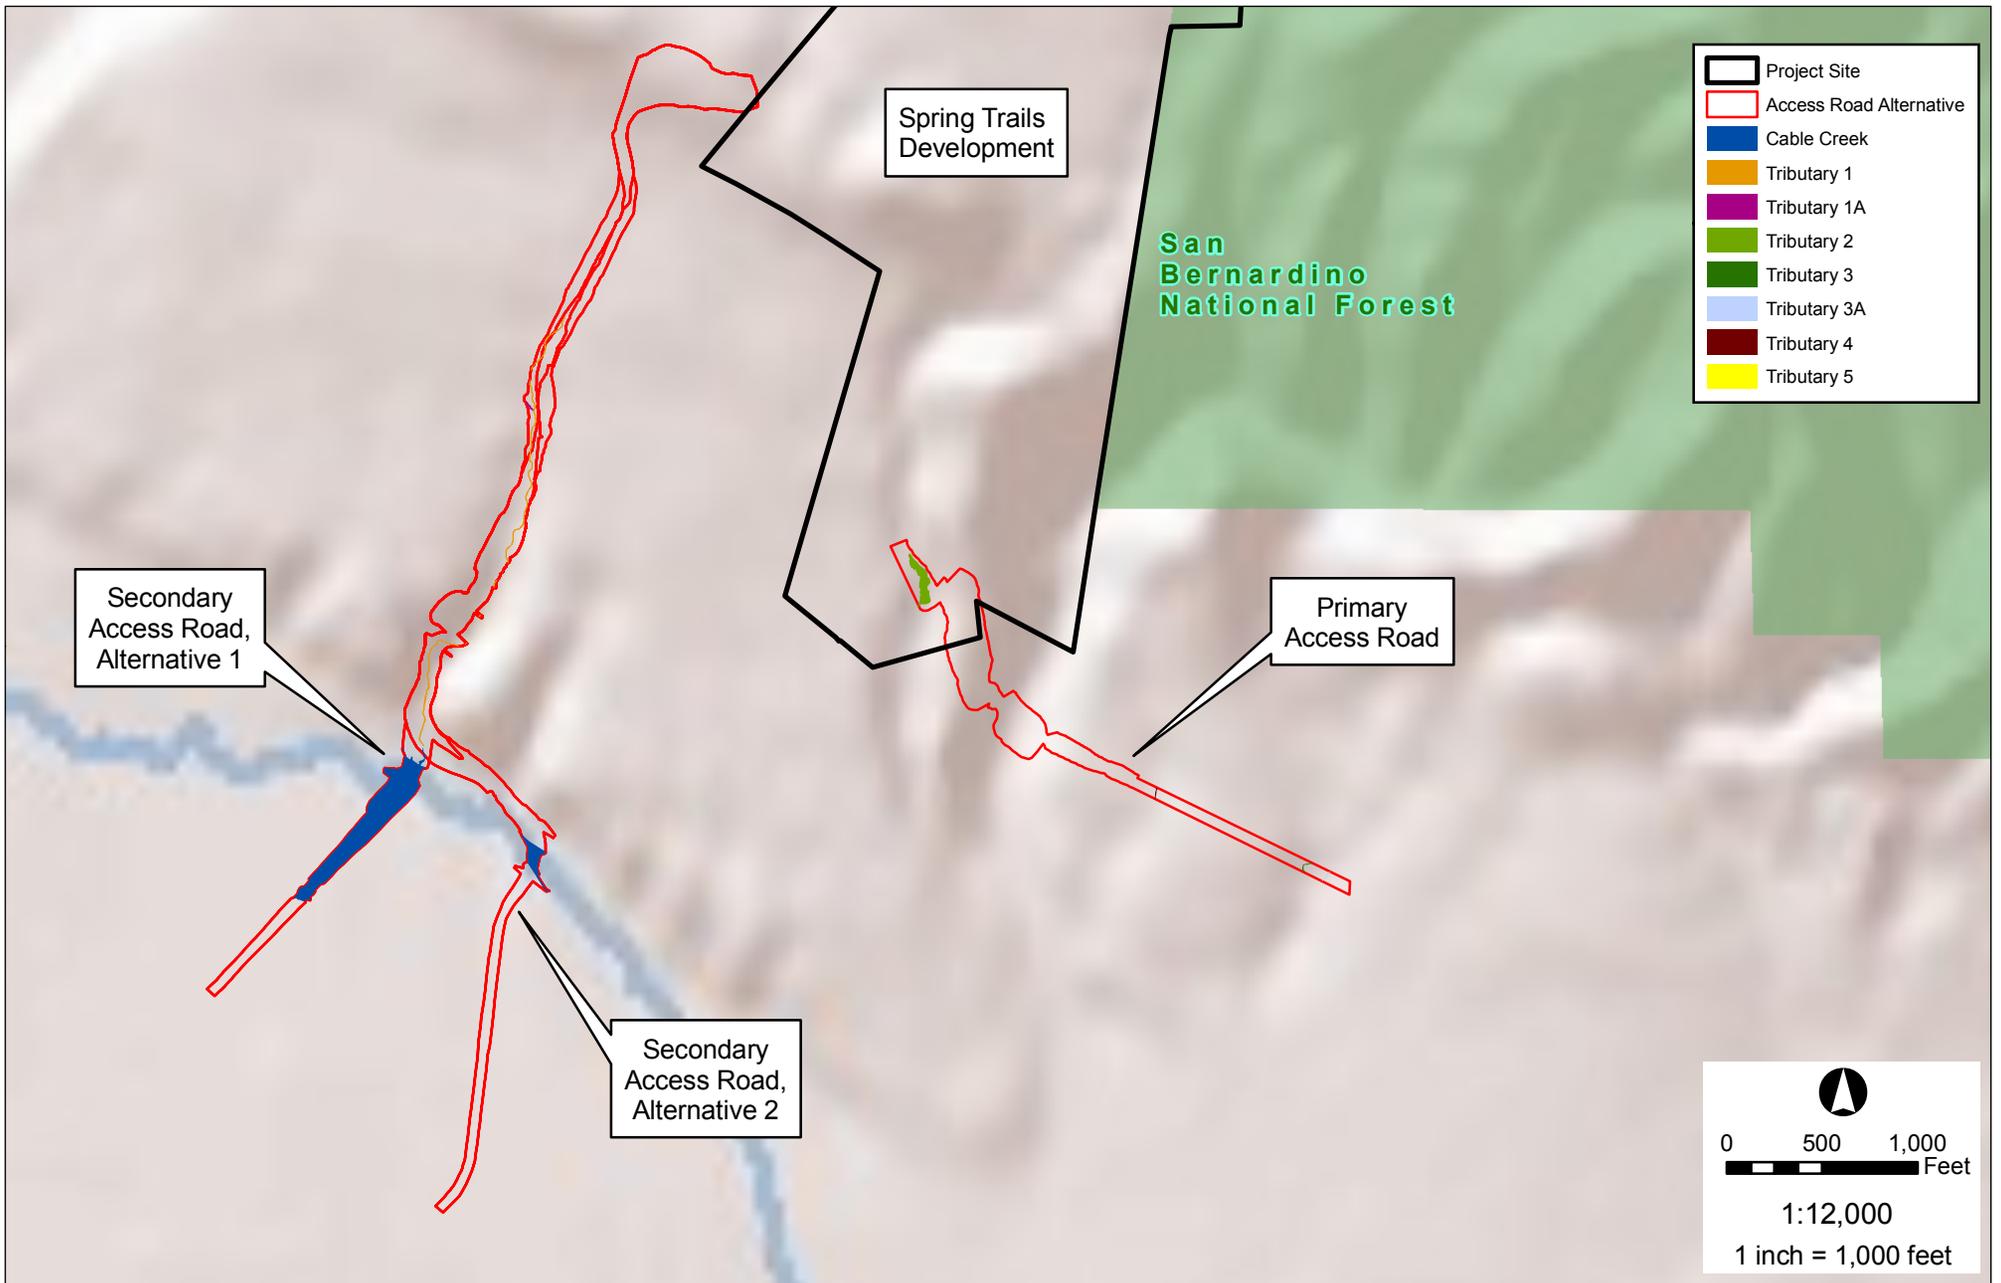
FIGURE 7

Potential CDFG Jurisdictional Areas within the Project Site

The project site could support approximately 3.89 acres of streambed and bank that could fall under the regulatory authority of CDFG (Table 2). In addition, CDFG could assert jurisdiction over approximately 11.85 acres of Riversidean sage scrub and 3.18 acres of RAFSS communities that are considered sensitive by CDFG; however, these vegetation communities are upland from the streambeds and banks and thus will not be subject to Section 1602 of the California Fish and Game Code, but would be considered under the California Environmental Quality Act (CEQA). As such, for regulatory permitting purposes, these acreages are not included in Table 2.

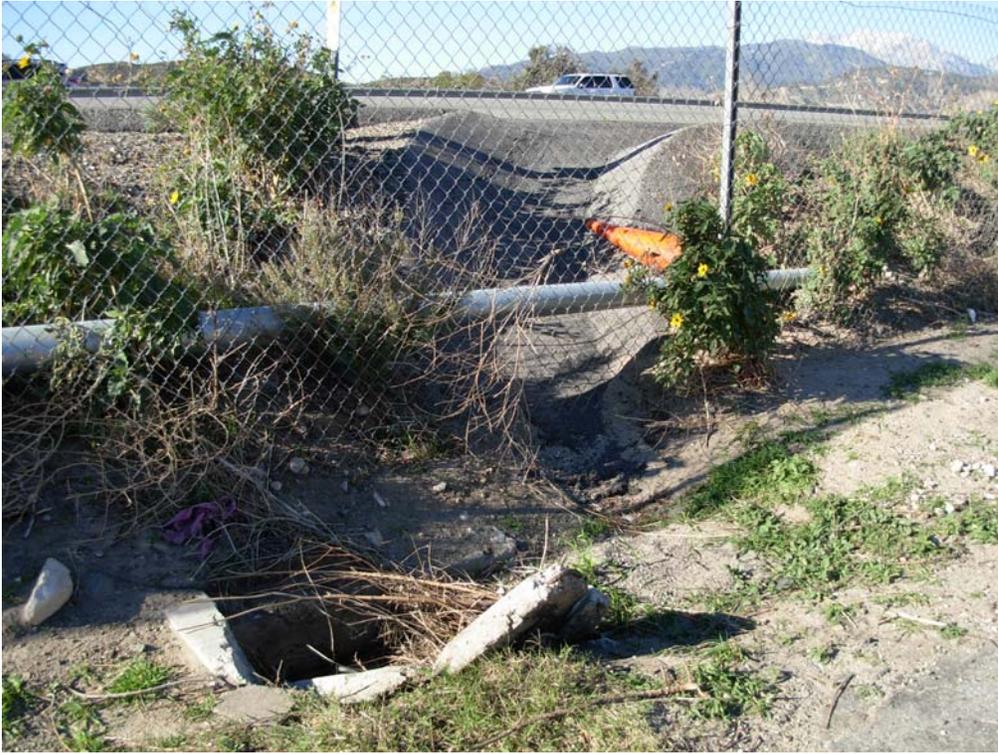
Photo 1: Urban Runoff Draining To Relevant Reach of Cable Creek
