Delineation of Jurisdictional Wetlands and Waters

Spring Trails Specific Plan (Access Roads), San Bernardino County, California

June 9, 2009

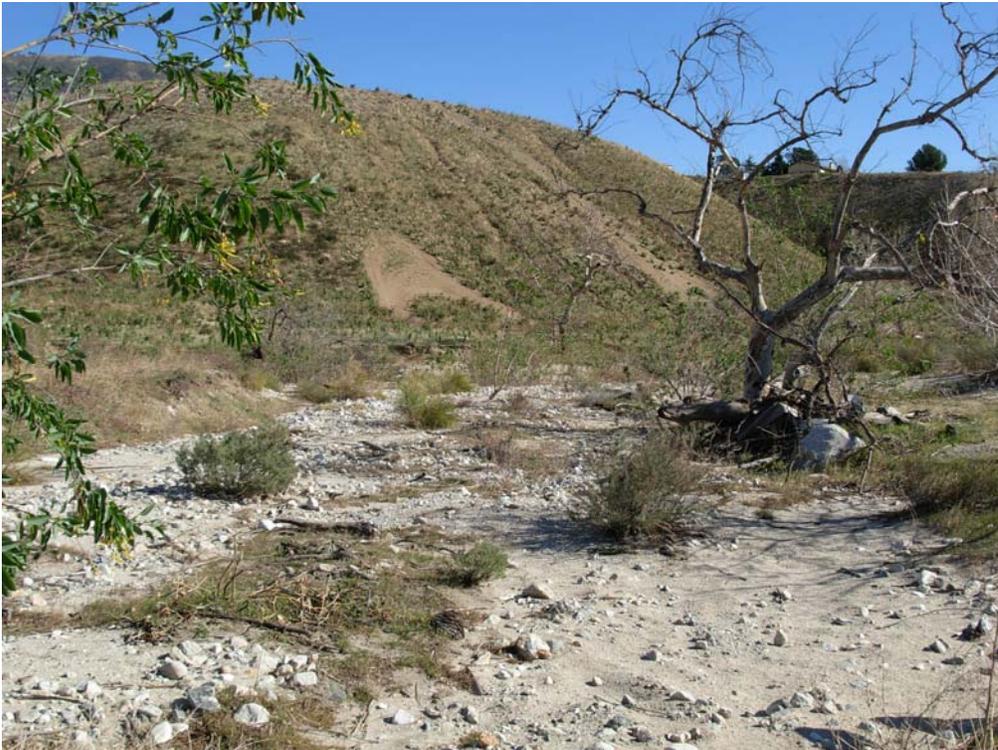
Cable Creek is an earthen-bottom feature comprised of RAFSS habitat. Dominant vegetation observed within the proposed secondary road alignments includes scalebroom (*Lepidospartum squamatum*), common ragweed (*Ambrosia artemisiifolia*), and yerba santa (*Eriodictyon glutinosum*). Other species observed included mountain mahogany (*Cercocarpus betuloides*), tree tobacco (*Nicotiana glauca*), coastal prickly pear (*Opuntia littoralis*), California sagebrush (*Artemisia californica*) and limited herbaceous vegetation, such as small forbs and grasses.

Photo 2: Looking North Across Cable Creek

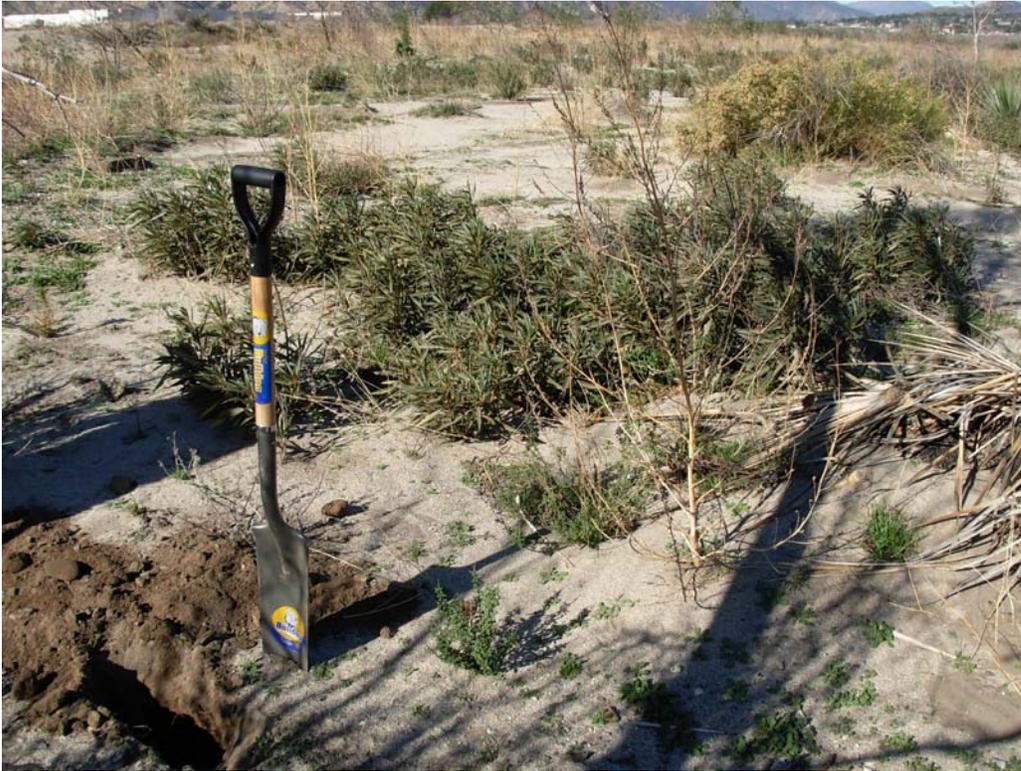
Remarks: Sampled area within the wash (Cable Creek) is a waters of the U.S. Average widths of tributaries to Cable Creek:
 Tributary 01: 3-4 feet; ~ 3.5 foot average
 Tributary 01A: 4.25 feet
 Tributary 01B: 3-4 feet; ~ 3.5 foot average

Photo 3: Datapoint 1 within Secondary Access Road Alignment, Alternative 1, Cable Creek

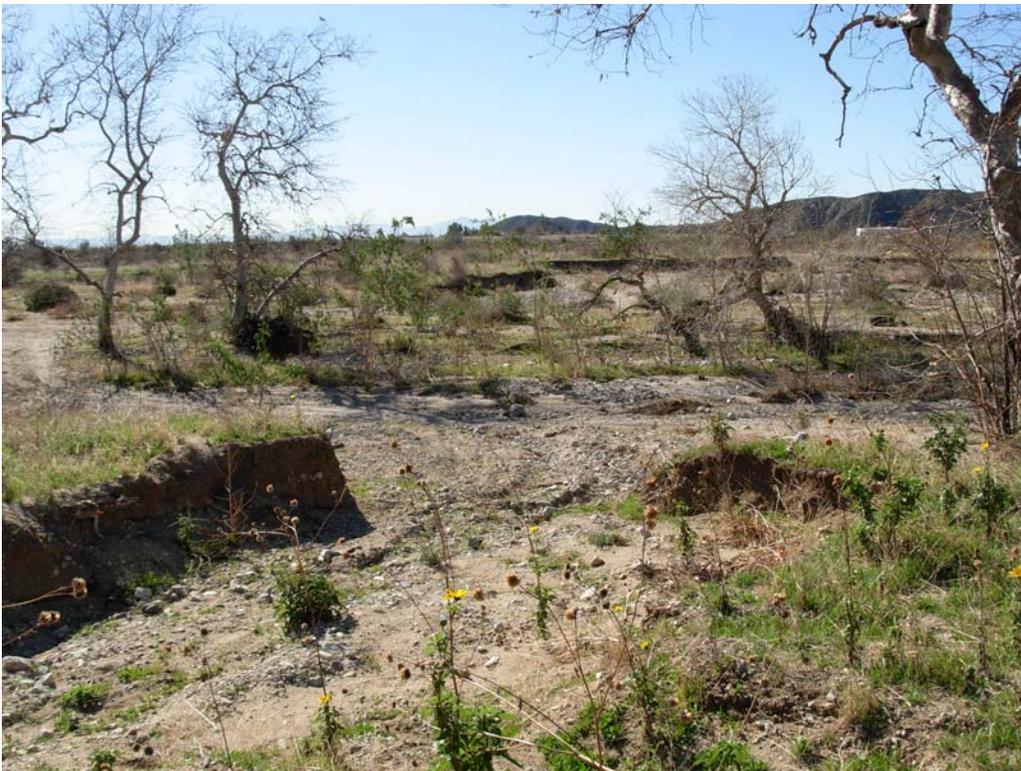
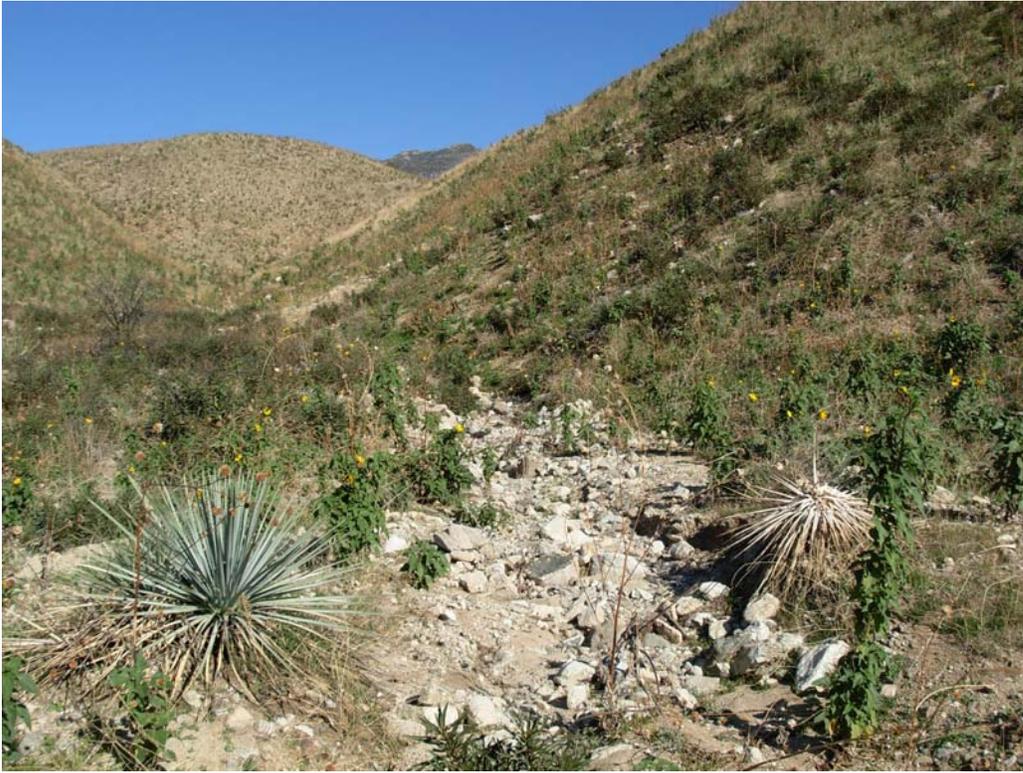
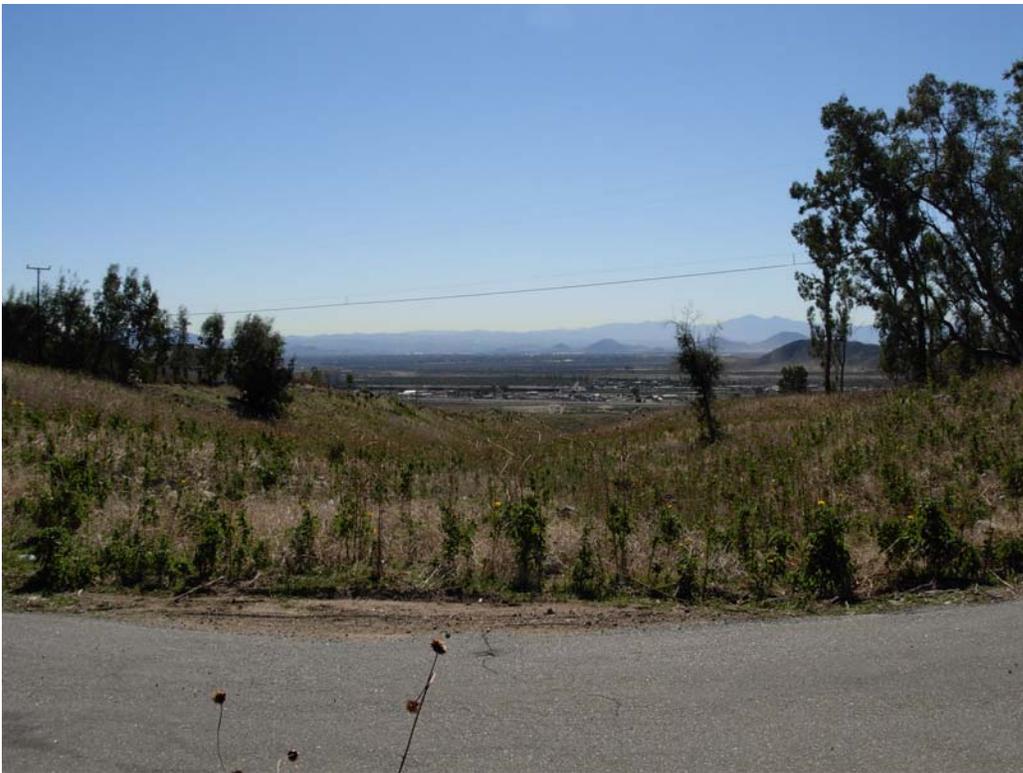
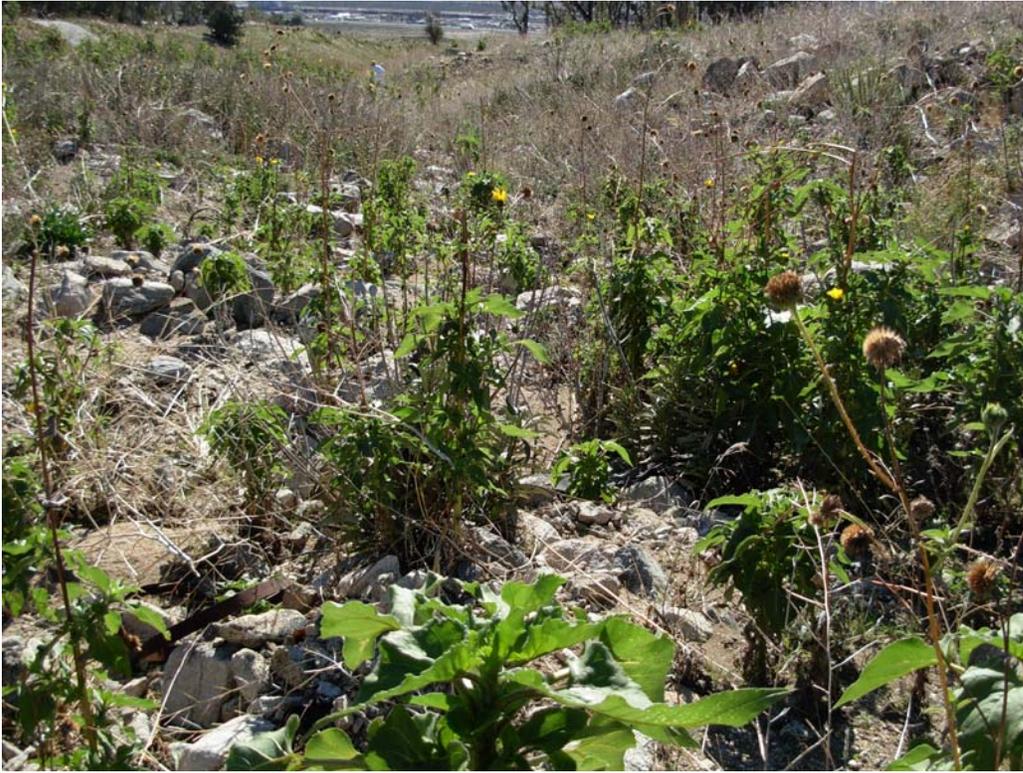
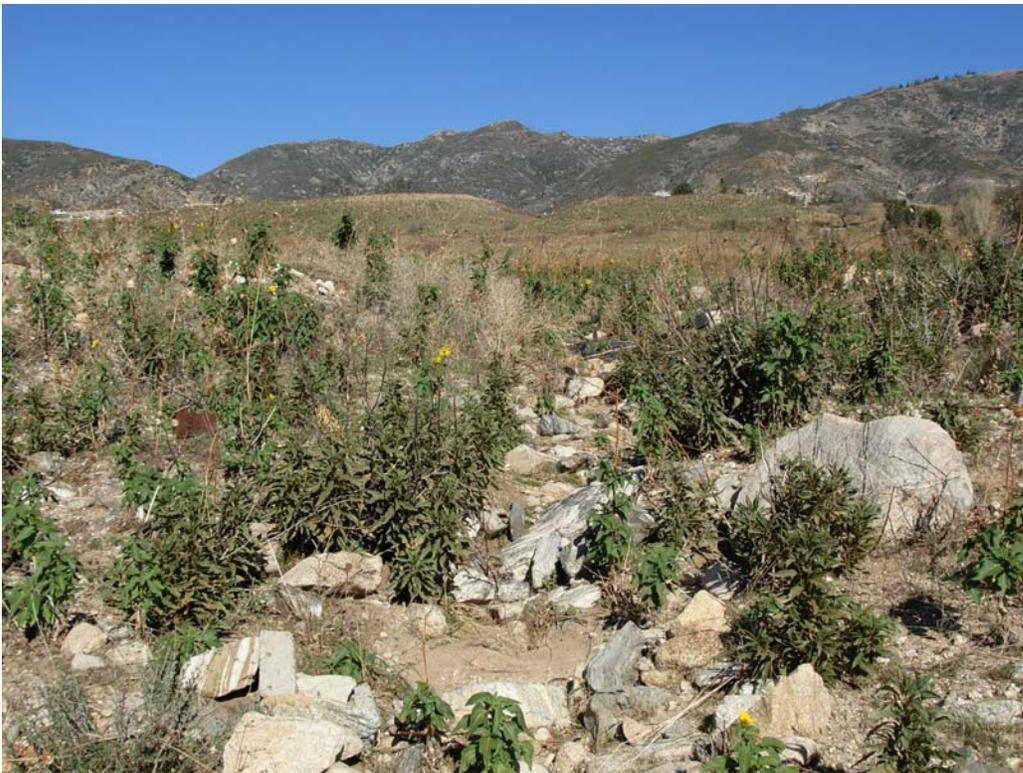
banks consists of non-native grassland, the dominant species observed being California sunflower, California sagebrush, and cheeseweed (Photos 4 through 8).

The OHWM for the active channel measures approximately three feet to 15 feet wide, with an average width of approximately five feet. Approximately 0.254 acre within the proposed secondary access road alignments could fall under the jurisdiction of the USACE and RWQCB. The top of the banks extend an additional one foot on each side of the OHWM. Approximately 0.355 acre of this tributary could fall under CDFG jurisdiction.

Photo 4: Looking Downstream Tributary 1 at Convergence with Cable Creek

Photo 5: Looking Upstream Tributary 1 at Canyon Bottom

Photo 6: Looking Downstream Tributary 1 from Meyers Road

Photo 7: Looking Downstream Tributary 1, North of Meyers Road

Photo 8: Looking Upstream Tributary 1, North of Meyers Road

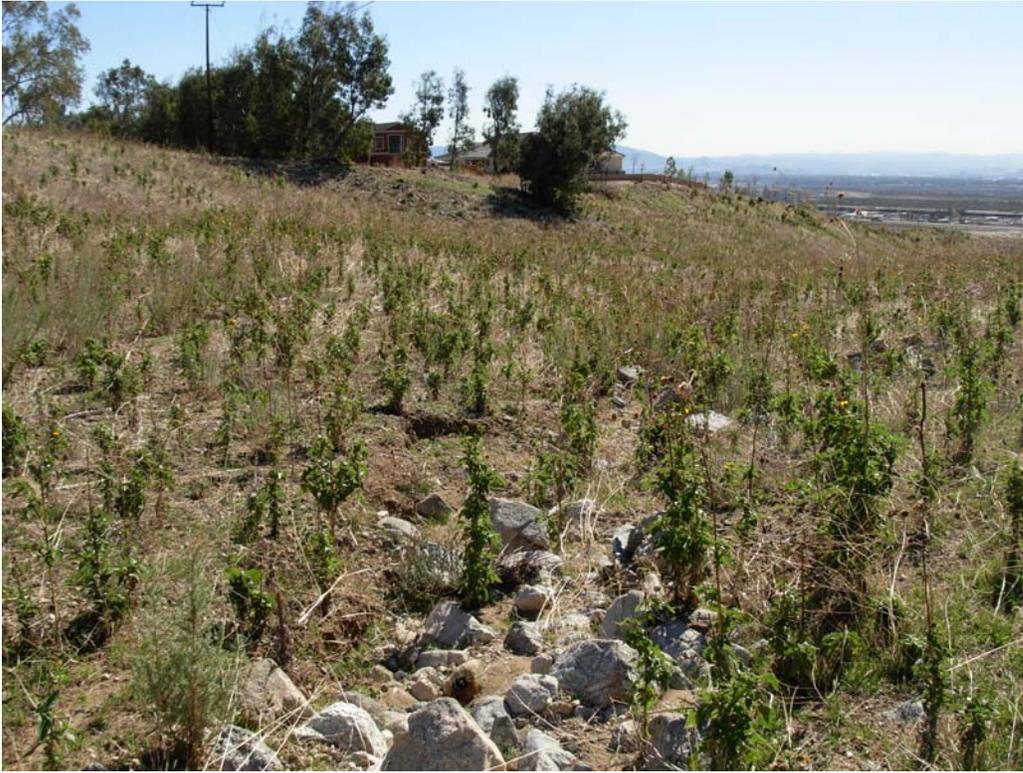
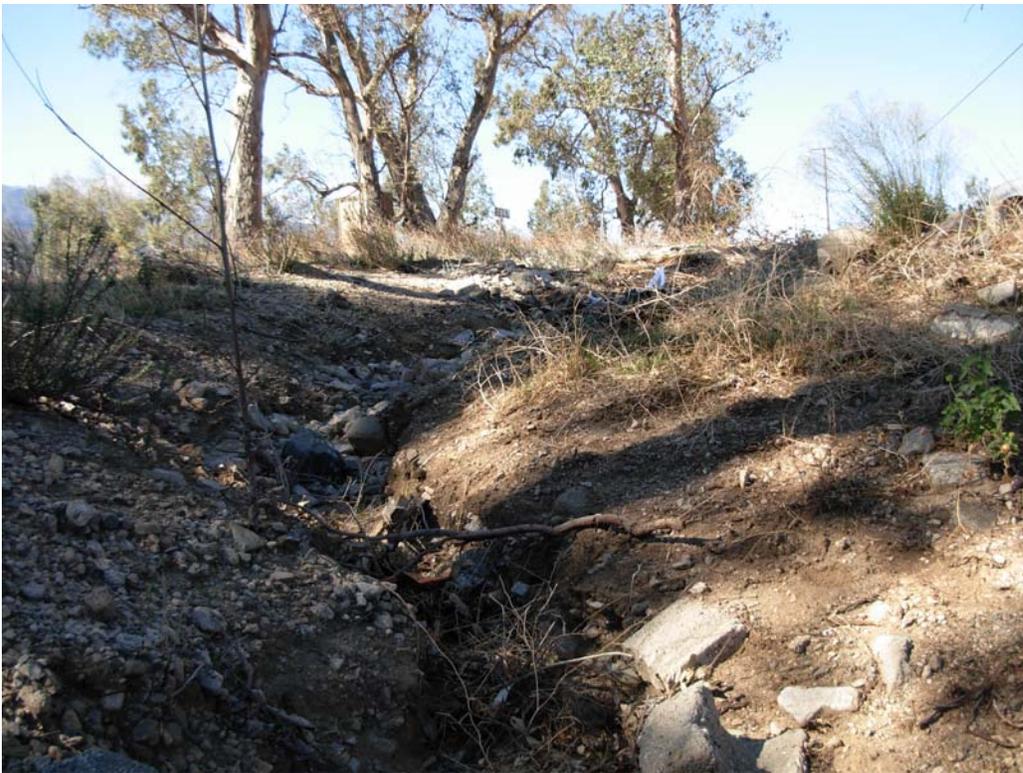
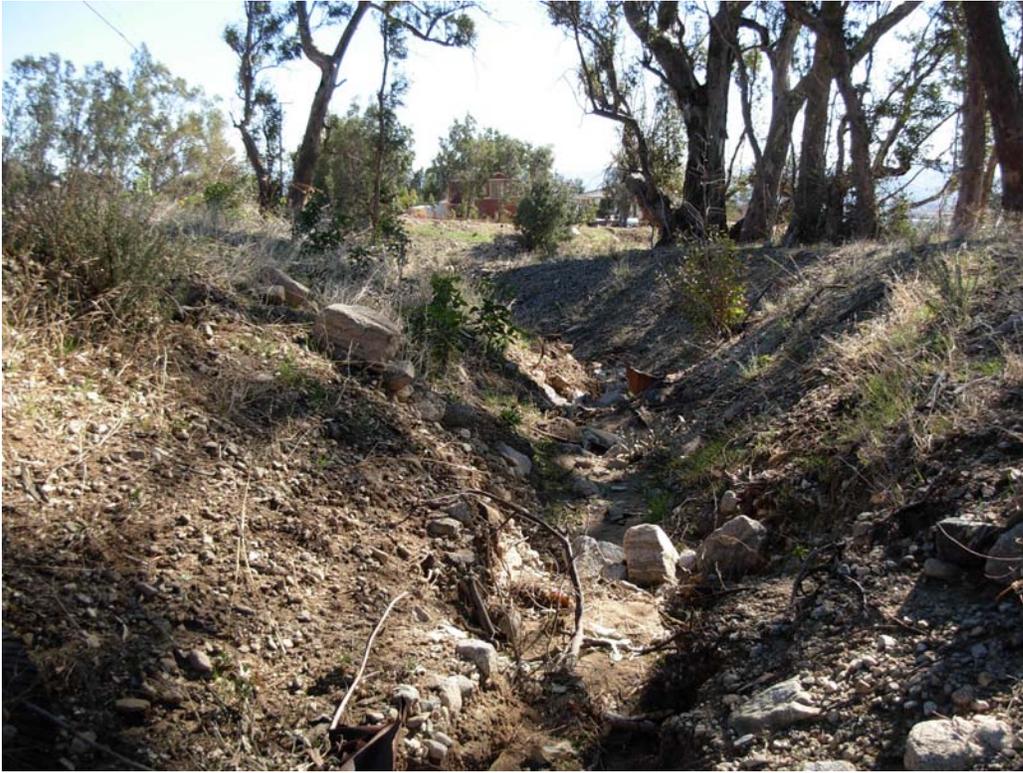
Tributary 1A is a small drainage feature that flows in a southeasterly direction into Tributary 1, and is located in the upper central portion of the secondary access road alignment, just south of Meyers Road (Figure 5 and Figure 6b). Similar to Tributary 1, the source of water into Tributary 1A is anticipated to be from off-site urban runoff and local topography. The streambed is mostly unvegetated, although there are some dispersed non-native grasses along the banks, and a small eucalyptus woodland community farther upstream that is outside of the proposed road alignment (Photos 9 through 11).

The OHWM for the active channel measures approximately four feet wide, with an average width of approximately 4.25 feet. Approximately 0.006 acre within the proposed secondary access road alignments could fall under the jurisdiction of the USACE and RWQCB. The top of the banks extend an additional 2.5 feet on each side of the OHWM. Approximately 0.013 acre of this tributary could fall under CDFG jurisdiction.

Photo 9: Convergence of Tributary 1A and Tributary 1

Photo 10: Looking Upstream Tributary 1A

Photo 11: Looking Downstream Tributary 1A

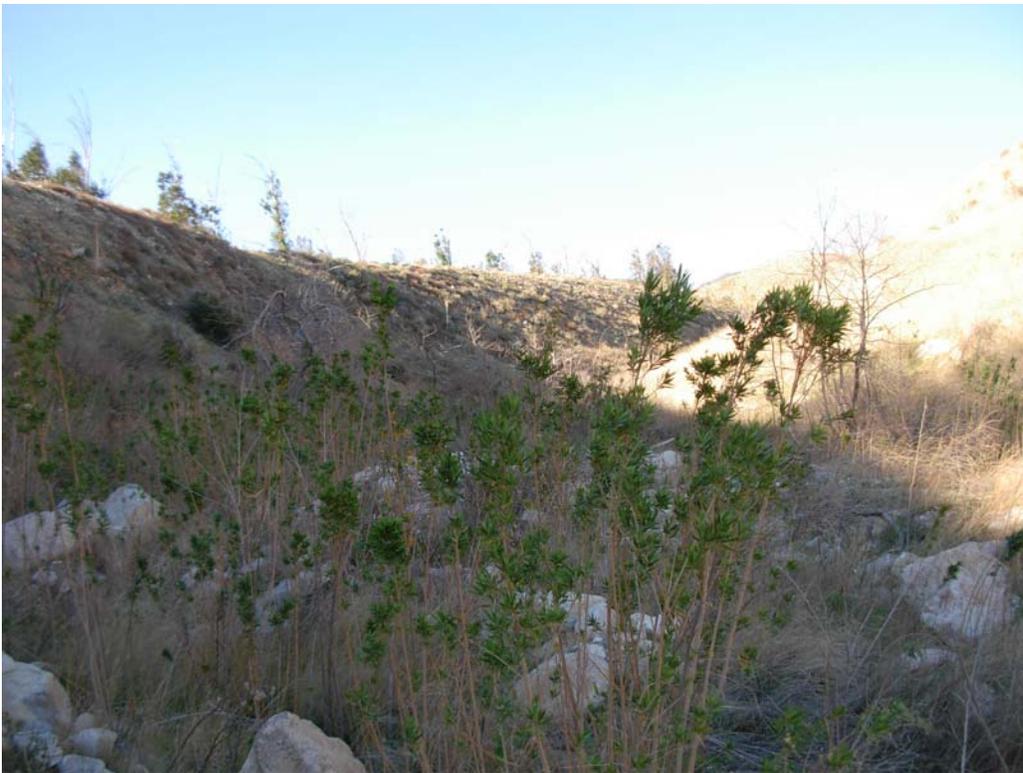
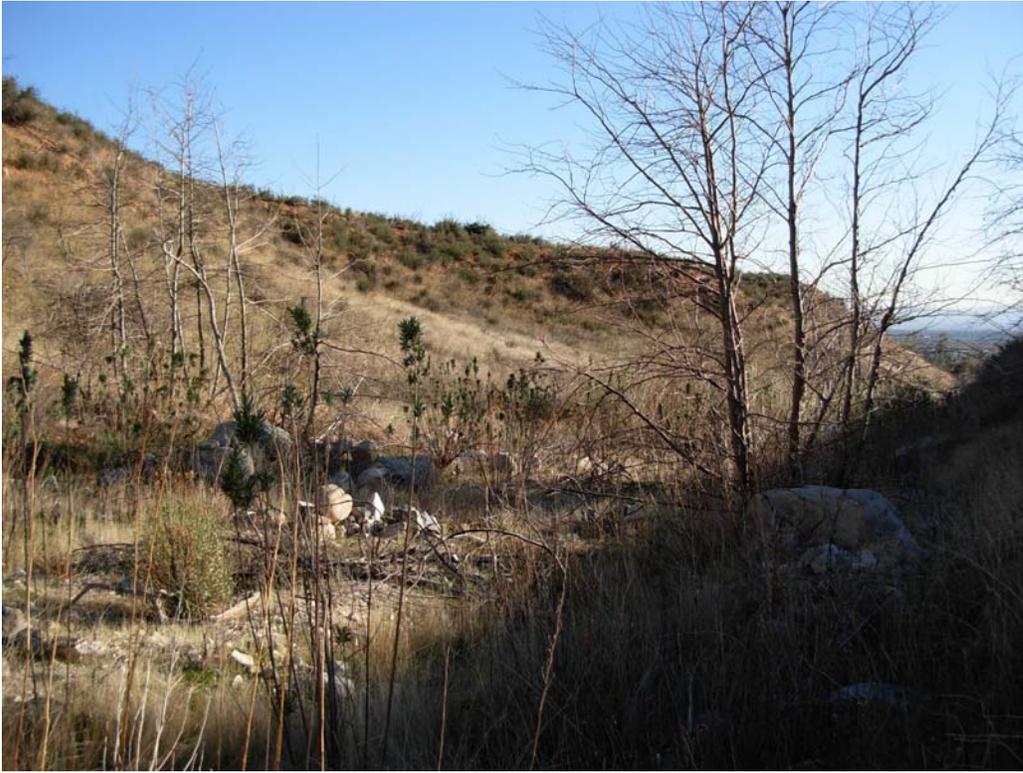
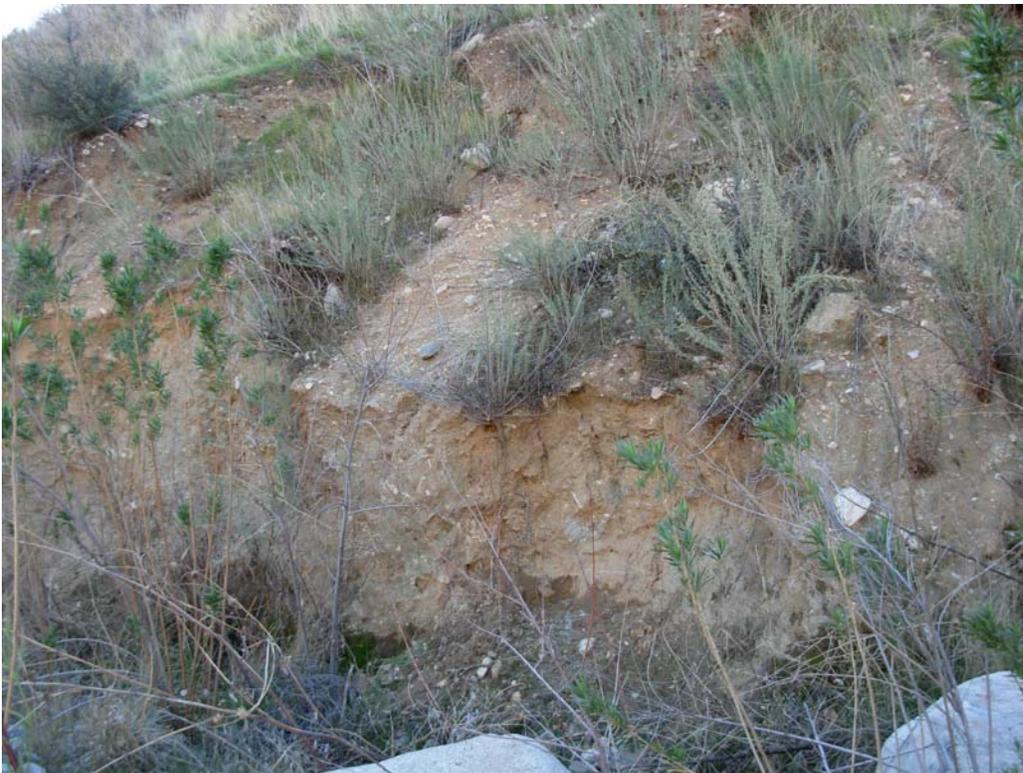
Tributary 2 is a drainage feature that is a tributary to Cable Creek, and is located in the western portion of the primary access road alignment (Figure 5 and Figure 6c). The source of water into Tributary 2 appears to be the upstream watershed directly north of the tributary, it may receive a small amount of urban runoff. The vegetation within the active channel consists of a Sycamore alluvial woodland community. The dominant species observed include willows, western sycamore, and tree tobacco. Other species present included mulefat (*Baccharis salidifolia*) and curly dock (*Rumex crispus*) (Photos 12 through 14). Approximately 0-1 inch of surface water was present during the wetland delineation survey, in small channels within the banks of the wash area.

The OHWM for the active channel measures approximately three to four feet wide, with an average width of approximately 3.5 feet. Approximately 0.251 acre within the proposed primary access road alignment could fall under the jurisdiction of the USACE and RWQCB. The top of the banks extend an additional 2.5 feet on each side of the OHWM. Approximately 0.281 acre of this tributary could fall under CDFG jurisdiction.

Photo 12: Looking Upstream Tributary 2

Photo 13: Looking Downstream Tributary 2

Photo 14: Eastern Bank of Tributary 2

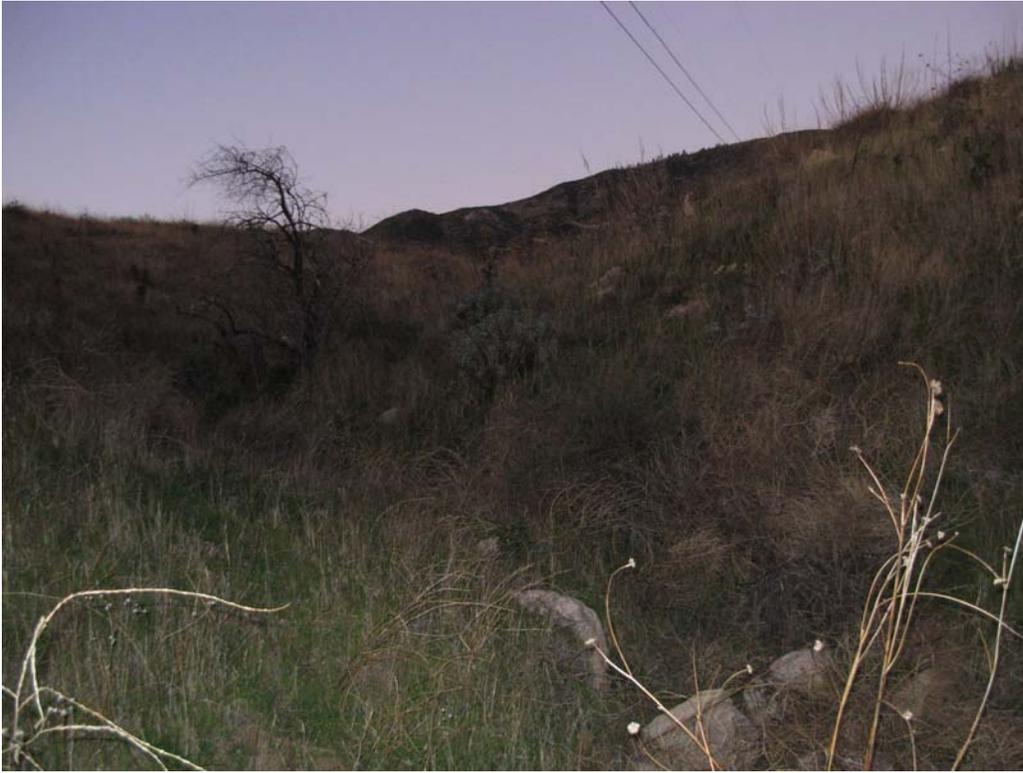
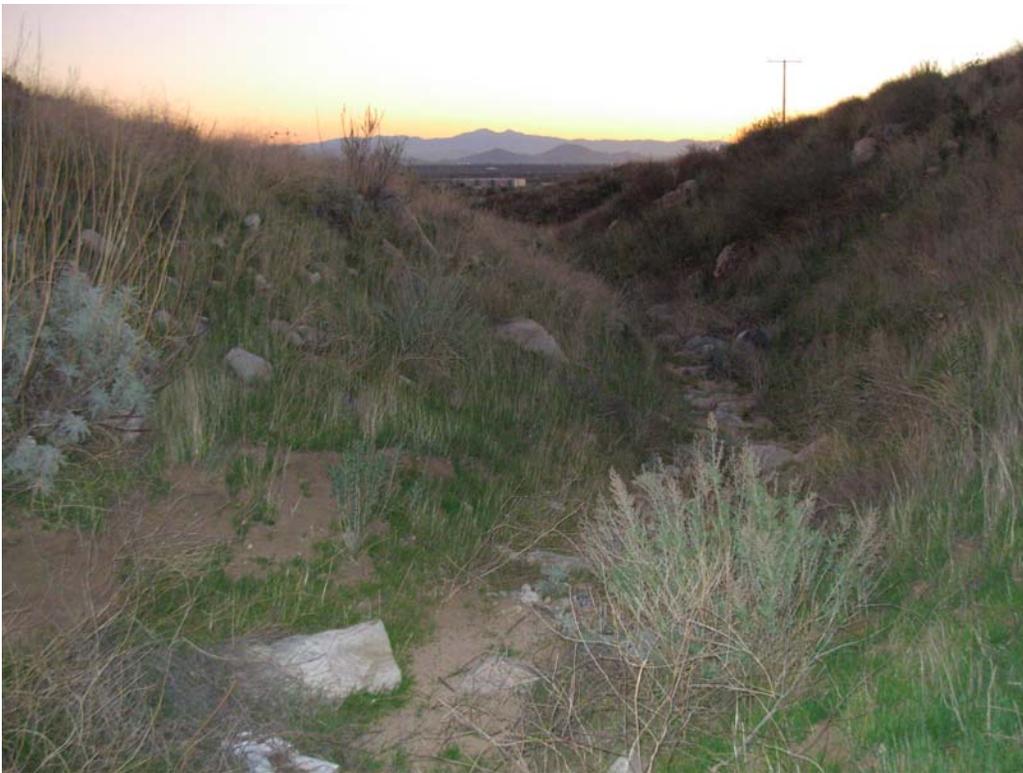
species observed being black mustard, yellow starthistle (*Centaurea solstitialis*), and California sagebrush (Photos 14 and 15).

The OHWM for the active channel measures approximately three feet wide, and approximately 0.006 acre within the proposed primary access road alignment could fall under the jurisdiction of the USACE and RWQCB. The top of the banks extend an additional one foot on each side of the OHWM. Approximately 0.010 acre of this tributary could fall under CDFG jurisdiction.

Photo 14: Looking Upstream Tributary 3

Photo 15: Looking Downstream Tributary 3

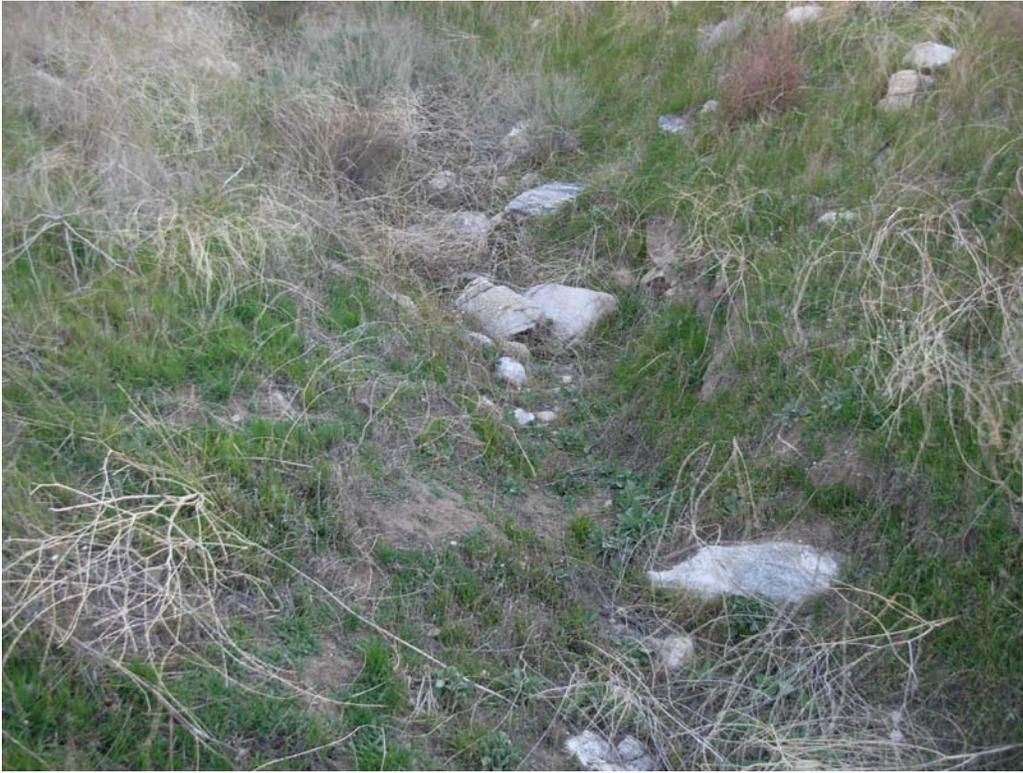
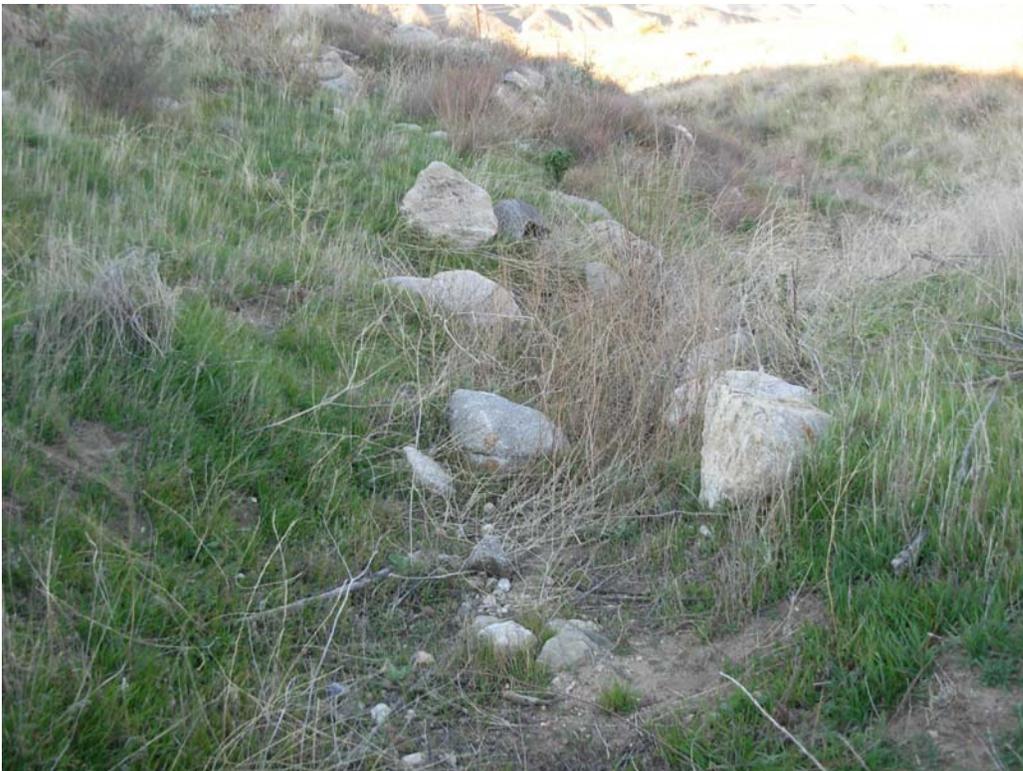
Tributary 3A is a small drainage feature that flows in a southerly direction into Tributary 3, and is located in the eastern portion of the primary access road alignment (Figure 5 and Figure 6g). Similar to Tributary 3, the source of water into Tributary 3A is anticipated to be from local topography and off-site urban runoff. The vegetation along the banks of this tributary consists of similar Riversidean sage scrub species as Tributary 3 (Photos 16 and 17).

The OHWM for the active channel measures approximately three feet wide, and approximately 0.005 acre within the proposed primary access road alignment could fall under the jurisdiction of the USACE and RWQCB. The top of the banks extend an additional one foot on each side of the OHWM. Approximately 0.008 acre of this tributary could fall under CDFG jurisdiction.

Photo 16: Looking Upstream Tributary 3A

Photo 17: Looking Downstream Tributary 3A

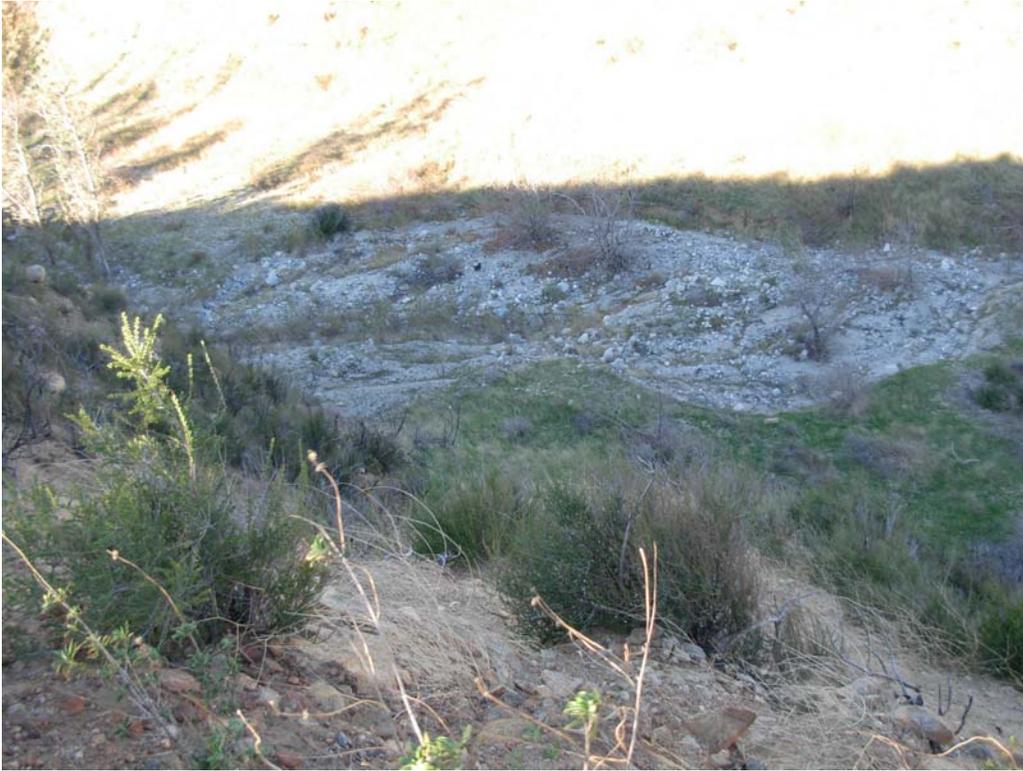
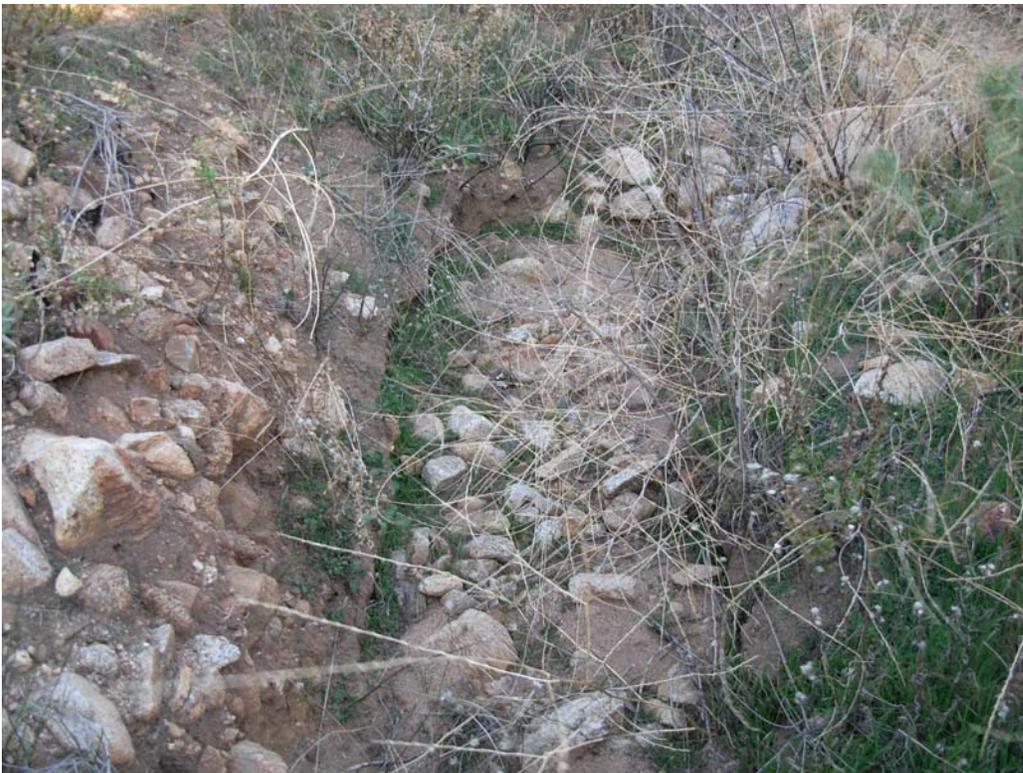
Tributary 4 is another drainage feature that emerges from Meyers Canyon, flows southerly through the central portion of the primary access road alignment, and then drains into Cable Creek (Figures 5, 6d, and 6g). The source of water into Tributary 4 is local topography and a small amount from off-site urban runoff. The vegetation along the banks of this tributary consists of Riversidean sage scrub, the dominant species observed being black mustard, California sunflower, yellow star thistle and California sagebrush (Photos 18 and 19).

The OHWM for the active channel measures approximately 2.5 feet wide, and approximately 0.028 acre within the proposed primary access road alignment could fall under the jurisdiction of the USACE and RWQCB. The top of the banks extend an additional one foot on each side of the OHWM. Approximately 0.050 acre of this tributary could fall under CDFG jurisdiction.

Photo 18: Looking Upstream Tributary 4 from West Slope

Photo 19: Bed and Bank features of Upper Segment of Tributary 4

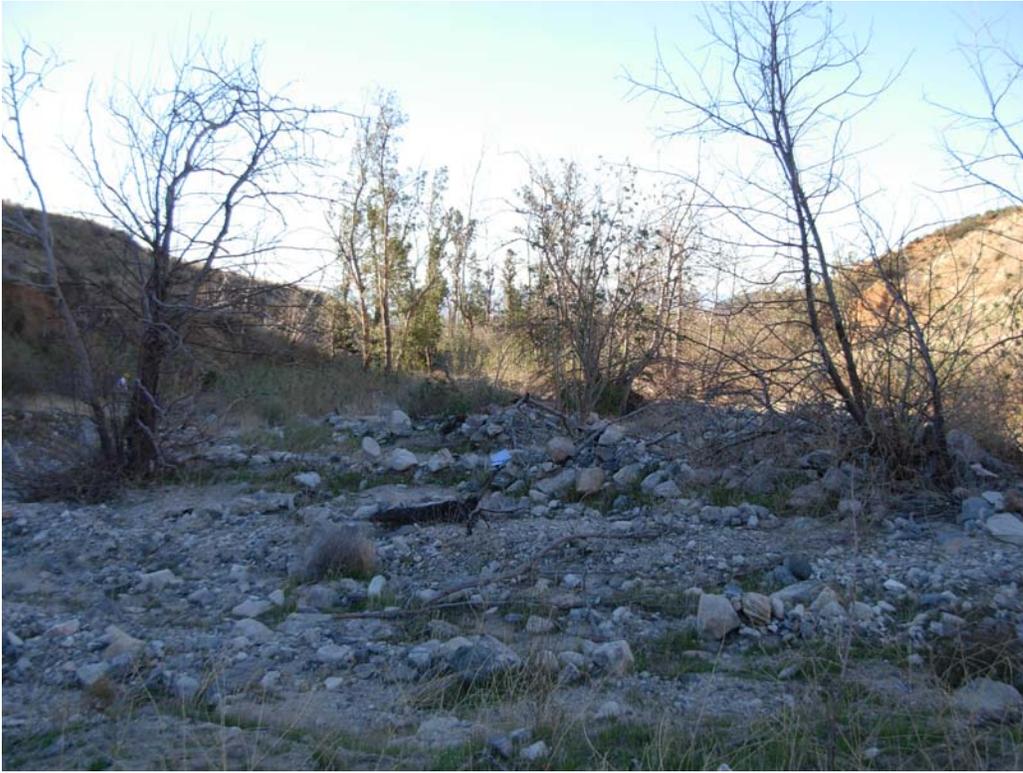
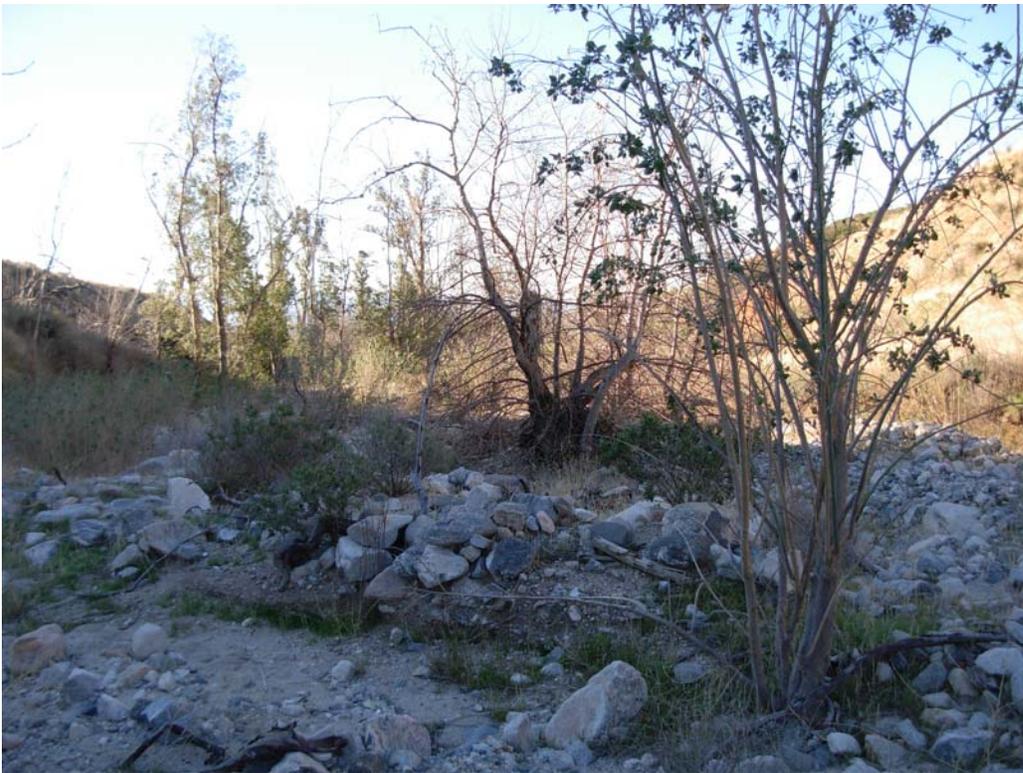
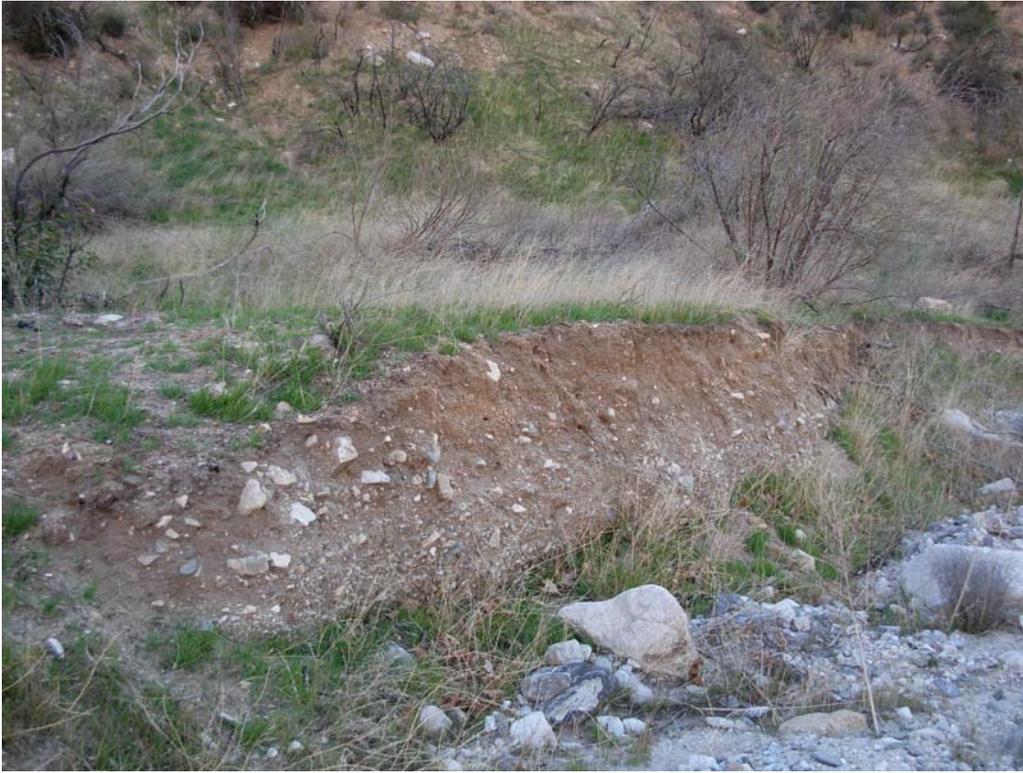
Tributary 5 is a drainage feature that flows southerly to Cable Creek, and is located in the central portion of the primary access road alignment (Figure 5 and Figure 6d). The source of water into Tributary 5 is from the up-stream watershed that is directly north of the creek channel. The vegetation within the active channel consists of a Sycamore Alluvial Woodland community. The dominant species observed include eucalyptus, western sycamore, and mulefat. Other species present included black mustard, erodium, and cheat grass (Photos 20 through 22).

The OHWM for the active channel measures approximately 16 to 62 feet wide, with an average width of approximately 39 feet. Approximately 0.108 acre within the proposed primary access road alignment could fall under the jurisdiction of the USACE and RWQCB. The top of the banks extend an additional two feet on each side of the OHWM. Approximately 0.121 acre of this tributary could fall under CDFG jurisdiction.

Photo 20: Looking Upstream Tributary 5

Photo 21: Looking Downstream Tributary 5

Photo 22: Scouring on East Bank of Tributary 5
