Delineation of Jurisdictional Wetlands and Waters

Spring Trails Specific Plan, San Bernardino County, California

July 28, 2009

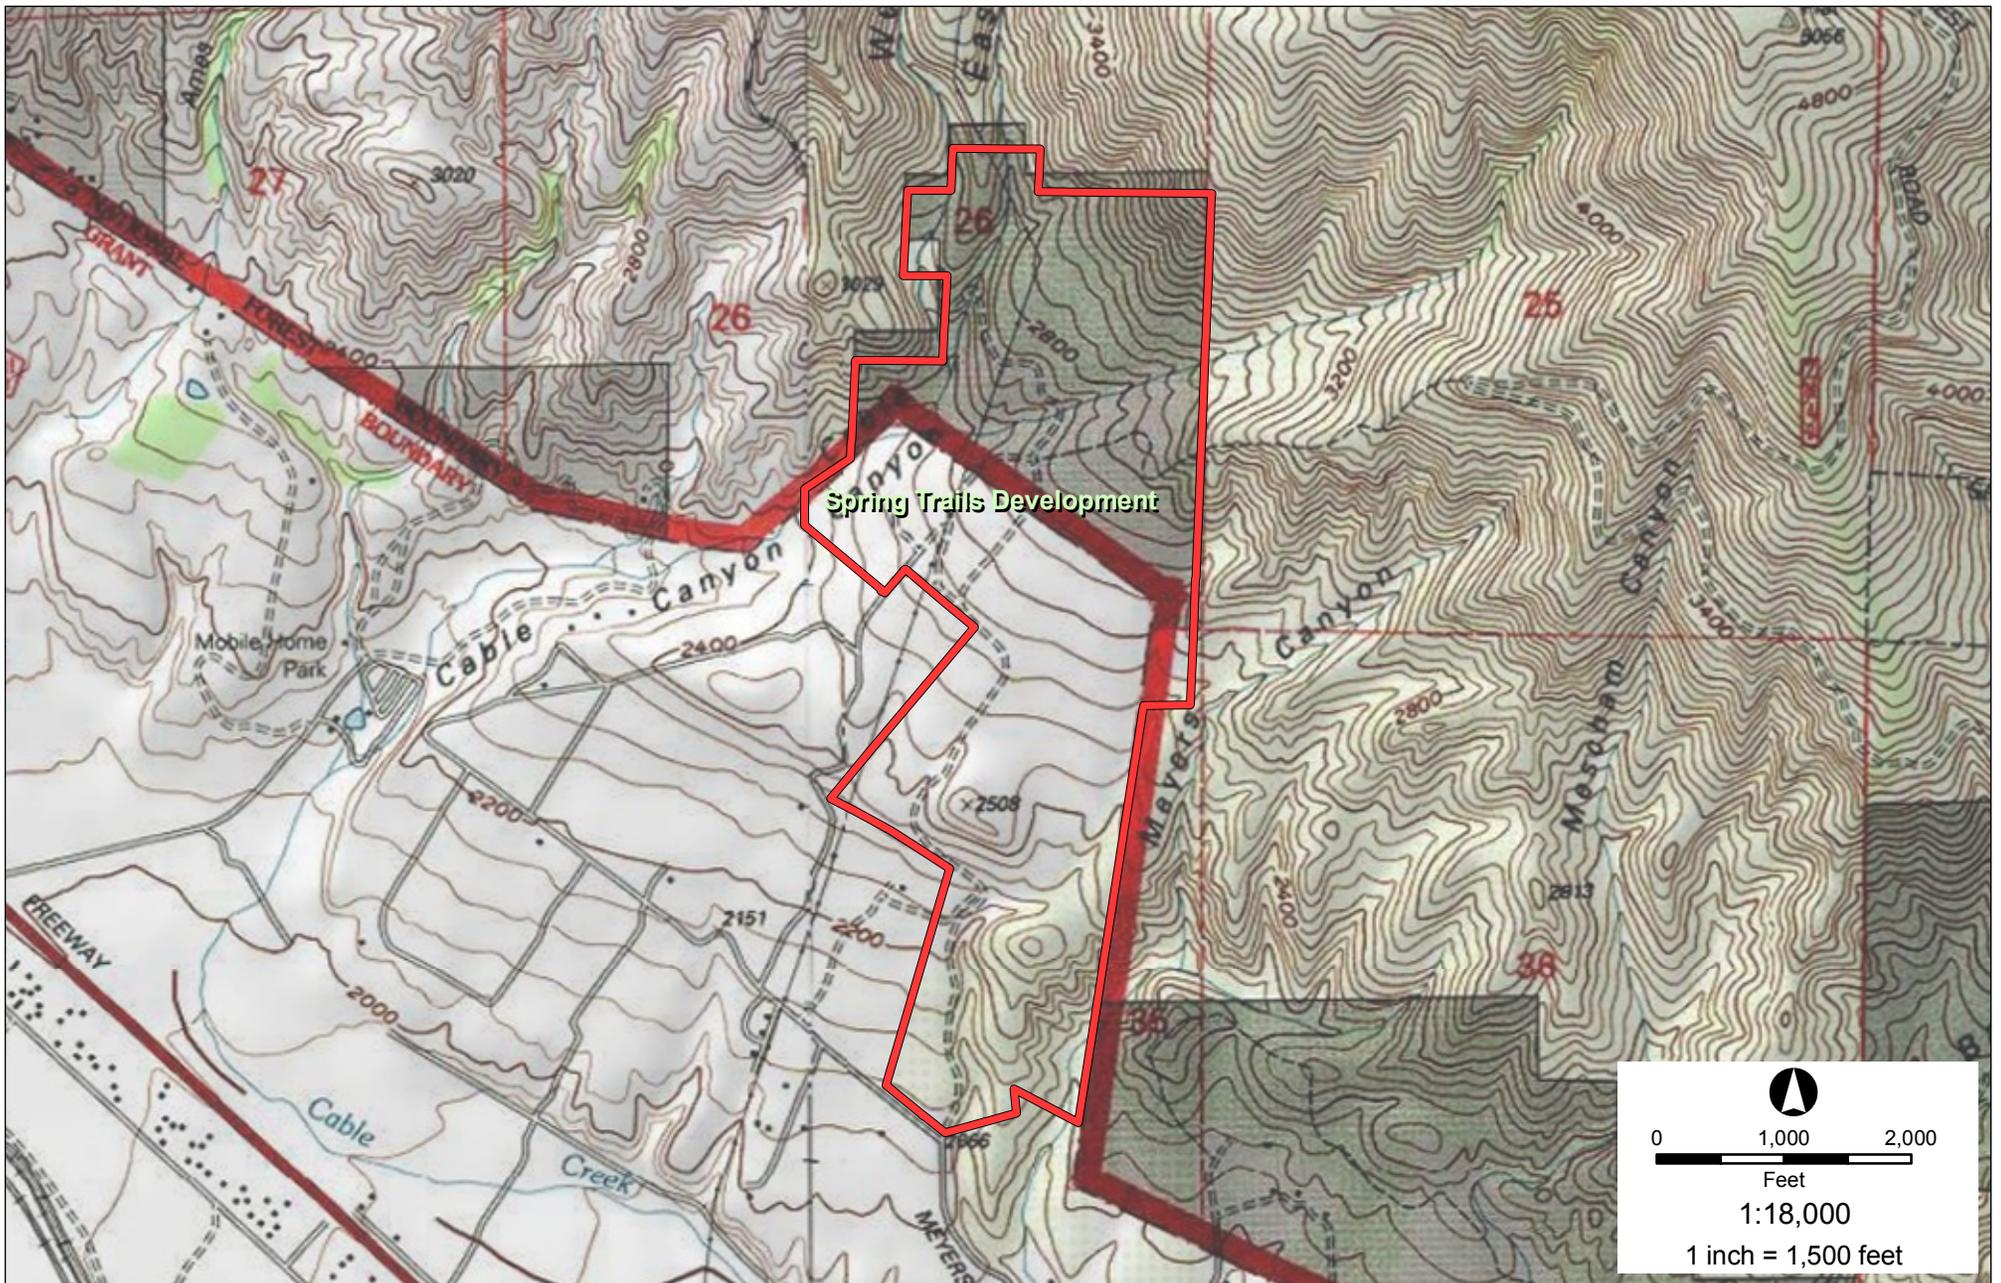
FIGURE 3
Topographic Map

The project site is located on gently sloping alluvial benches in between canyons, steep hillsides, and drainages. As shown in Figure 3, the topography of the project site varies from steep (over 30 percent slopes) in the north and southeast portions of the site to gentle (0–15 percent slopes) in the central portion of the site. The elevation of the site ranges from approximately 2,010 feet above sea level (AMSL) at its southern boundary to approximately 3,540 feet at the northern boundary, a difference of 1,530 feet. The site slopes to the southwest at approximately 10 to 15 percent.

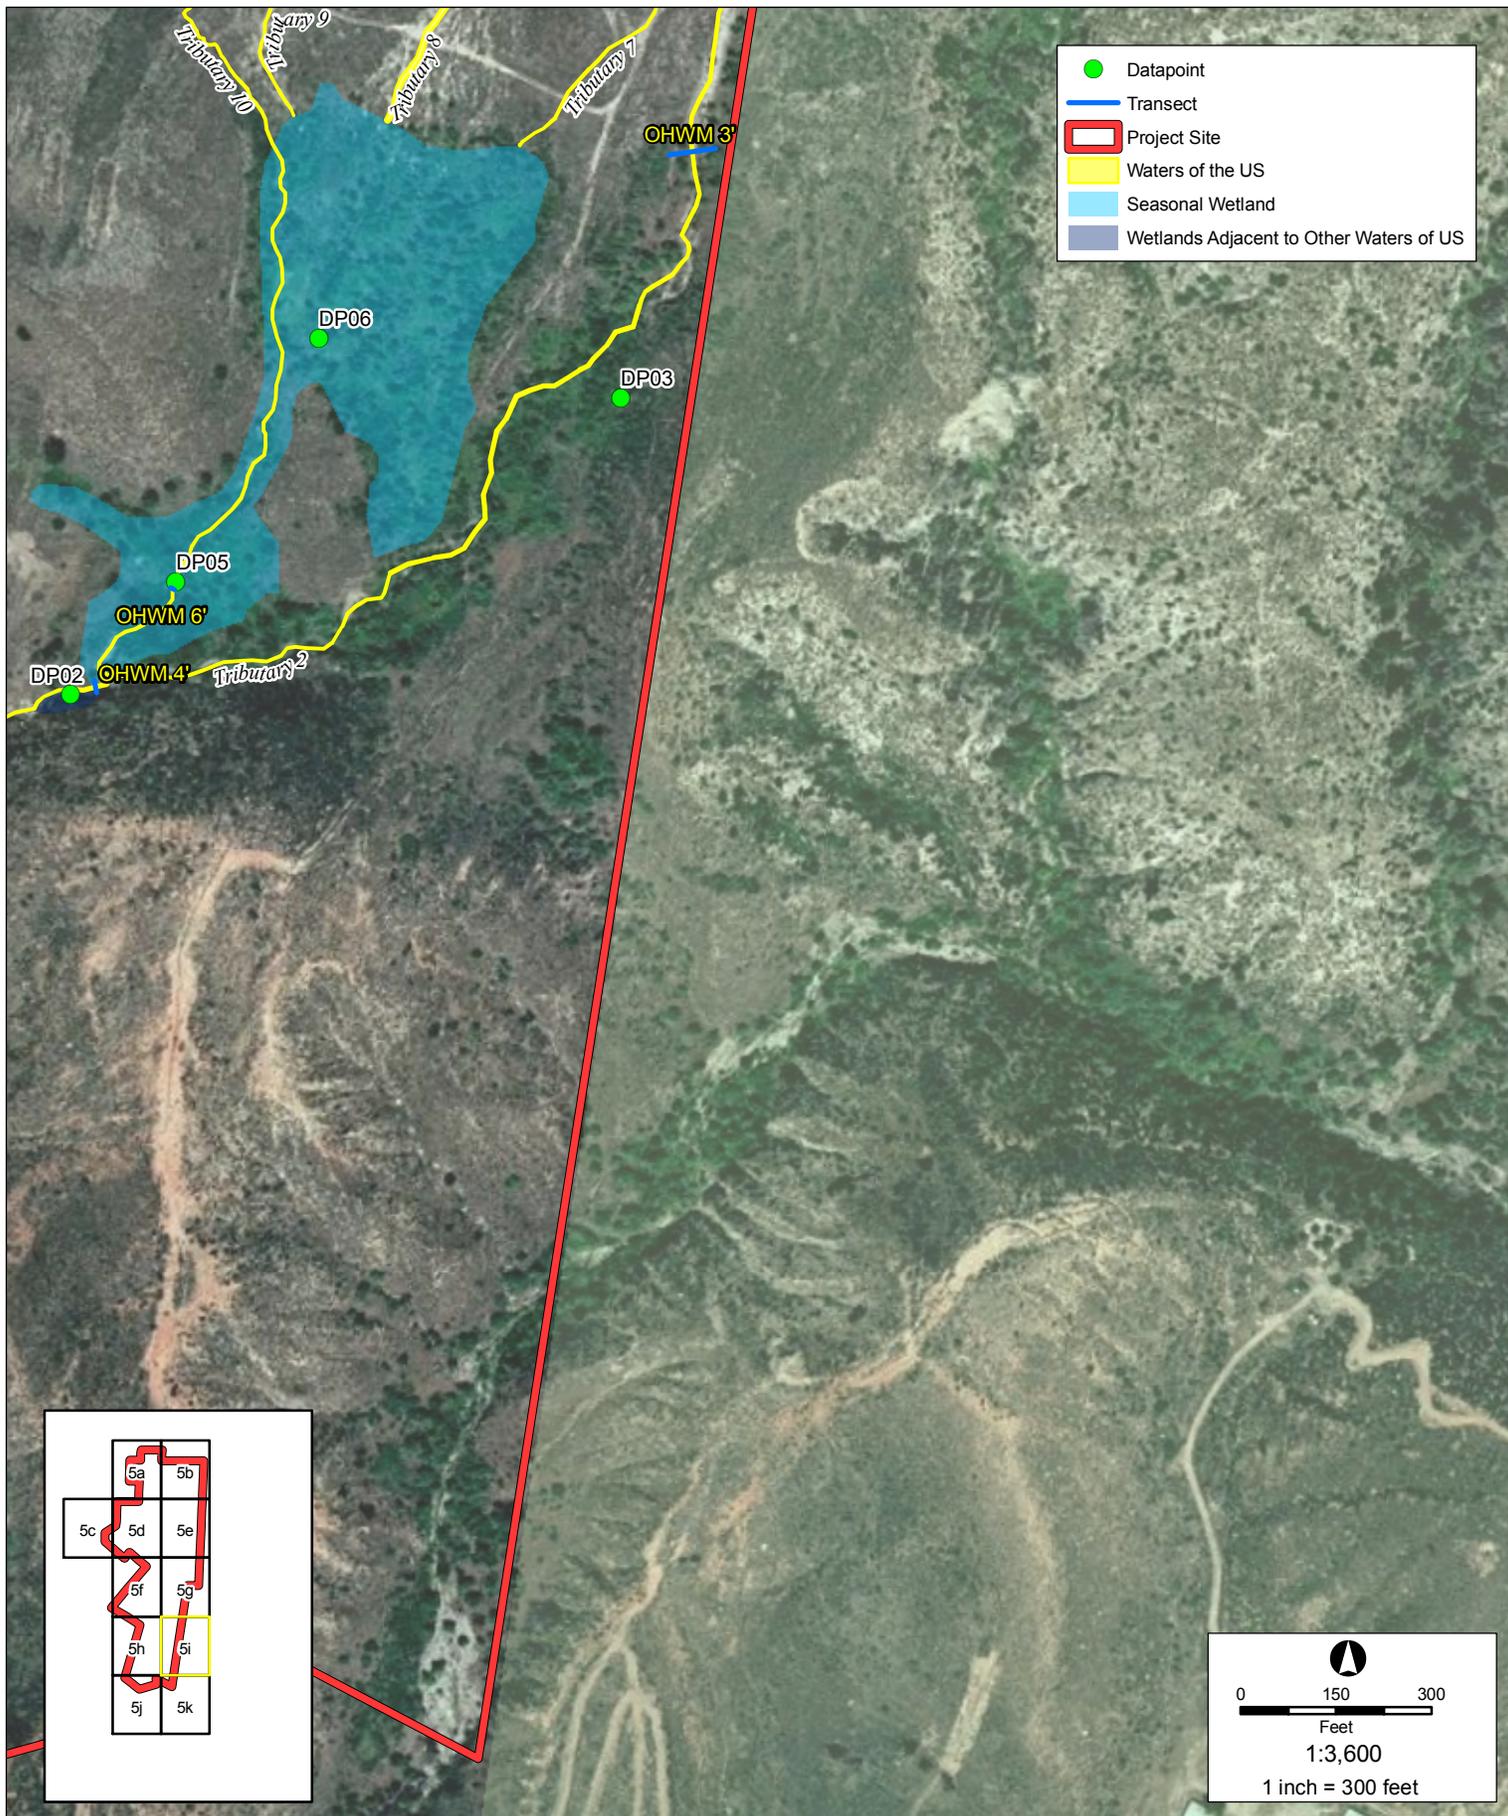
Figure 5i
**Potential Corps and RWQCB Jurisdictional Areas
 within Project Site**

A potential seasonal wetland is present in an upland area adjacent to Tributary 2 and Tributary 10 in the south-central portion of the project site (Figures 5i and 6i). Two data points (DPO5 and DP06) were taken within this potential wetland, including one within the active channel of Tributary T10 (DP05) to determine the presence/absence of similar conditions within the thalweg of the drainage versus the surrounding upland areas supporting the potential seasonal wetland. This feature is a problem area because while hydrophytic vegetation and wetland hydrology were present, no apparent hydric soil indicators were present during the delineation. Hydrophytic vegetation was dominated by cattails (*Typha latifolia*) and sedges, oxidized rhizospheres along living roots were the primary hydrology indicator. While soils that occur on this feature are not listed as hydric by NRCS, soils bordering Tributary 10 to the west are listed as hydric soils. In addition, a slightly gleyed matrix within the second stratified layer (although it does not meet the definition of a loamy gleyed matrix) indicates prolonged soil saturation. Nonetheless, since this feature resembles hydric soil indicators and exhibits wetland conditions, it could be considered a potential seasonal wetland. The approximate boundary of this seasonal wetland area was therefore delineated based primarily on vegetation and hydrology criterion, with the potential jurisdictional limits being defined by an overall dominance of hydrophytic vegetation, and hydrology indicators such as potential saturation visible on aerial imagery. Approximately 6.222 acres of this seasonal wetland could fall under the jurisdiction of the Corps, RWQCB, and CDFG.

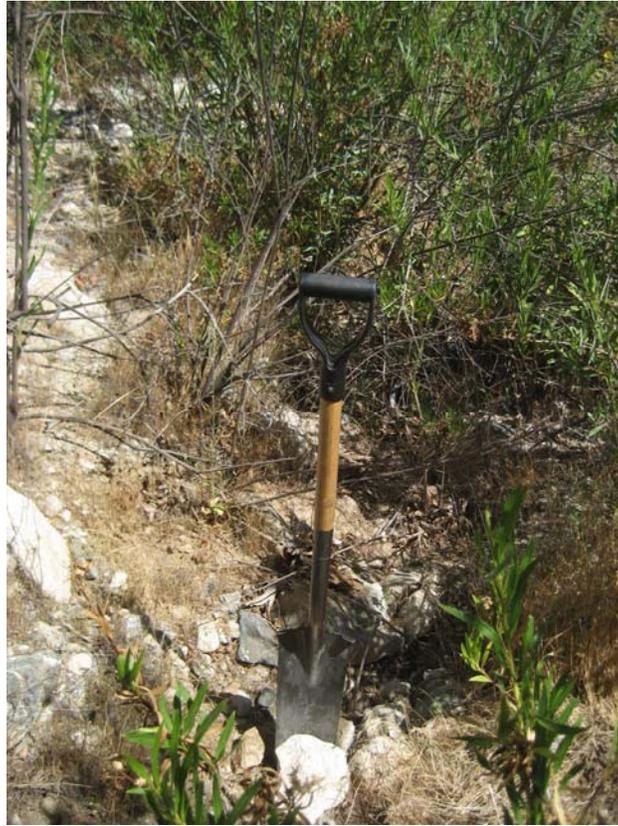
Photo 1: Upstream view of sample pit taken at DP01 within lower reach of Tributary 2, facing north. Field data confirmed the absence of wetlands within this area.

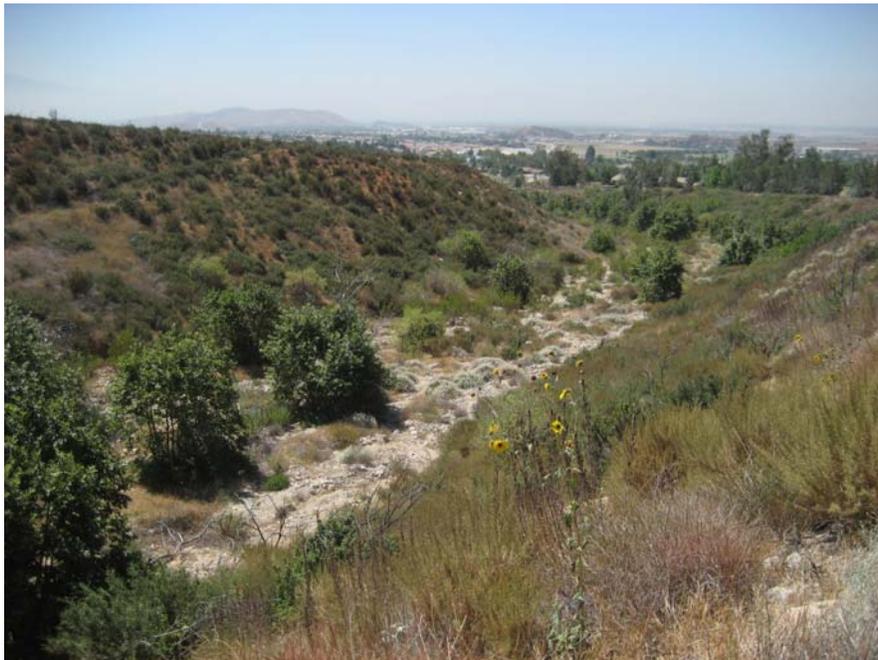
Photo 2: Downstream overview of lower reach of Tributary 2 within the project site, facing southwest.

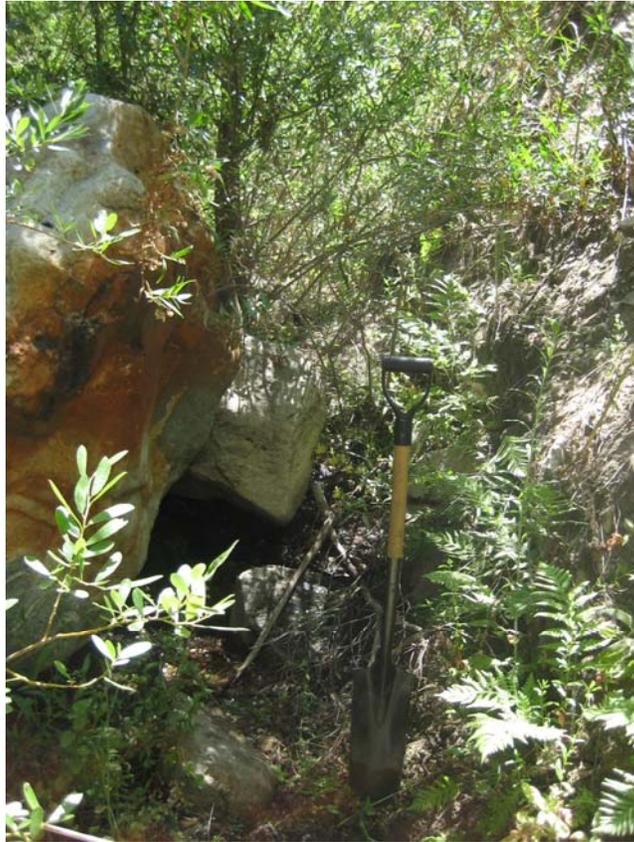
Photo 3: Upstream view of DP02 within middle reach of Tributary 2, facing northeast. Surface flows were observed and field data determined the presence of wetland conditions within this area.

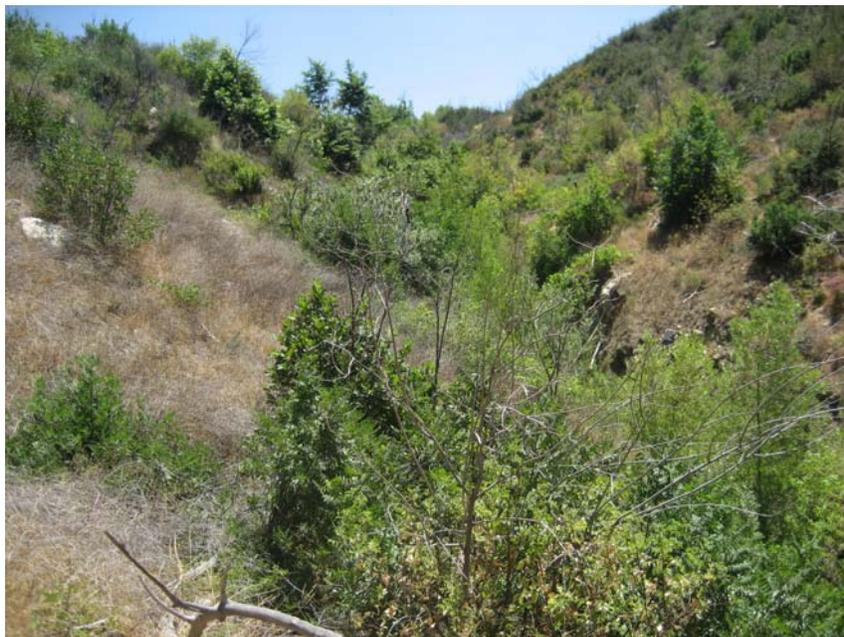
Photo 4: Upstream view of middle reach of Tributary 2, facing east. A steep grade and narrow channel was observed within this section of Tributary 2.

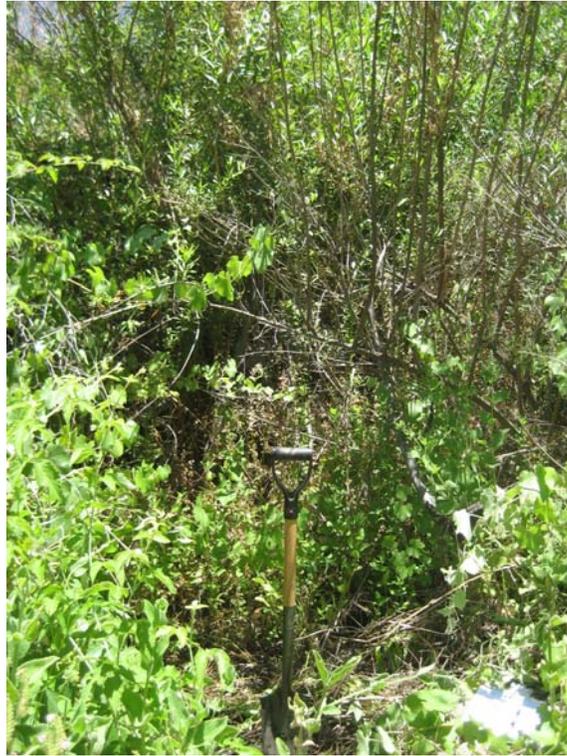
Photo 5: Cross-sectional view of DP05 taken within the lower reach of Tributary 10, facing northeast. Wetland conditions were confirmed at this location.

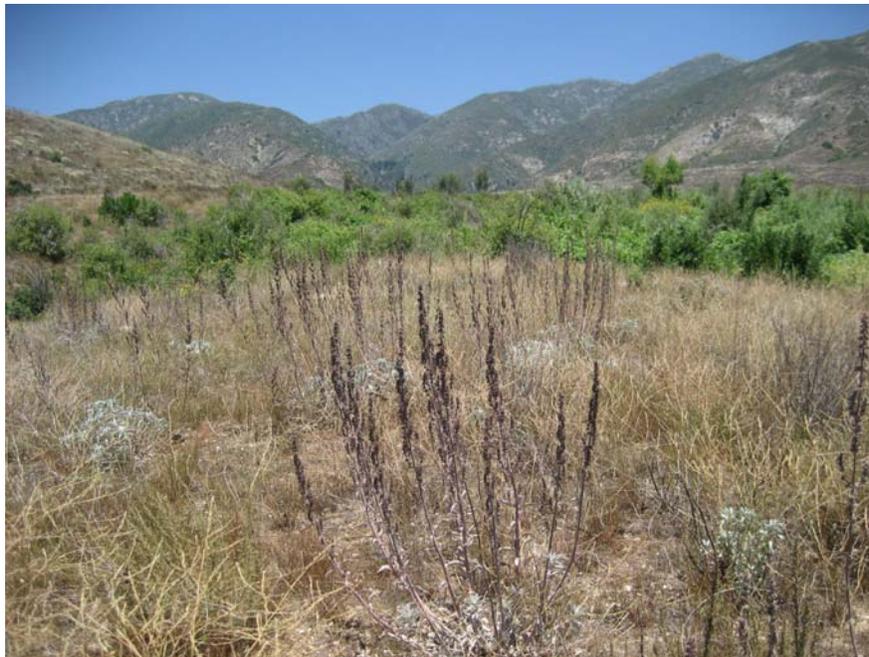
Photo 6: Overview of western portions of seasonal wetland area in southern-central portions of the site, facing north. The seasonal wetland is depicted in the mid-ground and adjacent uplands in the foreground.

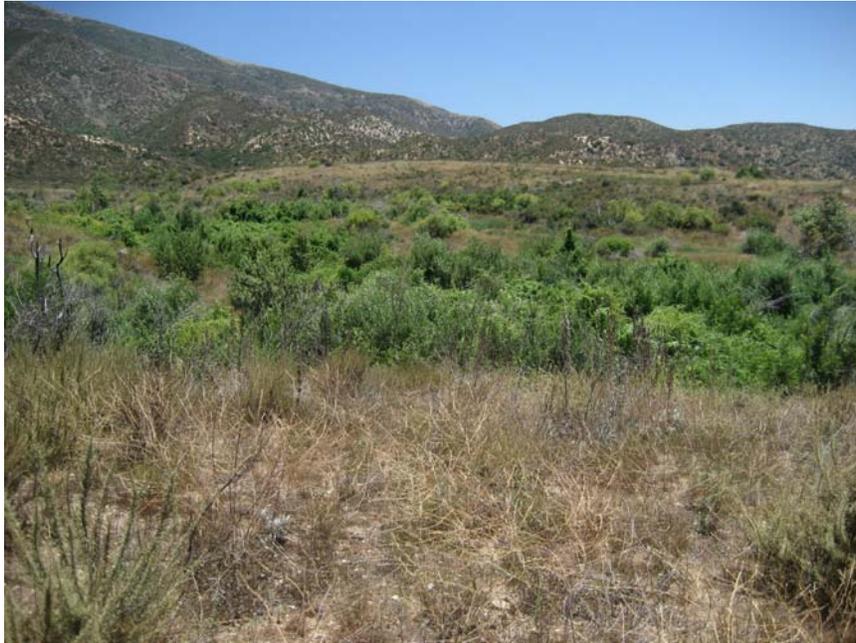
Photo 7: Overview of eastern portions of seasonal wetland area in southern-central portions of the site, facing north.

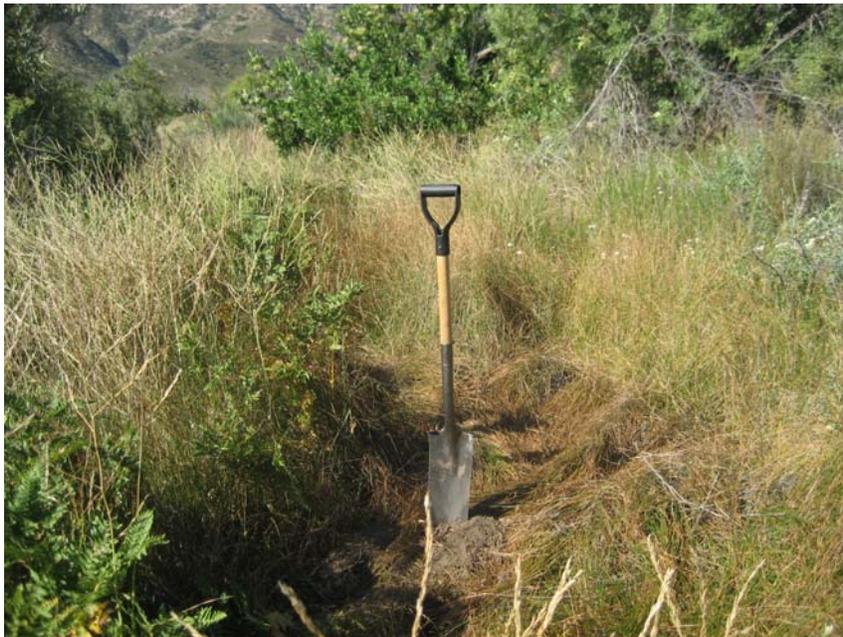
Photo 8: North-facing view of DP03 taken at the riparian drip-line within the middle reach of Tributary 2. No wetland conditions were determined to exist at this location.

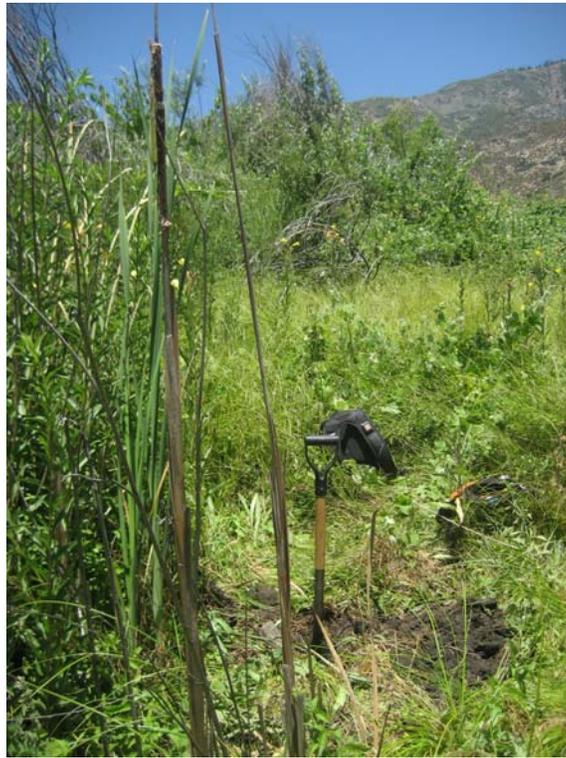
Photo 9: View of sample pit taken at DP06 within seasonal wetland area, facing north. This area was determined a potential problem area due to the lack of obvious hydric soil indicators, but dominance of hydrophytic vegetation and presence of hydrology indicators.

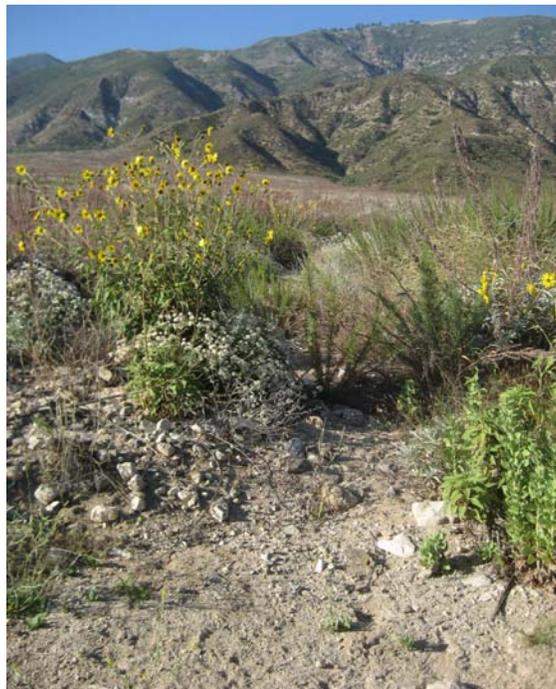
Photo 10: Upstream view of Tributary 9 taken upstream of seasonal wetland area, facing north. This feature is one of four ephemeral erosional features that occur in the central portions of the site.

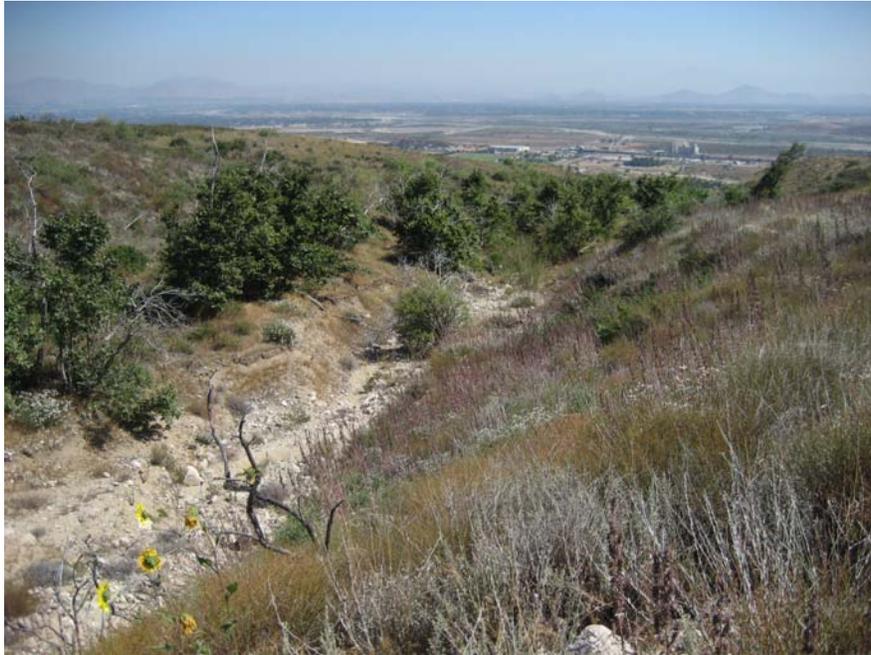
Photo 11: Downstream overview of upper reach of Tributary 2, facing south.

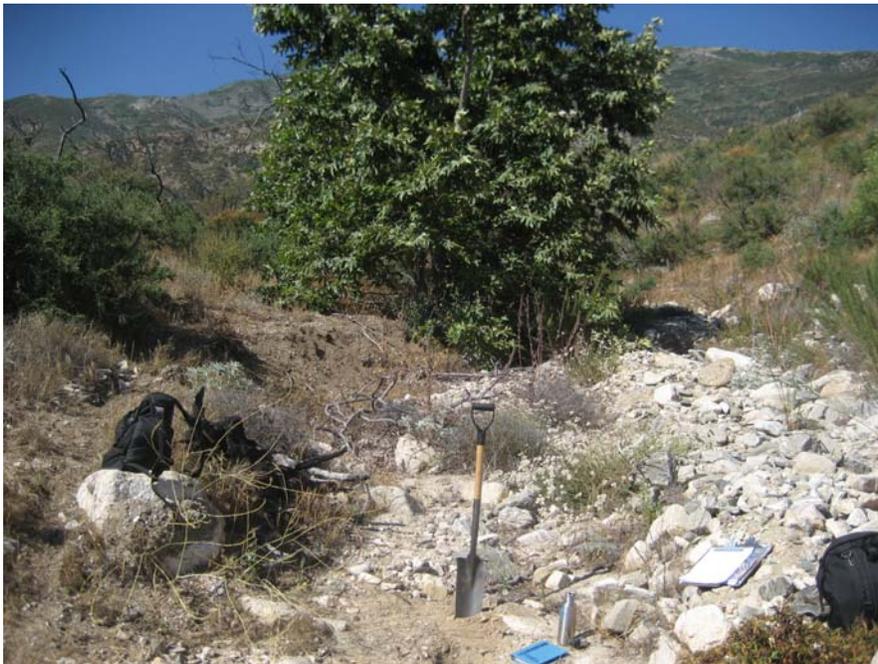
Photo 12: View of sample pit taken at DP04, facing north and upstream. No wetland conditions were determined to exist at this location.

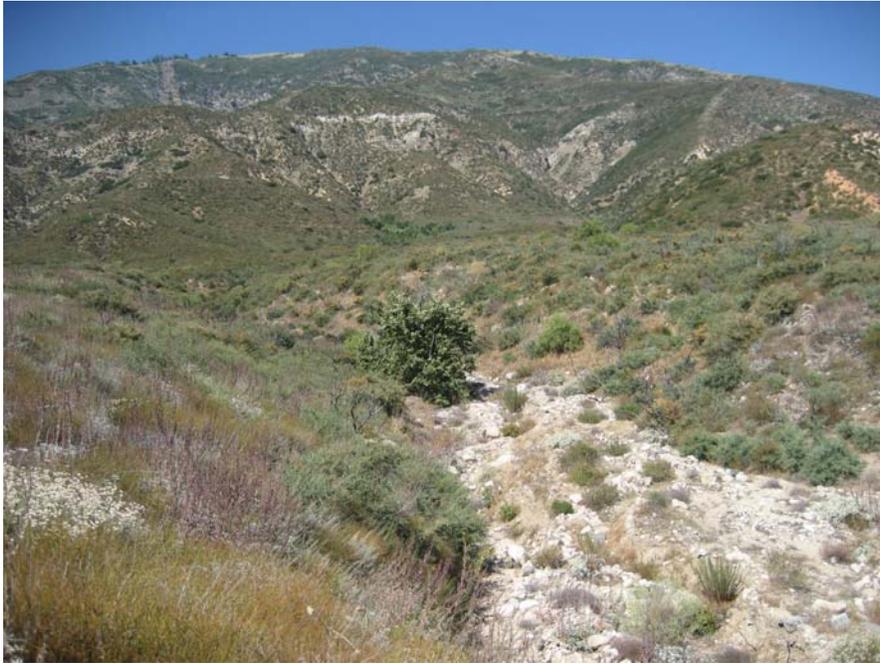
Photo 13: Upstream overview of upper reach of Tributary 2, facing northeast.

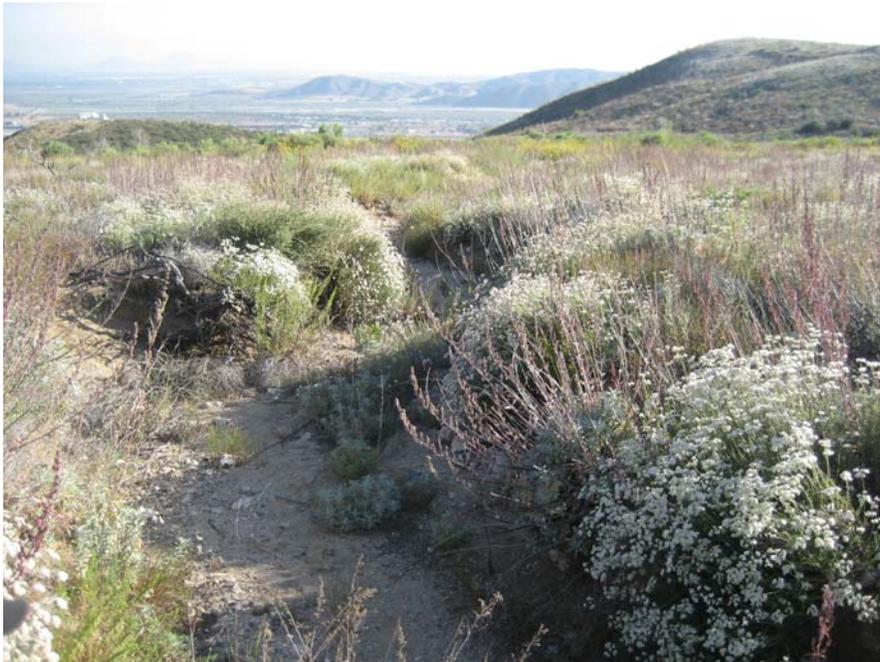
Photo 14: Downstream view of lower reach of Tributary 8, facing south. Tributary 8 is one of four ephemeral erosional features that traverse the central portions of the site.

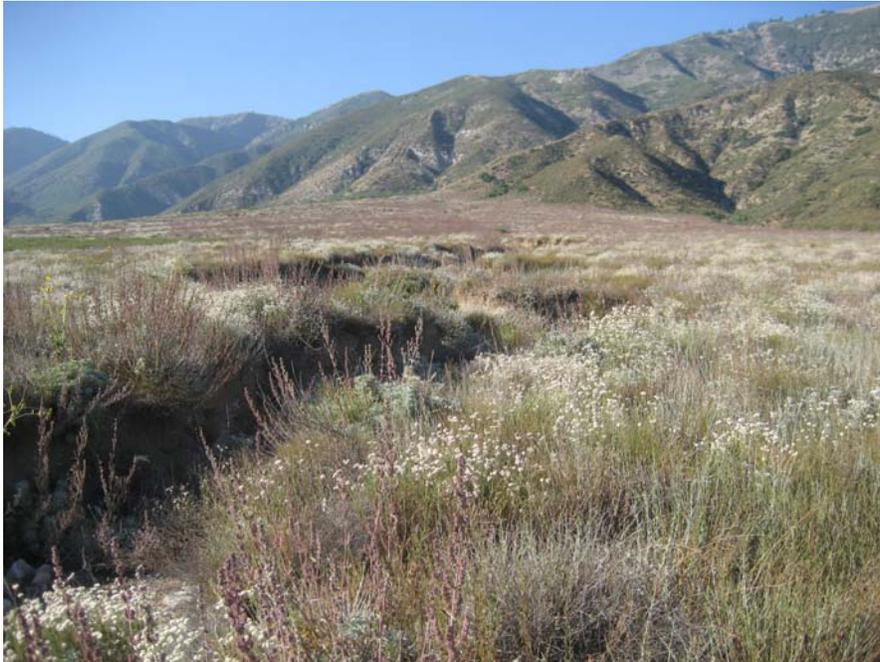
Photo 15: Upstream view of middle reach of Tributary 8, facing north. Note incised banks and dominance of homogeneous, upland alluvial fan sage scrub.

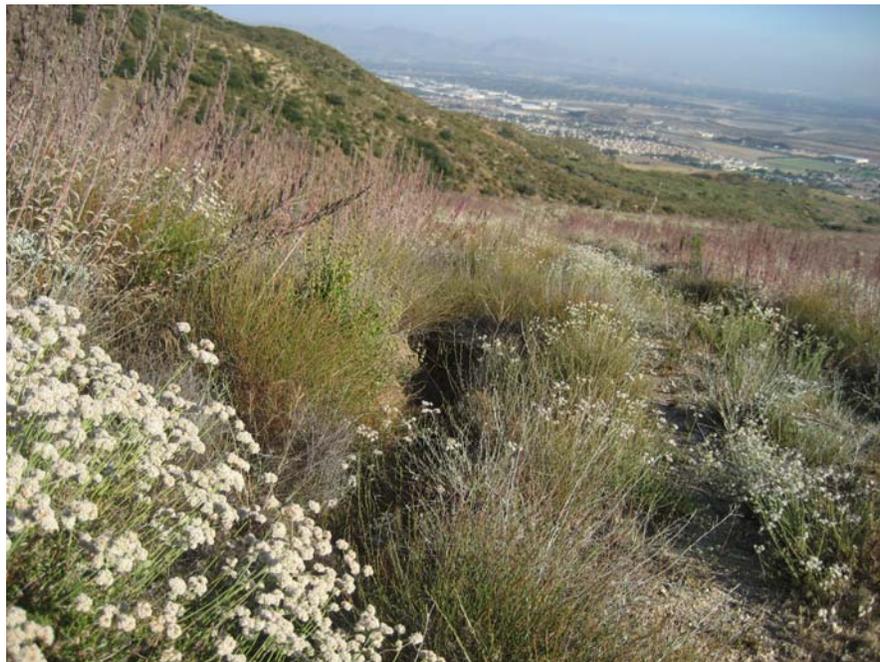
Photo 16: Downstream view of upper reach and origin of Tributary 7, facing southwest. This feature runs parallel to an existing dirt access road (depicted on right side of photo) throughout its entire reach. Tributary 7 is one of four ephemeral erosional features that drain the alluvial fan in the central portions of the site.

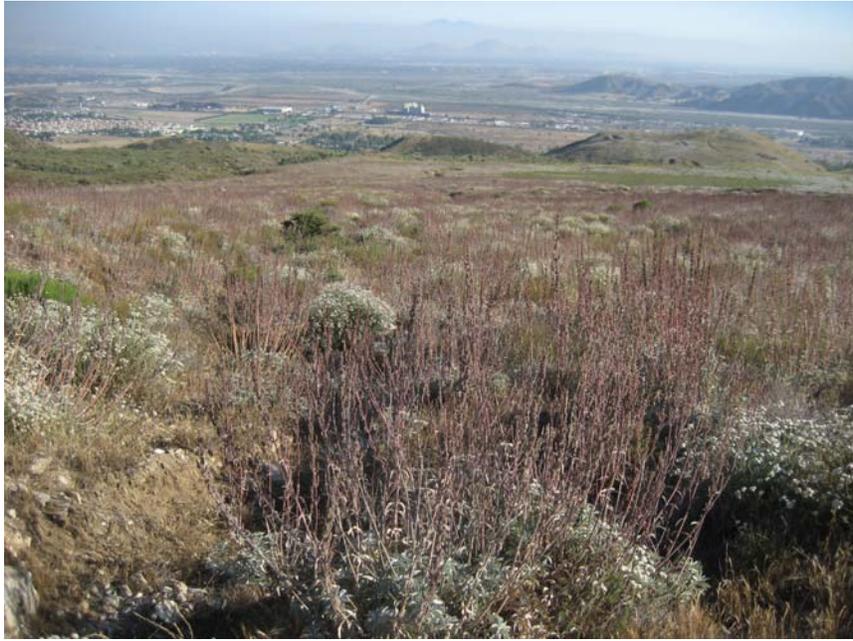
No potential wetland features were apparent, namely, hydrophytic vegetation; therefore, no data points were taken. No surface flows were observed within Tributary 8 during the delineation. Transect data for Tributary 8 reveals the OHWM for the active channel measuring at approximately two to eight feet wide, with an average width of approximately 5.0 feet. Approximately 0.193 acre of Tributary 8 that occurs within the project site could fall under the jurisdiction of the Corps and RWQCB. Jurisdiction under the CDFG measures at approximately 8.5 feet. Approximately 0.592 acre of this tributary could fall under CDFG jurisdiction.

Photo 17: Downstream view looking across the alluvial fan at the middle reach of Tributary 8, facing southwest.

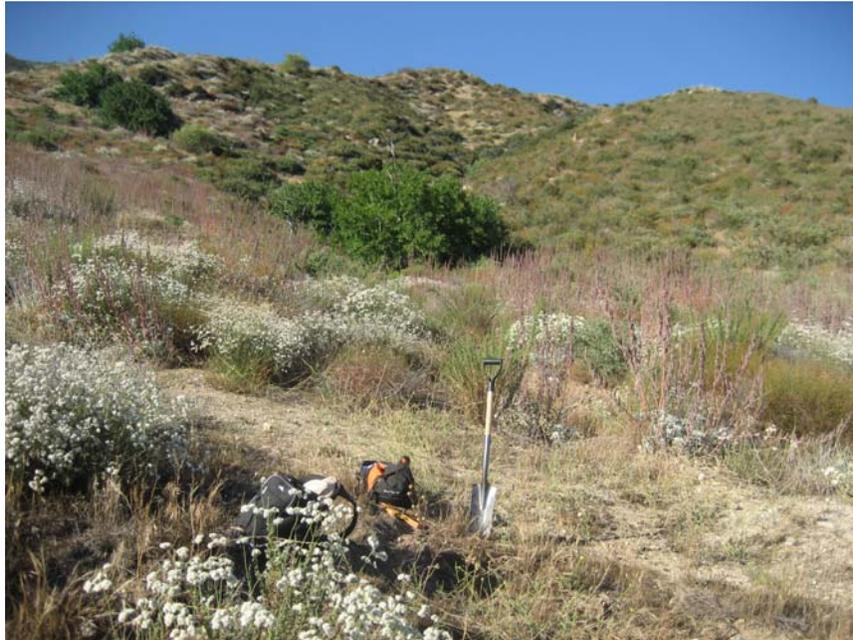
Photo 18: Upstream view of upper reach of Tributary 8, facing northeast. The headwaters and watershed for Tributary 8 are depicted in the background.

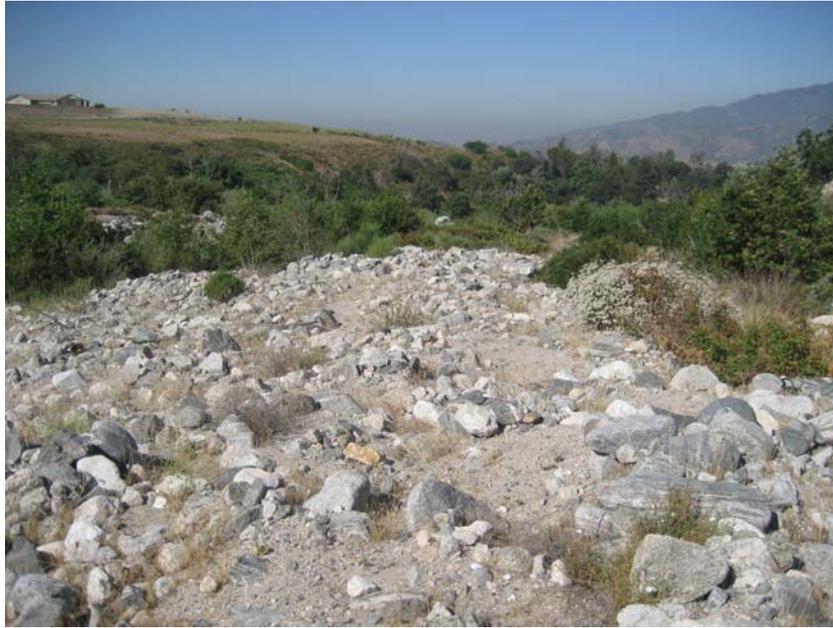
Photo 19: Downstream overview of lower reach of Cable Creek floodplain as it discharges from the site, facing southwest. Note broad bench and terrace in foreground and riparian canopy along main channel in background.

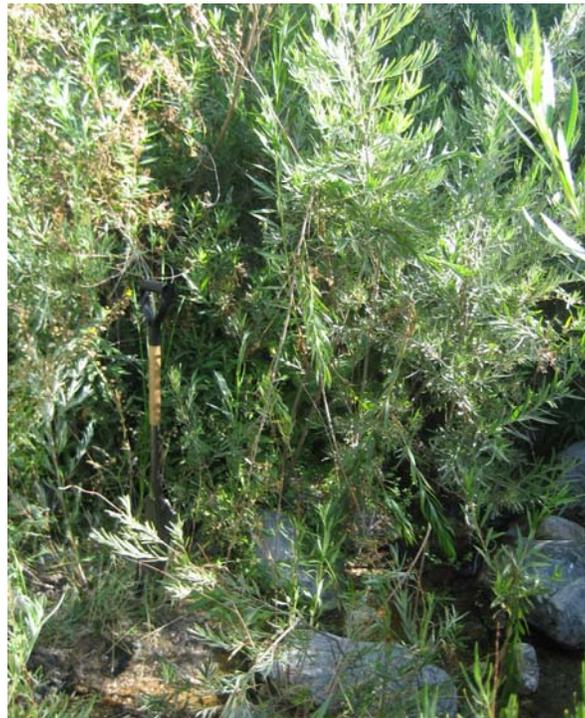
Photo 20: View of sample pit taken at DP07 within lower reach of Cable (Canyon) Creek, facing southeast. This sample point was taken at an access point immediately downstream and west of the project site. Perennial flows and wetland conditions were observed within the active channel at this location.

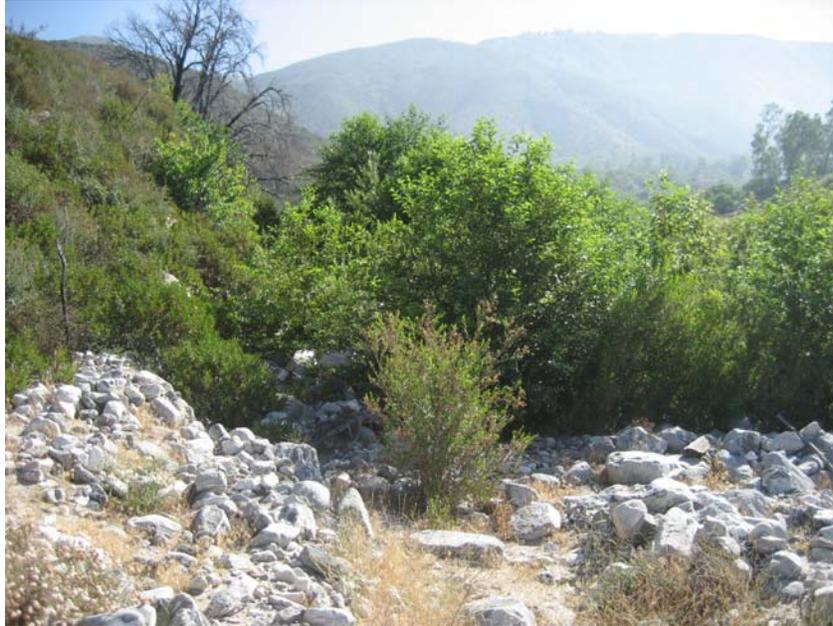
Photo 21: Upstream view of lower reach of Cable (Canyon) Creek, facing northeast. Photo taken from upland bench. Note sycamore-alder-willow riparian canopy associated within active channel in mid-ground.

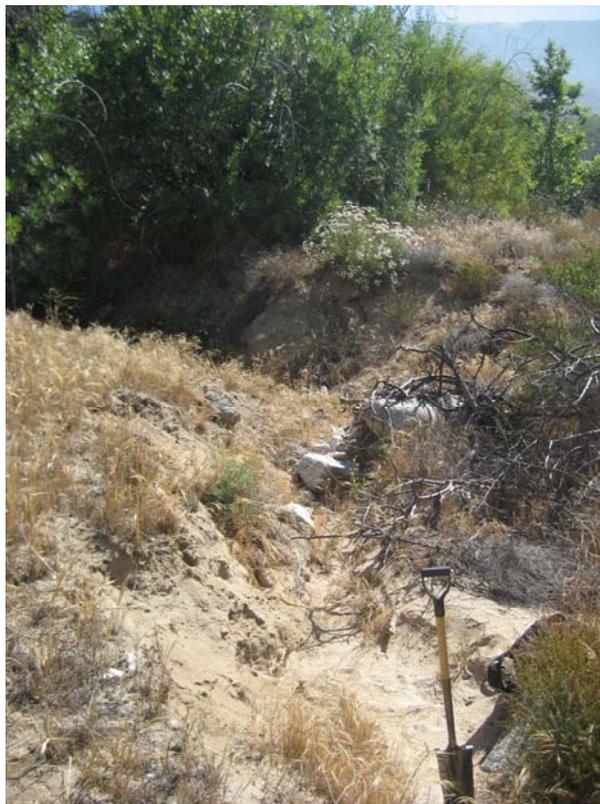
No potential wetland features were present; therefore, no data points were taken. No surface flows were observed within Tributary 10 during the delineation. Transect data for Tributary 11 reveals the OHWM for the active channel measuring at approximately three to 3.5 feet wide, with an average width of approximately 3.3 feet. Approximately 0.065 acre within the proposed project could fall under the jurisdiction of the Corps and RWQCB. Jurisdiction under the CDFG measures at approximately five to 12.5 feet wide, with an average width of approximately 8.8 feet. Approximately 0.072 acre of this tributary could fall under CDFG jurisdiction. However, Tributary 11 would not be impacted by the proposed project.

Photo 22: Upstream view of lower reach of Tributary 11, facing north.

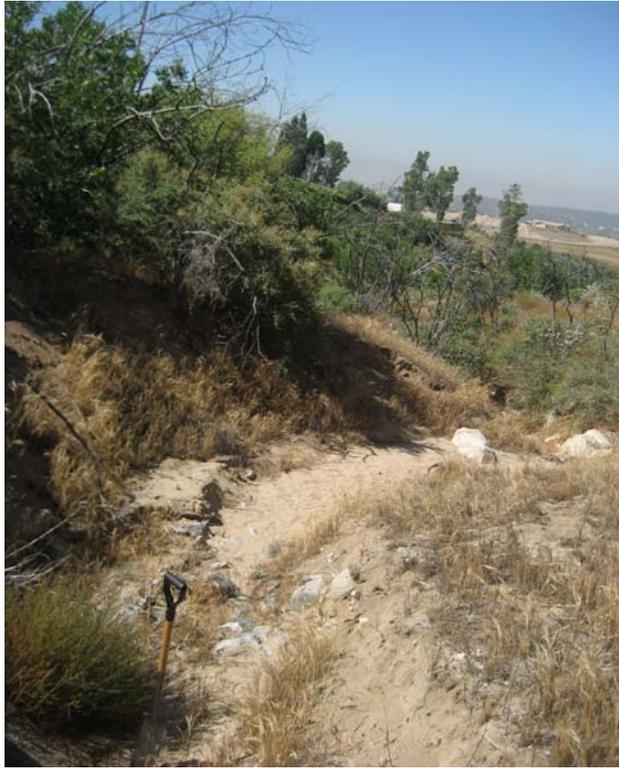
Photo 23: Downstream view of lower reach of Tributary 11, facing north. Cable (Canyon) Creek is depicted in background.

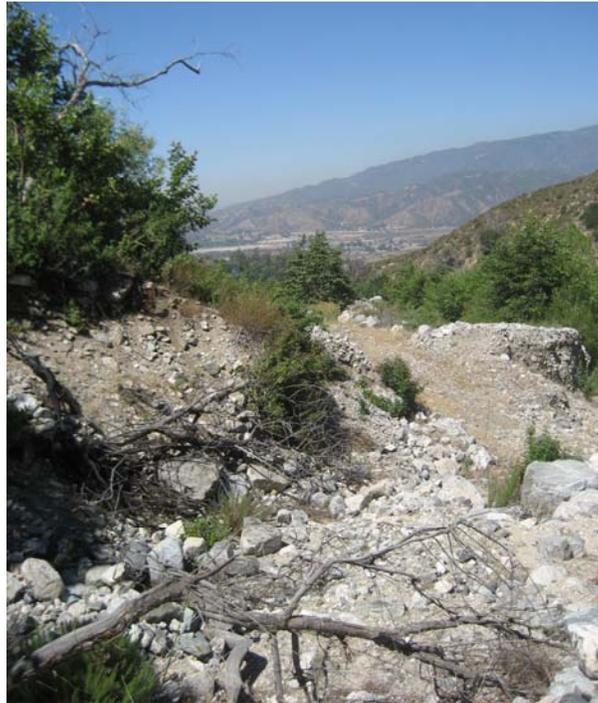
No potential wetland features were present; therefore, no data points were taken. No surface flows were observed during the delineation. Transect data for Tributary 17 reveals the OHWM for the active channel measuring at approximately two to 12 feet wide, with an average width of approximately 4.8 feet. Approximately 0.186 acre within the project site could fall under the jurisdiction of the Corps and RWQCB. Jurisdiction under the CDFG measures at approximately 16.5 to 35 feet wide, with an average width of approximately 23.1 feet. Approximately 1.156 acres of this tributary could fall under CDFG jurisdiction.

Photo 25: Downstream view of lower reach of Tributary 17 and confluence with Cable Canyon, facing west.

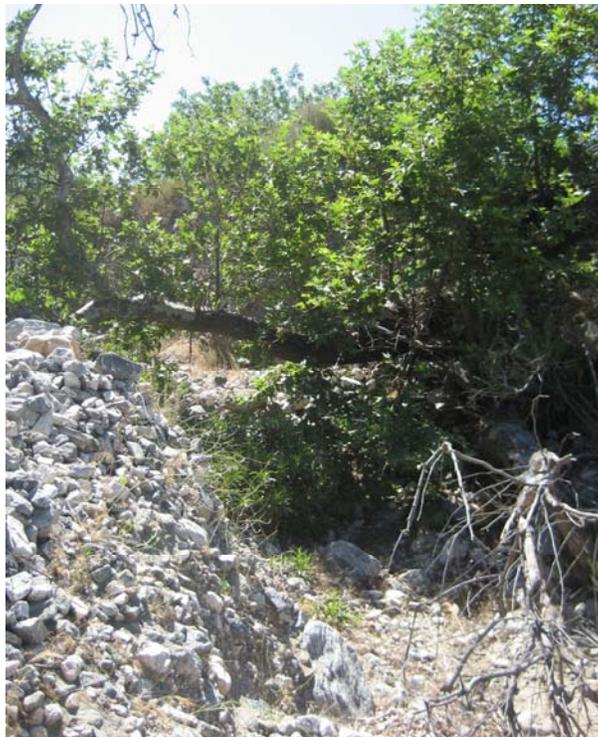
Photo 26: Upstream view of lower reach of Tributary 17, facing east.

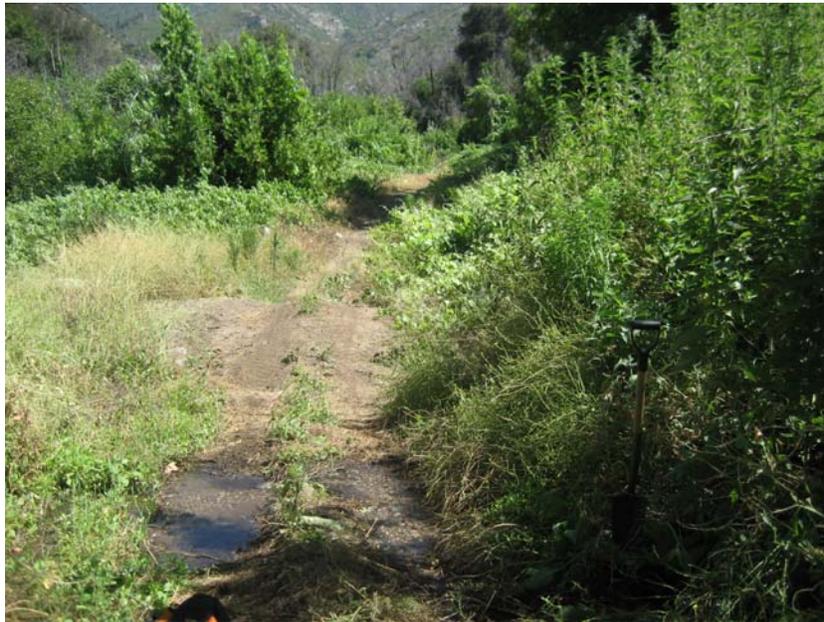
Photo 27: View sample pit taken at DP08, facing north. Normal conditions are not present at this location as it occurs below the outfall drain and valve switch for a plastic water pipe. The area is occasionally subjected to artificial inundation when the valve is open.

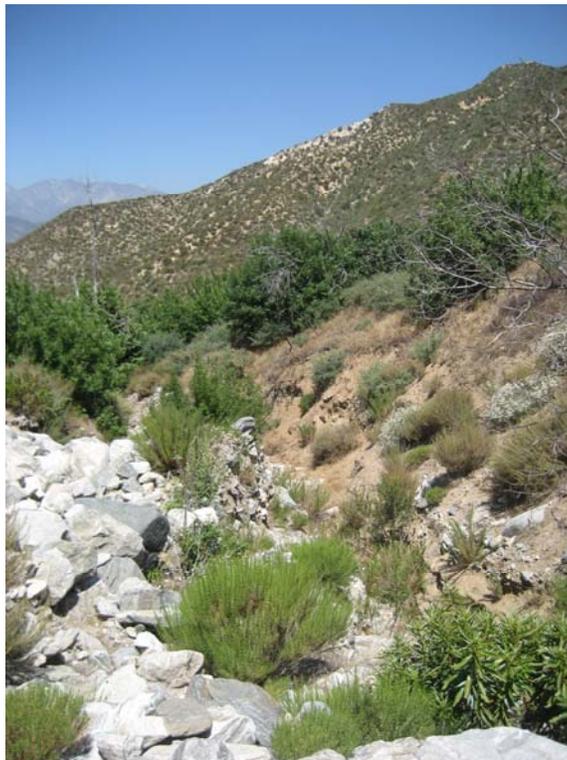
Photo 28: Downstream view of lower reach of Tributary 17, facing west.

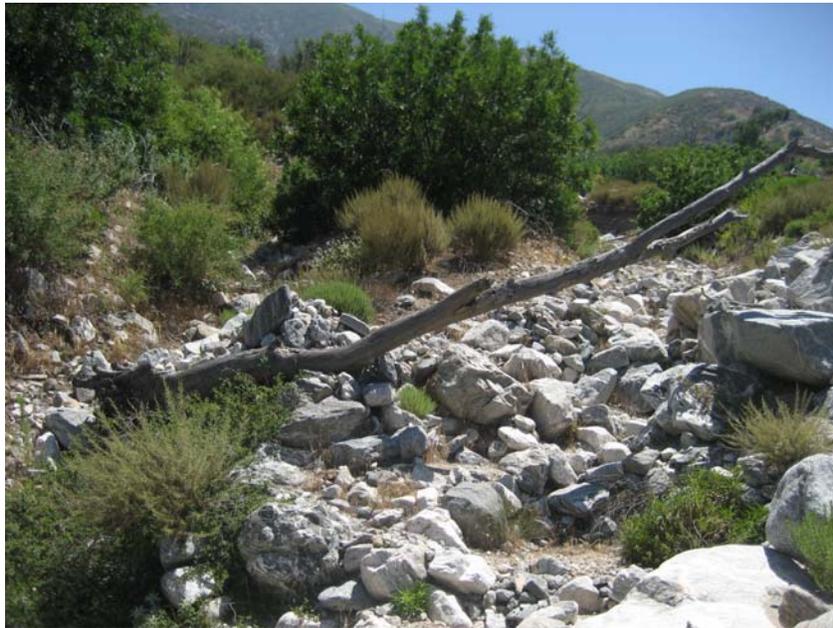
Photo 29: Upstream view of middle reach of Tributary 17 (foreground and right) where Tributary 15 (background left) converges, facing northeast.

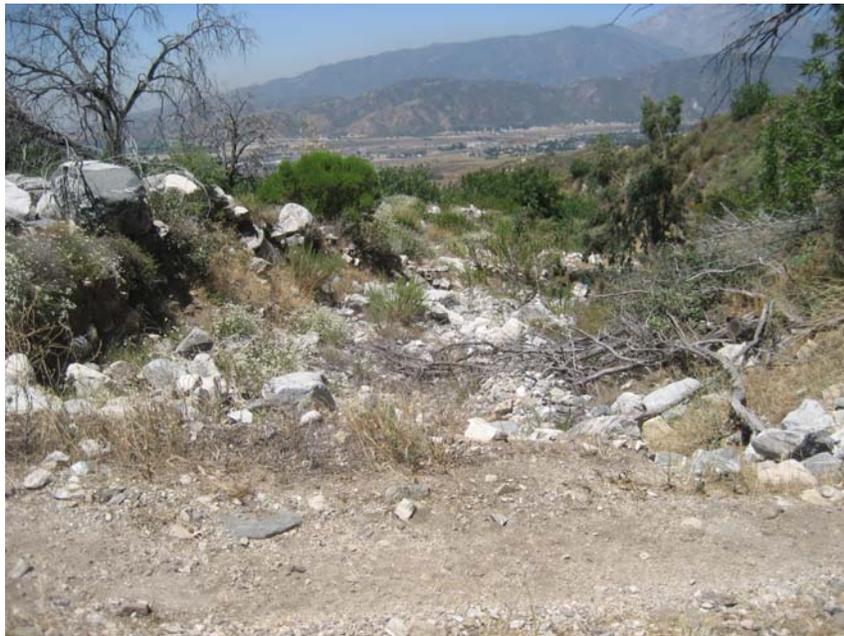
Photo 30: Downstream view of middle reach of Tributary 17, facing west. Photo taken from existing dirt access road that intersects the drainage feature.
