Delineation of Jurisdictional Wetlands and Waters

Spring Trails Specific Plan, San Bernardino County, California

July 28, 2009

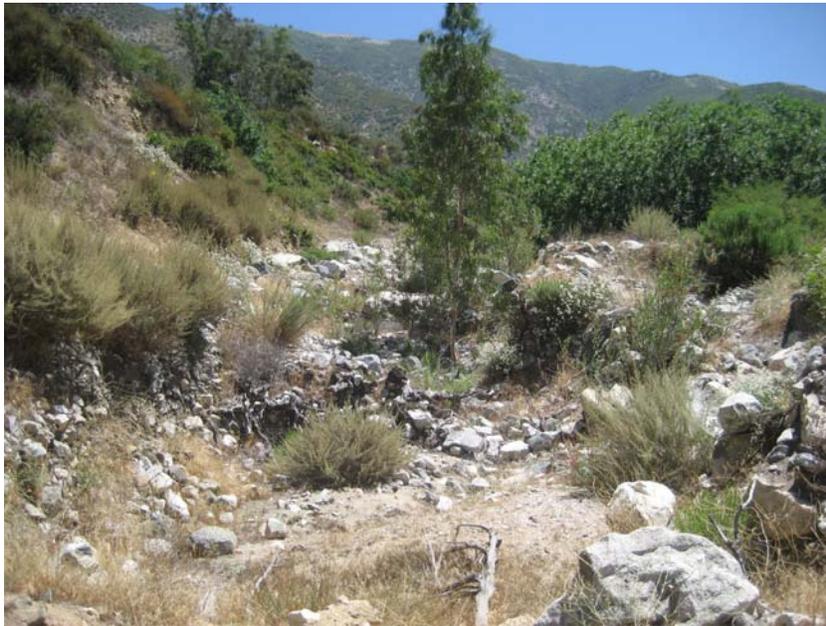
Photo 31: Upstream view of upper reach of Tributary 17, facing northeast. Photo taken from existing dirt access road that intersects the drainage feature.

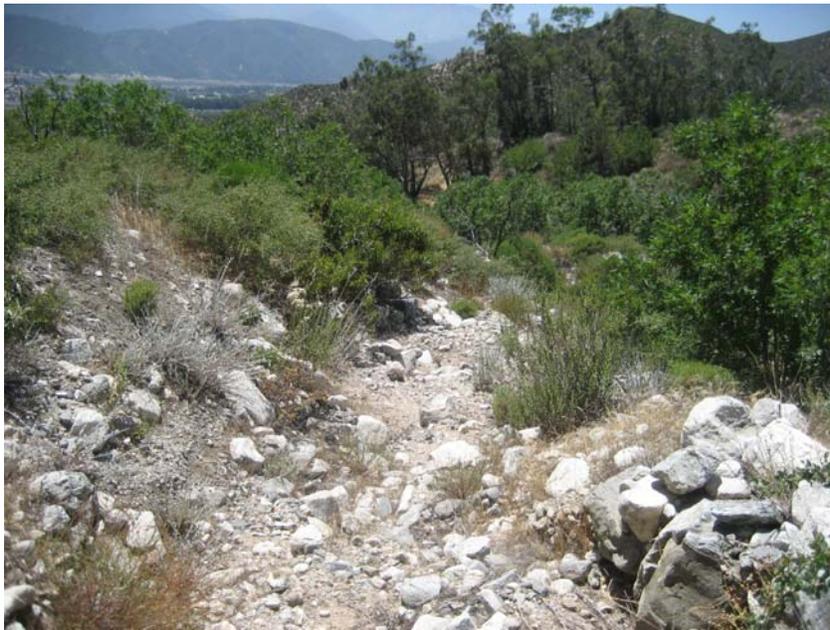
Photo 32: Downstream view of lower reach of Tributary 18, facing west. This feature converges with Tributary 17 approximately 300 feet downstream as depicted in mid-ground of the photo.

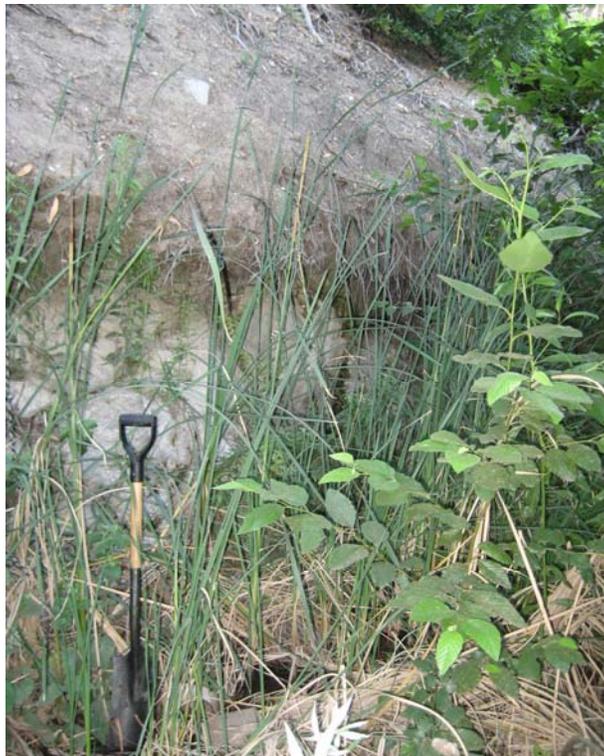
Photo 34: View of typical abutting wetland area at DP09 within upper reach of Cable Canyon (West Fork). Sample taken immediately outside of active channel.

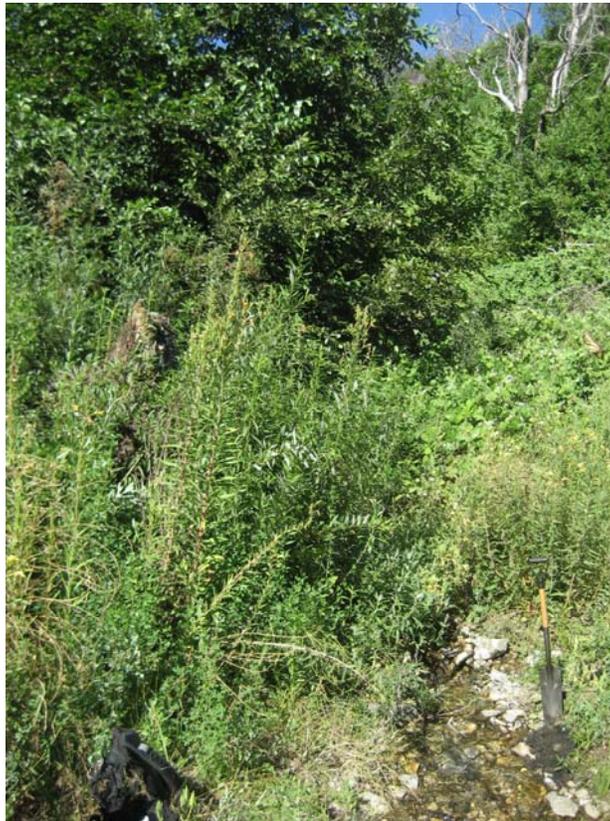
Photo 35: Upstream view of sample pit taken at DP10 within Cable Canyon (East Fork), facing northeast. Wetland conditions were confirmed abutting the active channel.

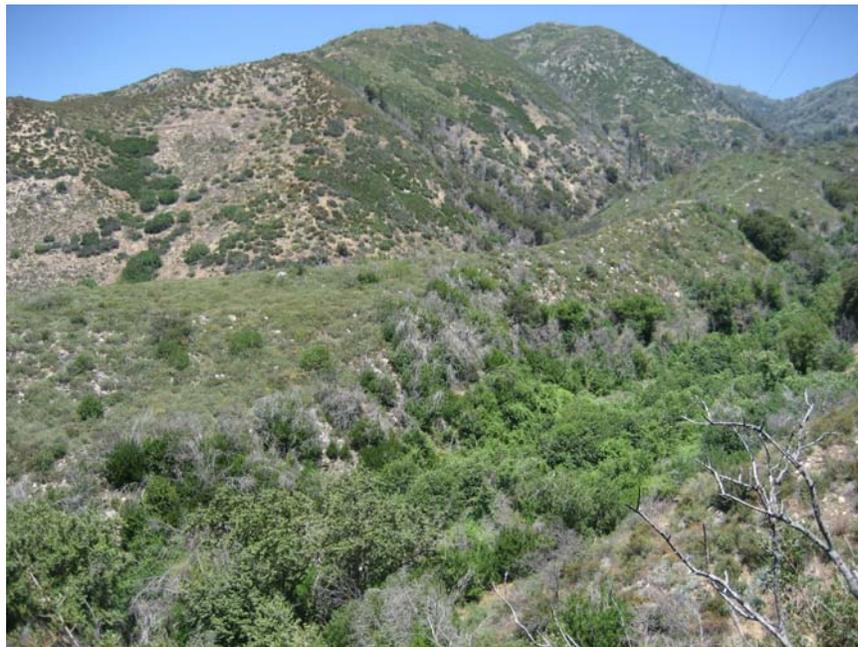
Photo 36: Overview of upper reaches of East Fork (foreground) and West Fork (background) of Cable Canyon, facing northwest. These areas were inaccessible by foot due to steep terrain and extremely dense vegetation.
