REVISED ASBESTOS AND LEAD-BASED PAINT SURVEY MOUNT VERNON AVENUE BRIDGE SAN BERNARDINO, CALIFORNIA

January 13, 2010
Project No. 205732002

Subject: Revised Asbestos and Lead-Based Paint Survey
Mount Vernon Avenue Bridge
San Bernardino, California

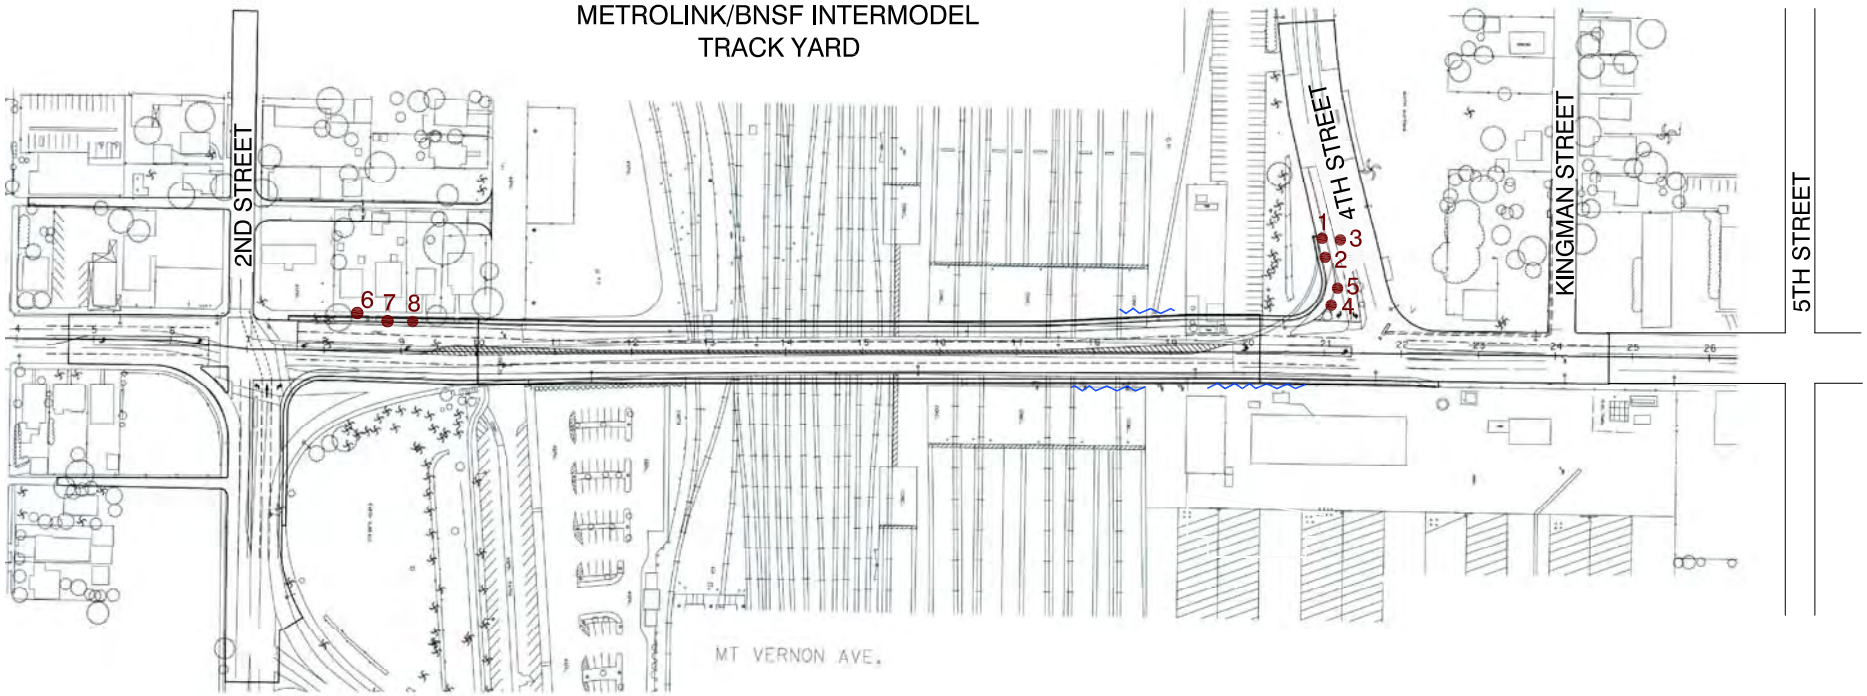
Ninyo & Moore		SAMPLE LOCATION MAP	FIGURE
PROJECT NO.	DATE	MOUNT VERNON AVENUE BRIDGE SAN BERNARDINO, CALIFORNIA	2
205732002	1/10

proximately 76 feet wide and approximately 1,000 feet long concrete bridge. Pipe insulation was noted on the northern portion of the bridge along the eastern and western sides. The insulation was situated near the lower edges of the bridge bottom.

A preliminary visual assessment and bulk-sampling survey of suspect ACMs was performed. Representative samples of the suspect ACMs were collected after identification of homogeneous sampling areas (areas in which the materials are uniform in color, texture, construction or application date, and general appearance). Each homogeneous area was observed for material type, location, condition, and friability. Representative samples were collected from each area except areas that were inaccessible, or areas of assumed ACM, within the limitations of the survey. Samples were collected using EPA-recommended sampling procedures. Building materials which were sampled and analyzed for the presence of asbestos are presented in Table 1. The locations of bulk asbestos samples are shown on Figure 2.

- Approximately 100 linear feet (LF) of pipe insulation, assumed to be asbestos-containing, located on the east side of the bridge. This material was inaccessible and could not be sampled.

- The identified ACMs should not be disturbed. Prior to renovation or demolition work which would disturb identified ACMs, a Cal OSHA-licensed certified asbestos abatement removal contractor should remove the ACMs.
